## Profile/Photo Observation Report

Date:	<b>03/20/2018</b>	Weather:		Coding:	<b>PACP 6.0</b>
Pipe Length (ft):	<b>207.0</b>	Owner:	<b>NA</b>	Pre Clean:	<b>No Pre-Cleaning</b>
P.O.#:		Surveyor:	<b>John Kuglmaier</b>	PSR:	<b>P-108-054-021</b>
Customer:		Clean Date:	<b>01/01/1900</b>	Shape:	<b>C</b>

Street:	<b>FOXCROFT STREET</b>	Flow Control:	<b>Not Controlled</b>
City:	<b>Hobart, IN</b>	Year Renewed:	
Location:	<b>Light Highway</b>	Tape/Media #:	
Purpose:	<b>Routine Assessment</b>	Dia/Height:	<b>10"</b>
Use:	<b>Sanitary</b>	Material:	<b>PVC</b>
Drain Area:	<b>NA</b>	Lining:	
Category:	<b>NA</b>		
Comment:	<b>P_C at 53 ft nothing visible .Flow direction wrong</b>		
Location Details:		Direction of Survey:	<b>Upstream</b>
US MH:	<b>M-208-021</b>	DS MH:	<b>M-108-054</b>
		Total Length Surveyed (ft):	<b>54.4</b>

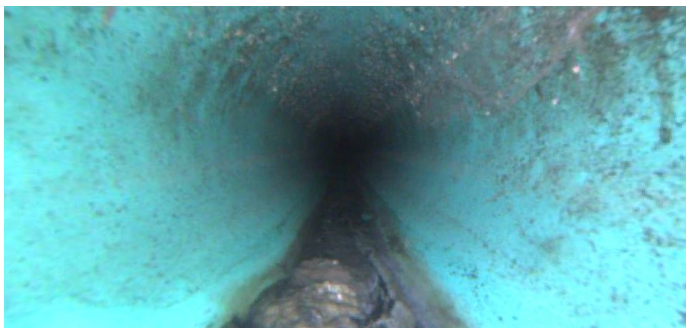
Code: **AMH**  
Description: **Manhole**

Distance (ft): **.0**  
Structural Grade: **0**  
O&M Grade: **0**  
Clock Start/From:  
Clock To:  
1st Value:  
2nd Value:  
Value Percent:  
Continuous Index:  
Within 8" of Joint: **NO**  
Remarks: **M-108-054**

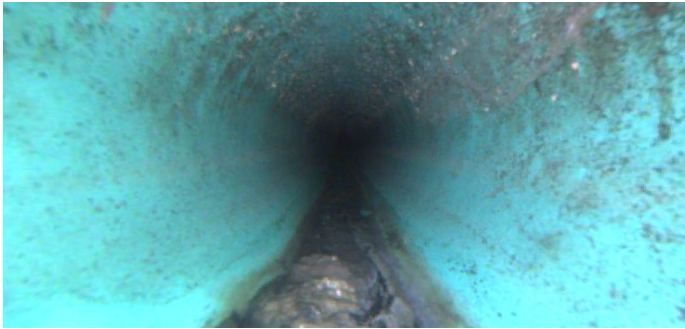
Code:	<b>MWL</b>
Description:	<b>Water Level</b>

Distance (ft):	<b>.0</b>
Structural Grade:	<b>0</b>
O&M Grade:	<b>0</b>
Clock Start/From:	
Clock To:	
1st Value:	
2nd Value:	
Value Percent:	<b>5.000</b>
Continuous Index:	
Within 8" of Joint:	<b>NO</b>
Remarks:

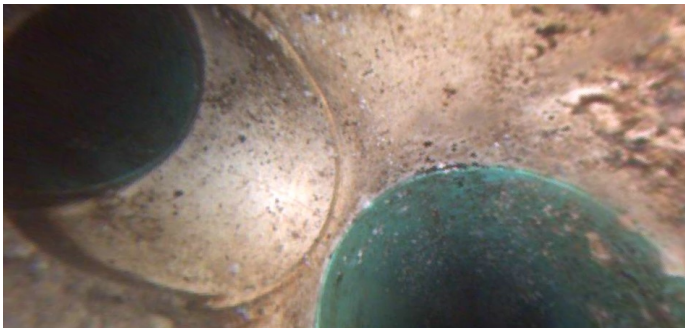
Code:	<b>TF</b>
Description:	<b>Tap Factory</b>

Distance (ft):	<b>39.1</b>
Structural Grade:	<b>0</b>
O&M Grade:	<b>0</b>
Clock Start/From:	<b>10</b>
Clock To:	
1st Value:	<b>4.000</b>
2nd Value:	
Value Percent:	
Continuous Index:	
Within 8" of Joint:	
Remarks:

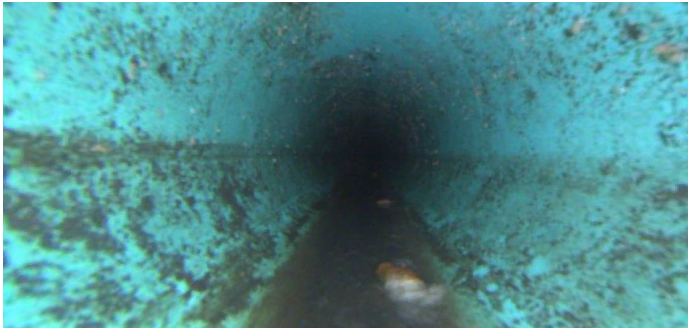
Code:	<b>MSA</b>
Description:	<b>Abandoned Survey</b>
Distance (ft):	<b>54.4</b>
Structural Grade:	<b>0</b>
O&M Grade:	<b>0</b>
Clock Start/From:	
Clock To:	
1st Value:	
2nd Value:	
Value Percent:	
Continuous Index:	
Within 8" of Joint:	<b>NO</b>
Remarks:	<b>Unknown</b>
