Profile/Photo Observation Report

Street:	South Liverpool Road	Flow Control:	Not Controlled
City:	Hobart, IN	Year Renewed:	
Location:	Easement/Right of Way	Tape/Media #:	DEP226
Purpose:	Routine Assessment	Dia/Height:	15"
Use:	Sanitary	Material:	VCP
Drain Area:		Lining:	
Category:	NA		
Comment:	YES501824 Submittal 2		
Location Details:		Direction of Survey:	Downstream
US MH:	M-208-024	DS MH:	M-208-023
		Total Length Surveyed (ft):	8.1

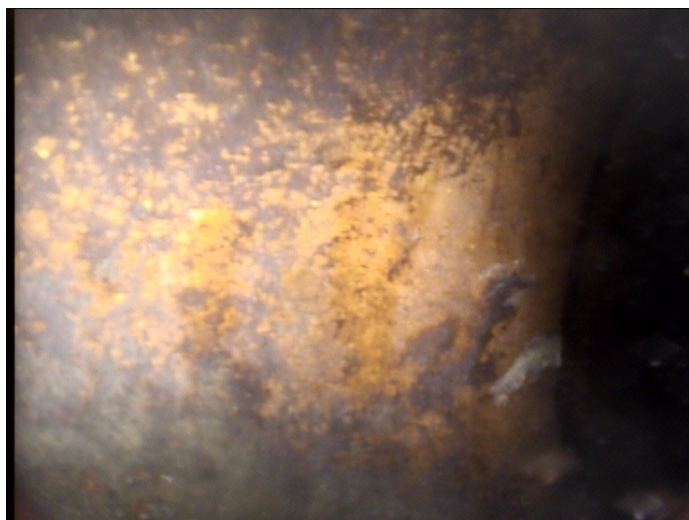
Code: **AMH**
Description: **Manhole**

Distance (ft): **.0**
Structural Grade: **0**
O&M Grade: **0**
Clock Start/From:
Clock To:
1st Value:
2nd Value:
Value Percent:
Continuous Index:
Within 8" of Joint: **NO**
Remarks: **M-208-023**

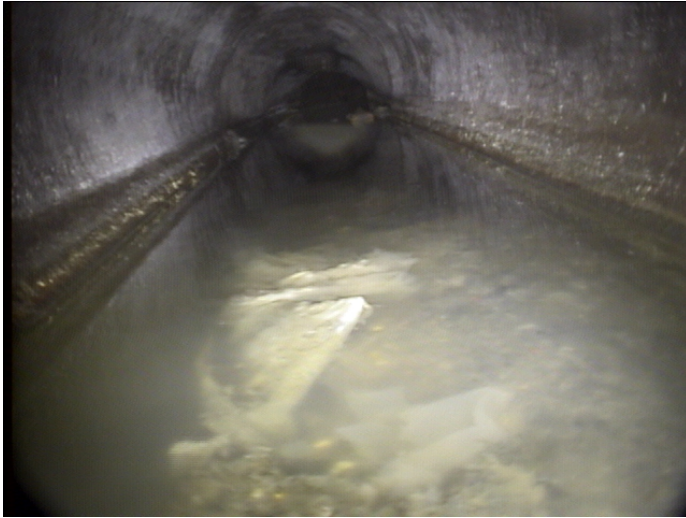
Code: **MWL**
Description: **Water Level**

Distance (ft): **.0**
Structural Grade: **0**
O&M Grade: **0**
Clock Start/From:
Clock To:
1st Value:
2nd Value:
Value Percent: **20.000**
Continuous Index:
Within 8" of Joint: **NO**
Remarks:

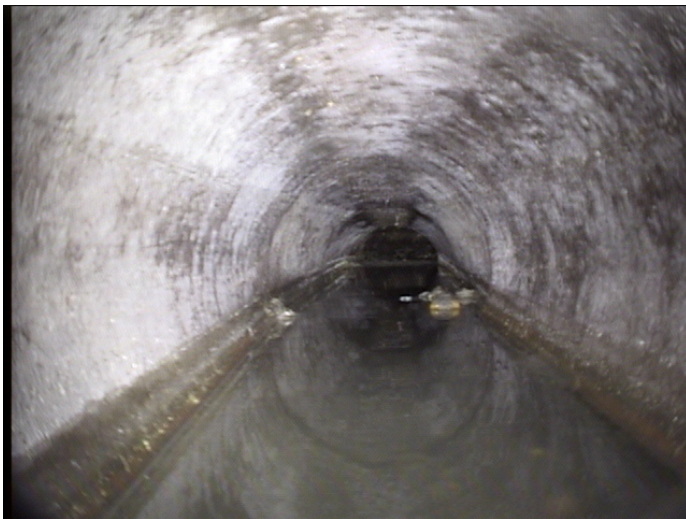
Code: **DSF**
Description: **Deposits Settled Fine**

Distance (ft): **.2**
Structural Grade: **0**
O&M Grade: **2**
Clock Start/From: **5**
Clock To: **7**
1st Value:
2nd Value:
Value Percent: **10.000**
Continuous Index: **S01**
Within 8" of Joint: **NO**
Remarks:

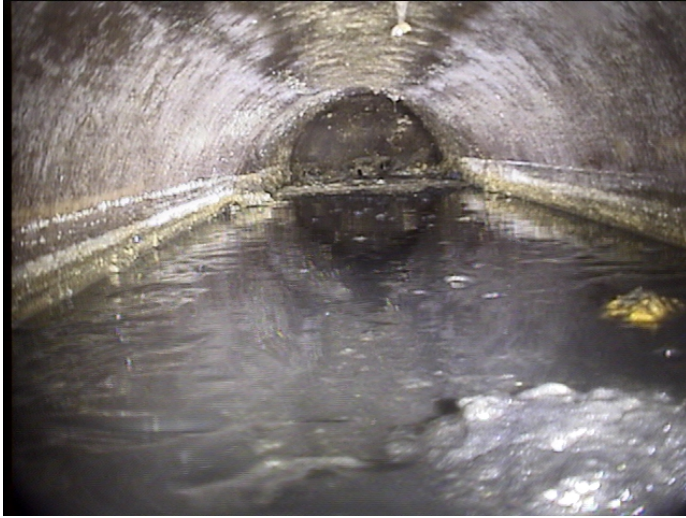
Code: **DSF**
Description: **Deposits Settled Fine**

Distance (ft): **7.0**
Structural Grade: **0**
O&M Grade: **2**
Clock Start/From: **5**
Clock To: **7**
1st Value:
2nd Value:
Value Percent: **10.000**
Continuous Index: **F01**
Within 8" of Joint: **NO**
Remarks:

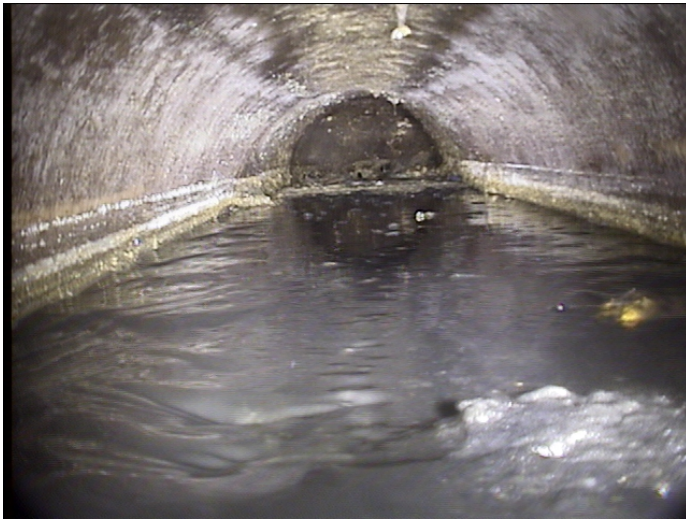
Code: **DSF**
Description: **Deposits Settled Fine**

Distance (ft): **7.0**
Structural Grade: **0**
O&M Grade: **5**
Clock Start/From: **4**
Clock To: **8**
1st Value:
2nd Value:
Value Percent: **35.000**
Continuous Index:
Within 8" of Joint: **NO**
Remarks:

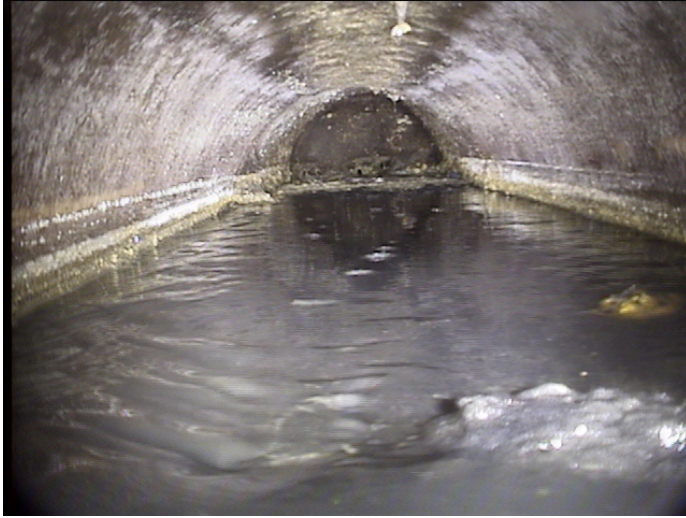
Code:	MSA
Description:	Abandoned Survey
Distance (ft):	7.0
Structural Grade:	0
O&M Grade:	0
Clock Start/From:	
Clock To:	
1st Value:	
2nd Value:	
Value Percent:	
Continuous Index:	
Within 8" of Joint:	NO
Remarks:	Heavy sediment. Possible rootball ahead
