Profile/Photo Observation Report

Street:	FOXCROFT STREET	Flow Control:	Not Controlled
City:	Hobart, IN	Year Renewed:	
Location:	Light Highway	Tape/Media #:	
Purpose:	Routine Assessment	Dia/Height:	8"
Use:	Sanitary	Material:	PVC
Drain Area:	NA	Lining:	
Category:	NA		
Comment:	Flow direction wrong

Location Details:		Direction of Survey:	Upstream
US MH:	M-208-026	DS MH:	M-208-027
		Total Length Surveyed (ft):	130.6

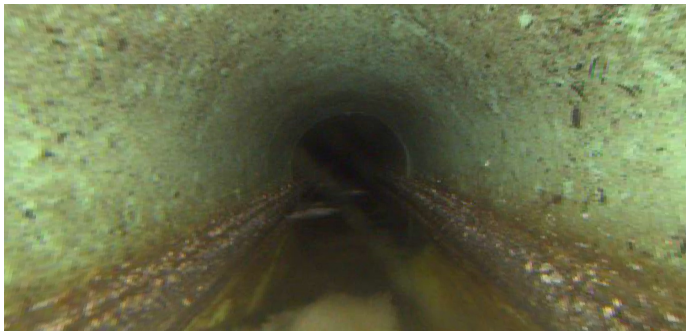
Code: **AMH**
Description: **Manhole**

Distance (ft): **.0**
Structural Grade: **0**
O&M Grade: **0**
Clock Start/From:
Clock To:
1st Value:
2nd Value:
Value Percent:
Continuous Index:
Within 8" of Joint: **NO**
Remarks: **M-208-027**

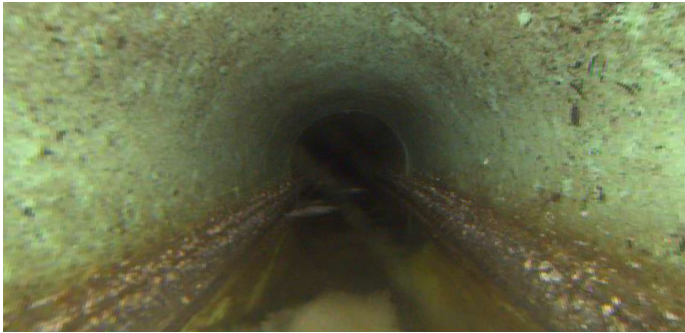
Code:	MWL
Description:	Water Level

Distance (ft):	.0
Structural Grade:	0
O&M Grade:	0
Clock Start/From:	
Clock To:	
1st Value:	
2nd Value:	
Value Percent:	5.000
Continuous Index:	
Within 8" of Joint:	NO
Remarks:

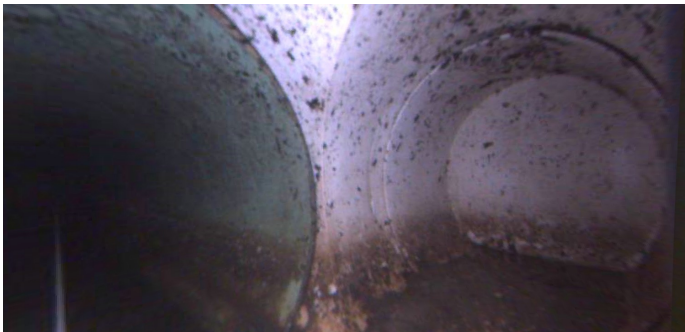
Code:	TFC
Description:	Tap Factory Capped

Distance (ft):	77.2
Structural Grade:	0
O&M Grade:	0
Clock Start/From:	9
Clock To:	
1st Value:	4.000
2nd Value:	
Value Percent:	
Continuous Index:	
Within 8" of Joint:	
Remarks:

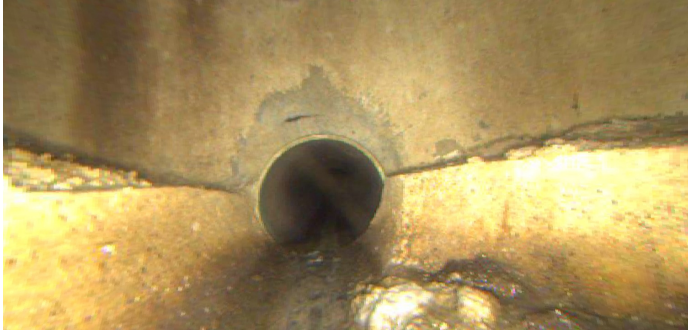
Code:	AMH
Description:	Manhole
Distance (ft):	130.6
Structural Grade:	0
O&M Grade:	0
Clock Start/From:	
Clock To:	
1st Value:	
2nd Value:	
Value Percent:	
Continuous Index:	
Within 8" of Joint:	NO
Remarks:	M-208-026
