Profile/Photo Observation Report

Street:	FOXCROFT STREET	Flow Control:	Not Controlled
City:	Hobart, IN	Year Renewed:	
Location:	Light Highway	Tape/Media #:	
Purpose:	Routine Assessment	Dia/Height:	8"
Use:	Sanitary	Material:	PVC
Drain Area:	NA	Lining:	
Category:	NA		
Comment:	Flow direction wrong

Location Details:		Direction of Survey:	Downstream
US MH:	M-208-027	DS MH:	M-208-028
		Total Length Surveyed (ft):	274.9

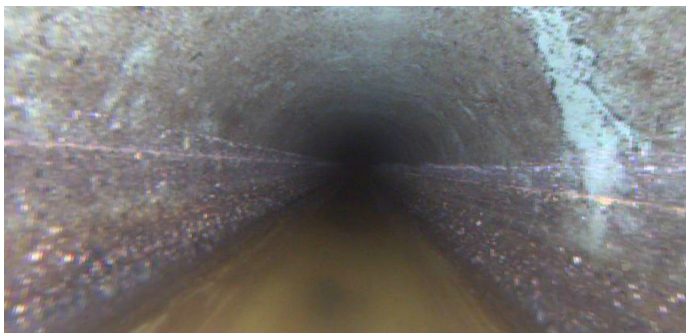
Code: **AMH**
Description: **Manhole**

Distance (ft): **.0**
Structural Grade: **0**
O&M Grade: **0**
Clock Start/From:
Clock To:
1st Value:
2nd Value:
Value Percent:
Continuous Index:
Within 8" of Joint: **NO**
Remarks: **M-208-027**

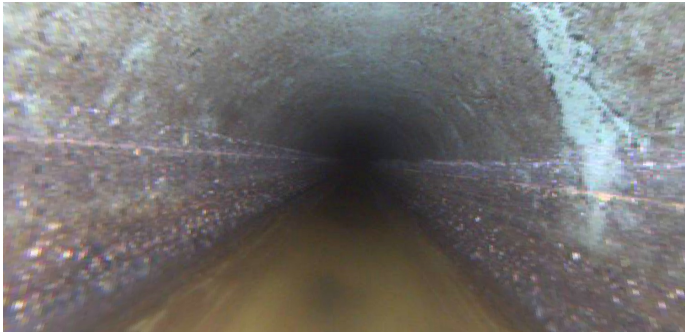
Code:	MWL
Description:	Water Level

Distance (ft):	.0
Structural Grade:	0
O&M Grade:	0
Clock Start/From:	
Clock To:	
1st Value:	
2nd Value:	
Value Percent:	5.000
Continuous Index:	
Within 8" of Joint:	NO
Remarks:

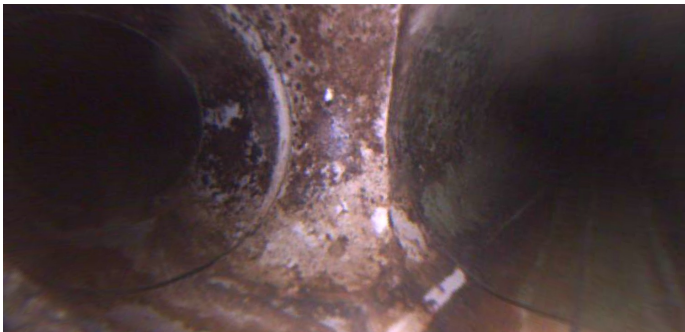
Code:	TF
Description:	Tap Factory

Distance (ft):	29.5
Structural Grade:	0
O&M Grade:	0
Clock Start/From:	3
Clock To:	
1st Value:	4.000
2nd Value:	
Value Percent:	
Continuous Index:	
Within 8" of Joint:	
Remarks:

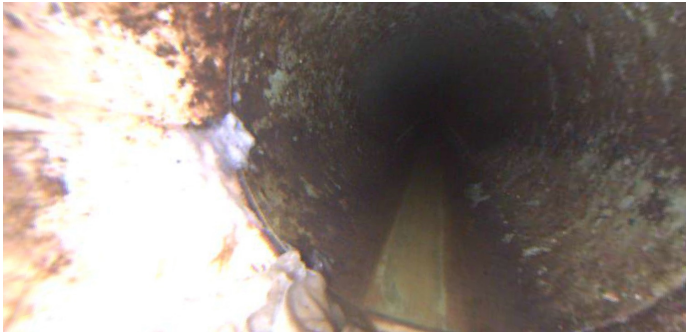
Code: **DAZ**
Description: **Deposits Attached Other**

Distance (ft): **135.2**
Structural Grade: **0**
O&M Grade: **2**
Clock Start/From: **7**
Clock To: **9**
1st Value:
2nd Value:
Value Percent: **5.000**
Continuous Index:
Within 8" of Joint: **YES**
Remarks:

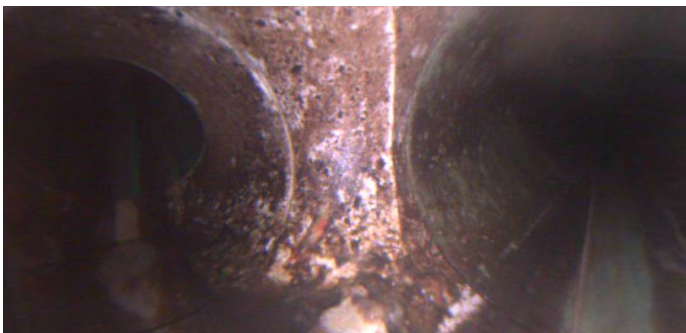
Code: **TFA**
Description: **Tap Factory Active**

Distance (ft): **135.5**
Structural Grade: **0**
O&M Grade: **0**
Clock Start/From: **3**
Clock To:
1st Value: **4.000**
2nd Value:
Value Percent:
Continuous Index:
Within 8" of Joint:
Remarks:

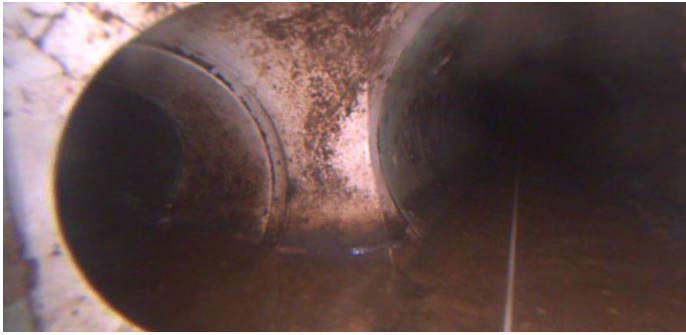
Code: **TFA**
Description: **Tap Factory Active**

Distance (ft): **268.1**
Structural Grade: **0**
O&M Grade: **0**
Clock Start/From: **3**
Clock To:
1st Value: **4.000**
2nd Value:
Value Percent:
Continuous Index:
Within 8" of Joint:
Remarks:

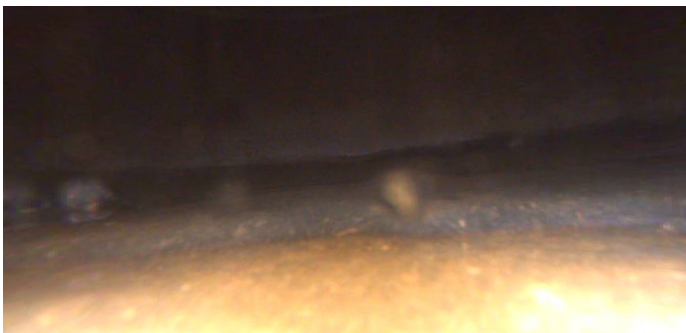
Code: **AMH**
Description: **Manhole**

Distance (ft): **274.9**
Structural Grade: **0**
O&M Grade: **0**
Clock Start/From:
Clock To:
1st Value:
2nd Value:
Value Percent:
Continuous Index:
Within 8" of Joint: **NO**
Remarks: **M-208-028**
