## Profile/Photo Observation Report

Date:	<b>03/20/2018</b>	Weather:		Coding:	<b>PACP 6.0</b>
Pipe Length (ft):	<b>282.4</b>	Owner:	<b>NA</b>	Pre Clean:	<b>No Pre-Cleaning</b>
P.O.#:		Surveyor:	<b>John Kuglmaier</b>	PSR:	<b>P-209-001-002</b>
Customer:		Clean Date:	<b>01/01/1900</b>	Shape:	<b>C</b>

Street:	<b>OFF OREGON ST</b>	Flow Control:	<b>Not Controlled</b>
City:	<b>Hobart, IN</b>	Year Renewed:	
Location:	<b>Light Highway</b>	Tape/Media #:	
Purpose:	<b>Routine Assessment</b>	Dia/Height:	<b>10"</b>
Use:	<b>Sanitary</b>	Material:	<b>VCP</b>
Drain Area:	<b>NA</b>	Lining:	
Category:	<b>NA</b>		
Comment:	<b>F_S_P_C at 0 ft sludge in the pipe .Flow direction wrong</b>		
Location Details:		Direction of Survey:	<b>Upstream</b>
US MH:	<b>M-209-002</b>	DS MH:	<b>M-209-001</b>
		Total Length Surveyed (ft):	<b>2.1</b>

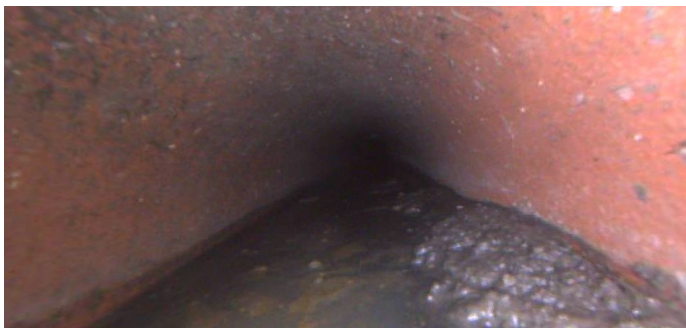
Code: **AMH**  
Description: **Manhole**

Distance (ft): **.0**  
Structural Grade: **0**  
O&M Grade: **0**  
Clock Start/From:  
Clock To:  
1st Value:  
2nd Value:  
Value Percent:  
Continuous Index:  
Within 8" of Joint: **NO**  
Remarks: **M-209-001**

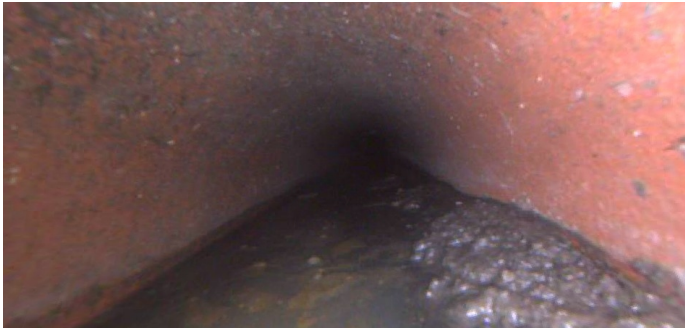
Code:	<b>MWL</b>
Description:	<b>Water Level</b>

Distance (ft):	<b>.0</b>
Structural Grade:	<b>0</b>
O&M Grade:	<b>0</b>
Clock Start/From:	
Clock To:	
1st Value:	
2nd Value:	
Value Percent:	<b>25.000</b>
Continuous Index:	
Within 8" of Joint:	<b>NO</b>
Remarks:

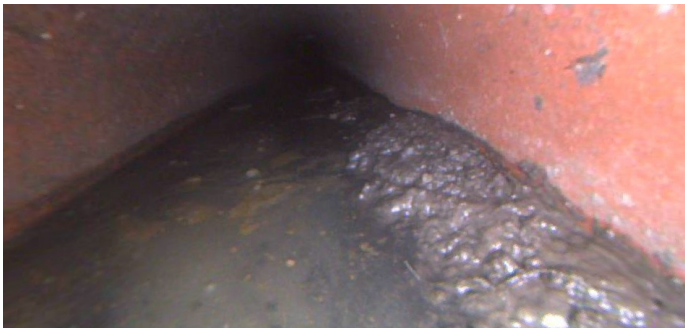
Code:	<b>DSF</b>
Description:	<b>Deposits Settled Fine</b>

Distance (ft):	<b>.0</b>
Structural Grade:	<b>0</b>
O&M Grade:	<b>3</b>
Clock Start/From:	<b>5</b>
Clock To:	
1st Value:	
2nd Value:	
Value Percent:	<b>15.000</b>
Continuous Index:	
Within 8" of Joint:	<b>NO</b>
Remarks:

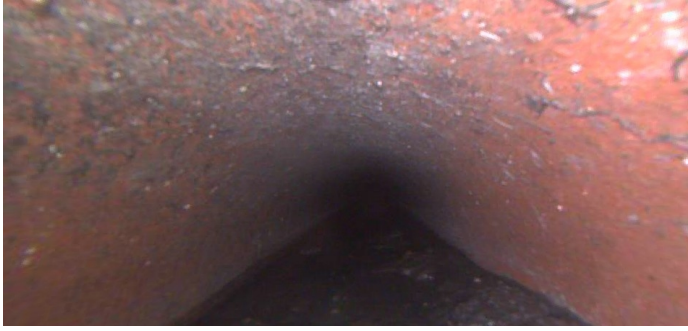
Code:	<b>MSA</b>
Description:	<b>Abandoned Survey</b>
Distance (ft):	<b>2.1</b>
Structural Grade:	<b>0</b>
O&M Grade:	<b>0</b>
Clock Start/From:	
Clock To:	
1st Value:	
2nd Value:	
Value Percent:	
Continuous Index:	
Within 8" of Joint:	<b>NO</b>
Remarks:	<b>DSF</b>
