## Profile/Photo Observation Report

Street:	<b>FOXCROFT STREET</b>	Flow Control:	<b>Not Controlled</b>
City:	<b>Hobart, IN</b>	Year Renewed:	
Location:	<b>Light Highway</b>	Tape/Media #:	
Purpose:	<b>Routine Assessment</b>	Dia/Height:	<b>10"</b>
Use:	<b>Sanitary</b>	Material:	<b>VCP</b>
Drain Area:	<b>NA</b>	Lining:	
Category:	<b>NA</b>		
Comment:	<b>F_S_P_C at 0 ft sludge in the pipe .Flow direction wrong</b>		
Location Details:		Direction of Survey:	<b>Upstream</b>
US MH:	<b>M-209-002</b>	DS MH:	<b>M-209-001</b>
		Total Length Surveyed (ft):	<b>2.1</b>

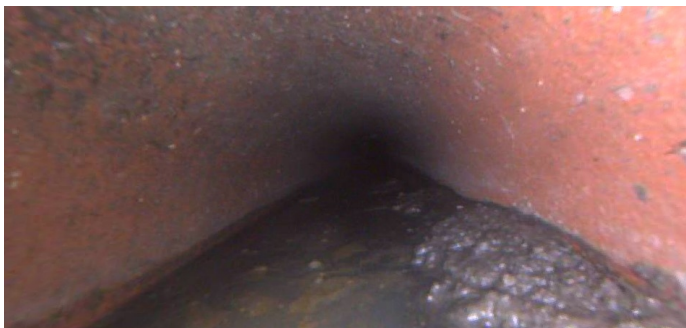
Code: **AMH**  
Description: **Manhole**

Distance (ft): **.0**  
Structural Grade: **0**  
O&M Grade: **0**  
Clock Start/From:  
Clock To:  
1st Value:  
2nd Value:  
Value Percent:  
Continuous Index:  
Within 8" of Joint: **NO**  
Remarks: **M-209-001**

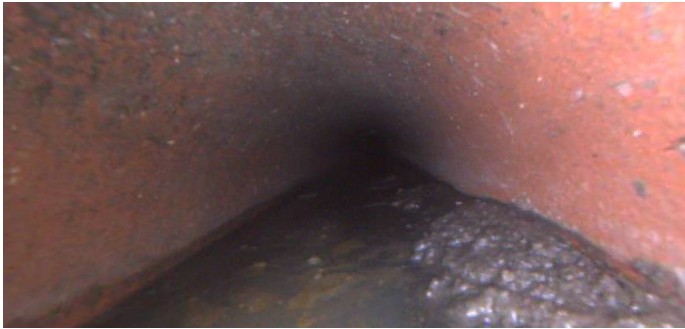
Code:	<b>MWL</b>
Description:	<b>Water Level</b>

Distance (ft):	<b>.0</b>
Structural Grade:	<b>0</b>
O&M Grade:	<b>0</b>
Clock Start/From:	
Clock To:	
1st Value:	
2nd Value:	
Value Percent:	<b>25.000</b>
Continuous Index:	
Within 8" of Joint:	<b>NO</b>
Remarks:

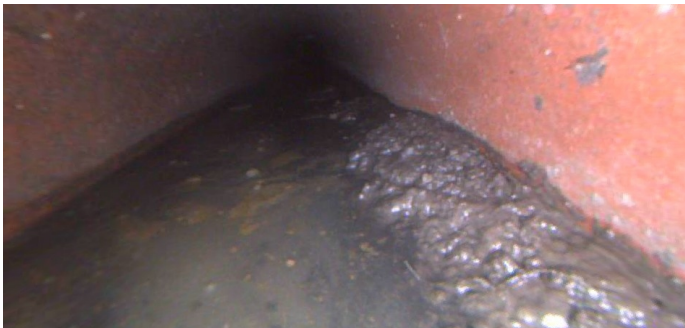
Code:	<b>DSF</b>
Description:	<b>Deposits Settled Fine</b>

Distance (ft):	<b>.0</b>
Structural Grade:	<b>0</b>
O&M Grade:	<b>3</b>
Clock Start/From:	<b>5</b>
Clock To:	
1st Value:	
2nd Value:	
Value Percent:	<b>15.000</b>
Continuous Index:	
Within 8" of Joint:	<b>NO</b>
Remarks:

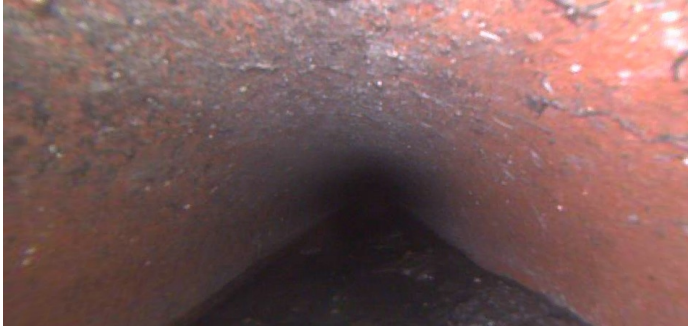
Code:	<b>MSA</b>
Description:	<b>Abandoned Survey</b>
Distance (ft):	<b>2.1</b>
Structural Grade:	<b>0</b>
O&M Grade:	<b>0</b>
Clock Start/From:	
Clock To:	
1st Value:	
2nd Value:	
Value Percent:	
Continuous Index:	
Within 8" of Joint:	<b>NO</b>
Remarks:	<b>DSF</b>
