## Profile/Photo Observation Report

Street:	<b>FOXCROFT STREET</b>	Flow Control:	<b>Not Controlled</b>
City:	<b>Hobart, IN</b>	Year Renewed:	
Location:	<b>Light Highway</b>	Tape/Media #:	
Purpose:	<b>Routine Assessment</b>	Dia/Height:	<b>8"</b>
Use:	<b>Sanitary</b>	Material:	<b>VCP</b>
Drain Area:	<b>NA</b>	Lining:	
Category:	<b>NA</b>		
Comment:	<b>P_C at 36 ft debris . Flow wrong</b>		
Location Details:		Direction of Survey:	<b>Upstream</b>
US MH:	<b>M-209-012</b>	DS MH:	<b>M-209-011</b>
		Total Length Surveyed (ft):	<b>37.9</b>

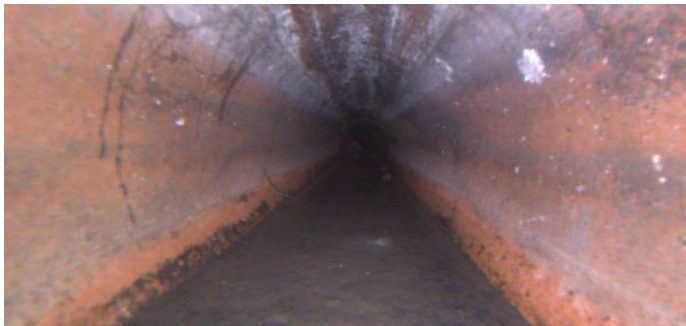
Code: **AMH**  
Description: **Manhole**

Distance (ft): **.0**  
Structural Grade: **0**  
O&M Grade: **0**  
Clock Start/From:  
Clock To:  
1st Value:  
2nd Value:  
Value Percent:  
Continuous Index:  
Within 8" of Joint: **NO**  
Remarks: **M-209-011**

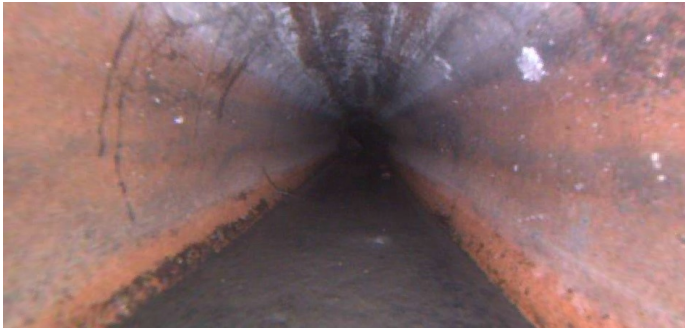
Code:	<b>MWL</b>
Description:	<b>Water Level</b>

Distance (ft):	<b>.0</b>
Structural Grade:	<b>0</b>
O&M Grade:	<b>0</b>
Clock Start/From:	
Clock To:	
1st Value:	
2nd Value:	
Value Percent:	<b>20.000</b>
Continuous Index:	
Within 8" of Joint:	<b>NO</b>
Remarks:

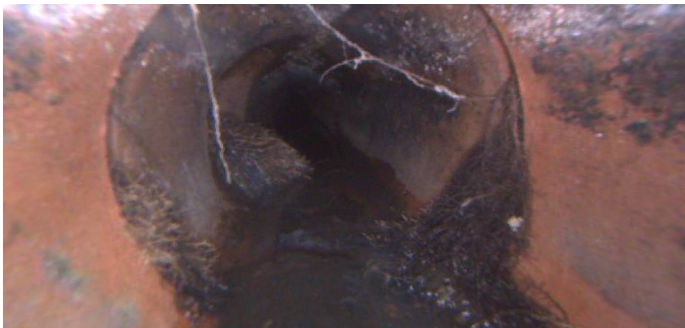
Code:	<b>RMJ</b>
Description:	<b>Roots Medium Joint</b>

Distance (ft):	<b>4.2</b>
Structural Grade:	<b>0</b>
O&M Grade:	<b>3</b>
Clock Start/From:	<b>3</b>
Clock To:	<b>9</b>
1st Value:	
2nd Value:	
Value Percent:	<b>15.000</b>
Continuous Index:	
Within 8" of Joint:	<b>YES</b>
Remarks:

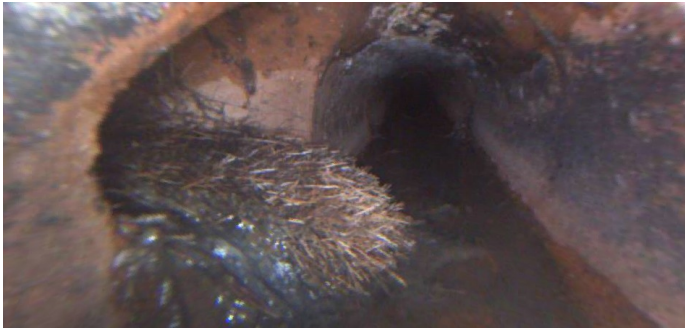
Code: **TFD**  
Description: **Tap Factory Defective**

Distance (ft): **4.8**  
Structural Grade: **0**  
O&M Grade: **2**  
Clock Start/From: **9**  
Clock To:  
1st Value: **4.000**  
2nd Value:  
Value Percent:  
Continuous Index:  
Within 8" of Joint:  
Remarks: **Roots**

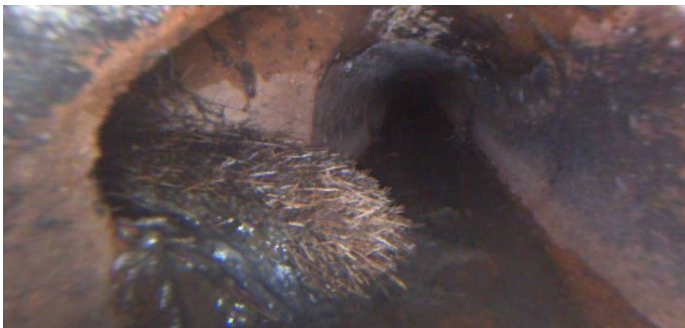
Code: **RML**  
Description: **Roots Medium Lateral**

Distance (ft): **4.8**  
Structural Grade: **0**  
O&M Grade: **3**  
Clock Start/From: **9**  
Clock To:  
1st Value:  
2nd Value:  
Value Percent: **25.000**  
Continuous Index:  
Within 8" of Joint: **NO**  
Remarks:

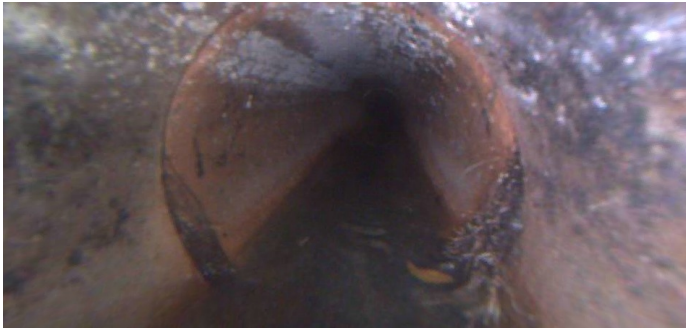
Code: **RFJ**  
Description: **Roots Fine Joint**

Distance (ft): **6.2**  
Structural Grade: **0**  
O&M Grade: **1**  
Clock Start/From: **3**  
Clock To: **9**  
1st Value:  
2nd Value:  
Value Percent:  
Continuous Index: **S01**  
Within 8" of Joint: **YES**  
Remarks:

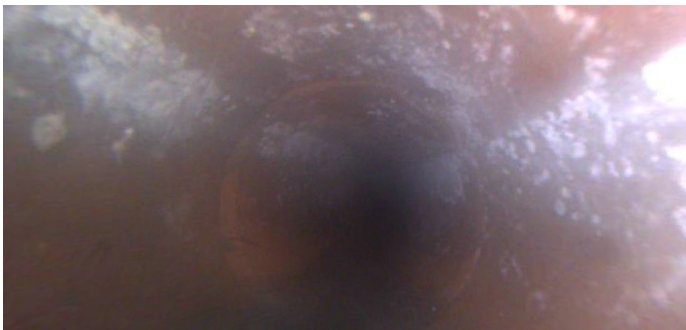
Code: **MSA**  
Description: **Abandoned Survey**

Distance (ft): **37.9**  
Structural Grade: **0**  
O&M Grade: **0**  
Clock Start/From:  
Clock To:  
1st Value:  
2nd Value:  
Value Percent:  
Continuous Index:  
Within 8" of Joint: **NO**  
Remarks: **RMC**

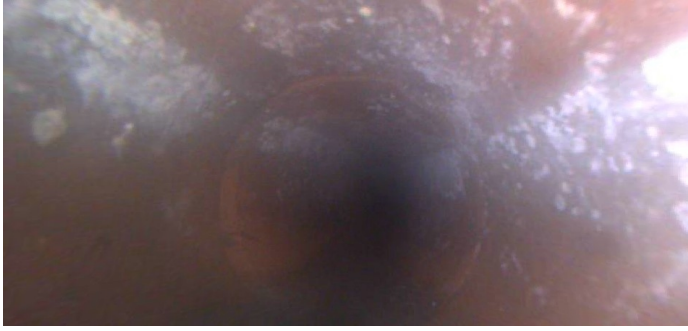
Code:	RFJ
Description:	Roots Fine Joint
Distance (ft):	37.9
Structural Grade:	0
O&M Grade:	1
Clock Start/From:	3
Clock To:	9
1st Value:	
2nd Value:	
Value Percent:	
Continuous Index:	F01
Within 8" of Joint:	YES
Remarks:	Clock positions vary
