Profile/Photo Observation Report

Street:	FOXCROFT STREET	Flow Control:	Not Controlled
City:	Hobart, IN	Year Renewed:	
Location:	Light Highway	Tape/Media #:	
Purpose:	Routine Assessment	Dia/Height:	8"
Use:	Sanitary	Material:	VCP
Drain Area:	NA	Lining:	
Category:	NA		
Comment:	P_C at 11 ft unknown obstruction . Flow wrong		
Location Details:		Direction of Survey:	Downstream
US MH:	M-209-013	DS MH:	M-209-012
		Total Length Surveyed (ft):	12.5

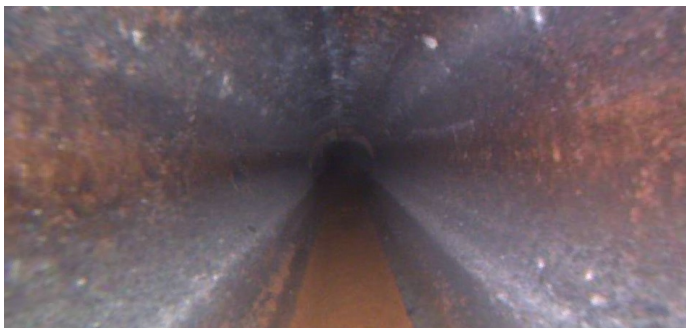
Code: **AMH**
Description: **Manhole**

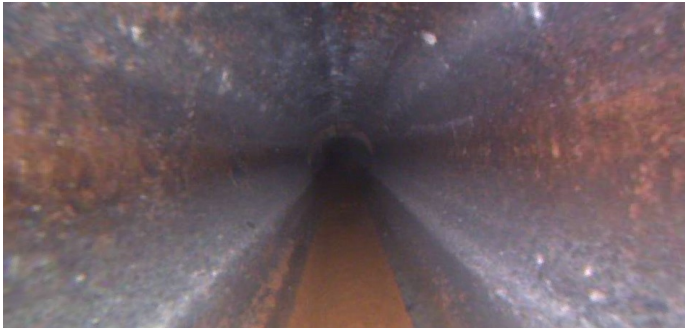
Code:	MWL
Description:	Water Level

Distance (ft):	.0
Structural Grade:	0
O&M Grade:	0
Clock Start/From:	
Clock To:	
1st Value:	
2nd Value:	
Value Percent:	5.000
Continuous Index:	
Within 8" of Joint:	NO
Remarks:

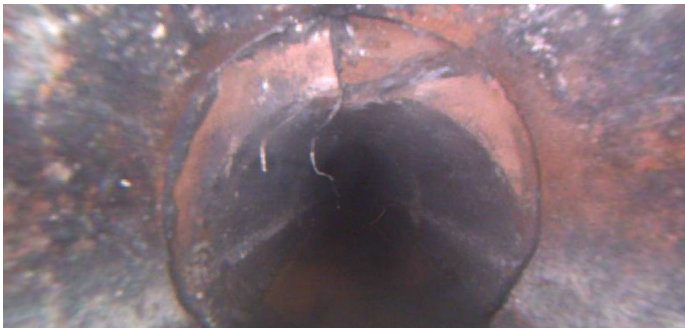
Code:	JOM
Description:	Joint Offset Medium

Distance (ft):	3.6
Structural Grade:	1
O&M Grade:	0
Clock Start/From:	
Clock To:	
1st Value:	
2nd Value:	
Value Percent:	
Continuous Index:	
Within 8" of Joint:	NO
Remarks:

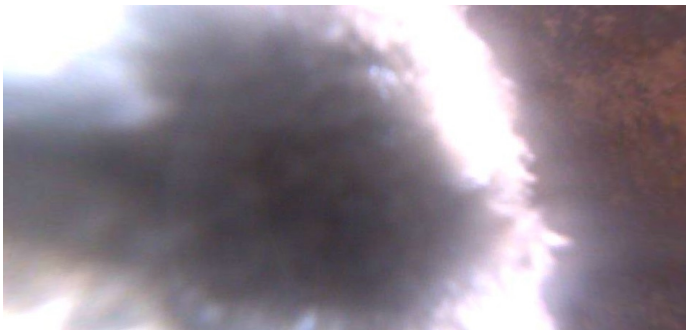
Code: **MSA**
Description: **Abandoned Survey**

Distance (ft): **12.5**
Structural Grade: **0**
O&M Grade: **0**
Clock Start/From:
Clock To:
1st Value:
2nd Value:
Value Percent:
Continuous Index:
Within 8" of Joint: **NO**
Remarks: **RMC**
