Profile/Photo Observation Report

Street:	FOXCROFT STREET	Flow Control:	Not Controlled
City:	Hobart, IN	Year Renewed:	
Location:	Light Highway	Tape/Media #:	
Purpose:	Routine Assessment	Dia/Height:	8"
Use:	Sanitary	Material:	VCP
Drain Area:	NA	Lining:	
Category:	NA		
Comment:	P_C at 27 ft roots . Flow direction wrong		
Location Details:		Direction of Survey:	Downstream
US MH:	M-209-014	DS MH:	M-209-013
		Total Length Surveyed (ft):	28.6

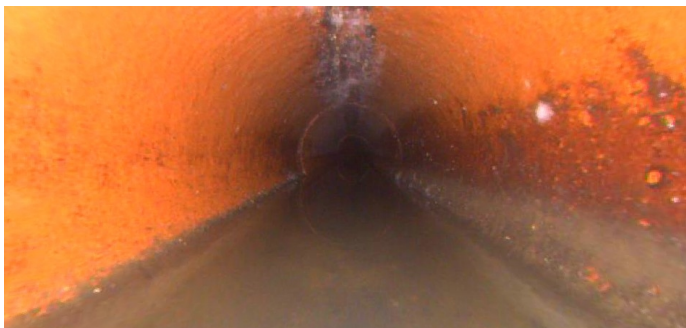
Code: **AMH**
Description: **Manhole**

Distance (ft): **.0**
Structural Grade: **0**
O&M Grade: **0**
Clock Start/From:
Clock To:
1st Value:
2nd Value:
Value Percent:
Continuous Index:
Within 8" of Joint: **NO**
Remarks: **M-209-014**

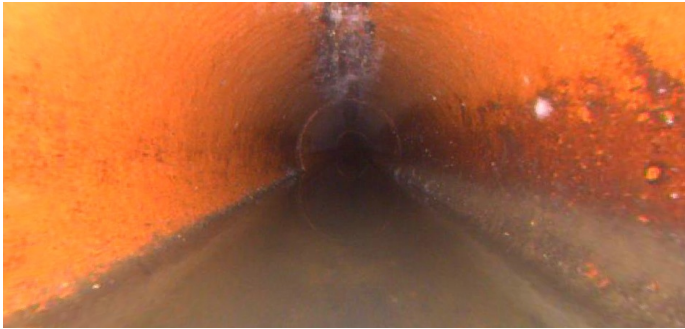
Code:	MWL
Description:	Water Level

Distance (ft):	.0
Structural Grade:	0
O&M Grade:	0
Clock Start/From:	
Clock To:	
1st Value:	
2nd Value:	
Value Percent:	25.000
Continuous Index:	
Within 8" of Joint:	NO
Remarks:

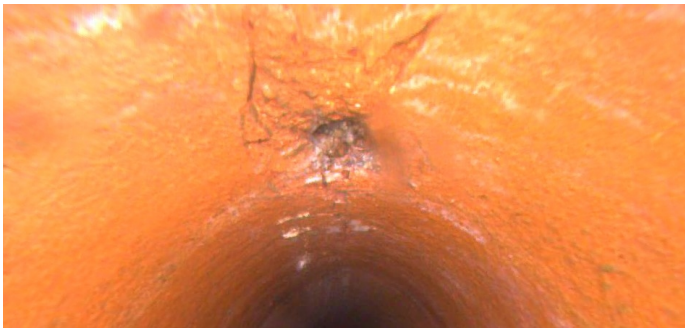
Code:	HSV
Description:	Hole Soil Visible

Distance (ft):	16.1
Structural Grade:	5
O&M Grade:	0
Clock Start/From:	12
Clock To:	
1st Value:	
2nd Value:	
Value Percent:	
Continuous Index:	
Within 8" of Joint:	
Remarks:

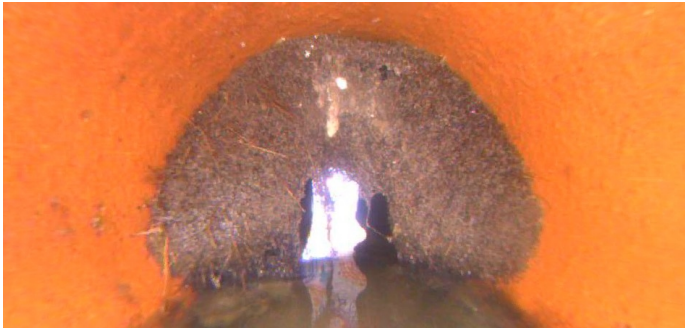
Code: **RBJ**
Description: **Roots Ball Joint**

Distance (ft): **27.8**
Structural Grade: **0**
O&M Grade: **4**
Clock Start/From: **8**
Clock To: **4**
1st Value:
2nd Value:
Value Percent: **70.000**
Continuous Index:
Within 8" of Joint: **YES**
Remarks:

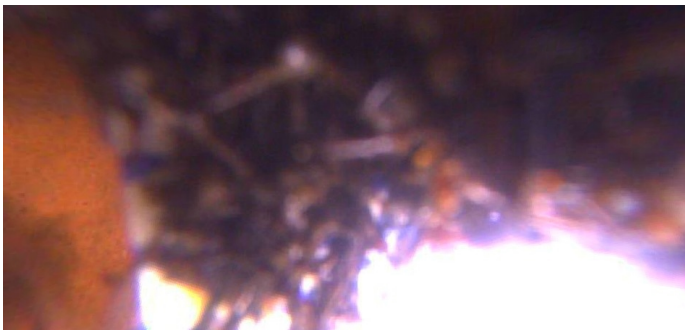
Code: **MSA**
Description: **Abandoned Survey**

Distance (ft): **28.6**
Structural Grade: **0**
O&M Grade: **0**
Clock Start/From:
Clock To:
1st Value:
2nd Value:
Value Percent:
Continuous Index:
Within 8" of Joint: **NO**
Remarks: **RBJ**
