Profile/Photo Observation Report

Date:	03/19/2018	Weather:		Coding:	PACP 6.0
Pipe Length (ft):	247.0	Owner:	NA	Pre Clean:	No Pre-Cleaning
P.O.#:		Surveyor:	John Kuglmaier	PSR:	P-209-015-016
Customer:		Clean Date:	01/01/1900	Shape:	C

Street:	FOXCROFT STREET	Flow Control:	Not Controlled
City:	Hobart, IN	Year Renewed:	
Location:	Light Highway	Tape/Media #:	
Purpose:	Routine Assessment	Dia/Height:	8"
Use:	Sanitary	Material:	VCP
Drain Area:	NA	Lining:	
Category:	NA		
Comment:	P_C at 97 ft root ball . flow direction wrong		
Location Details:		Direction of Survey:	Downstream
US MH:	M-209-016	DS MH:	M-209-015
		Total Length Surveyed (ft):	98.1

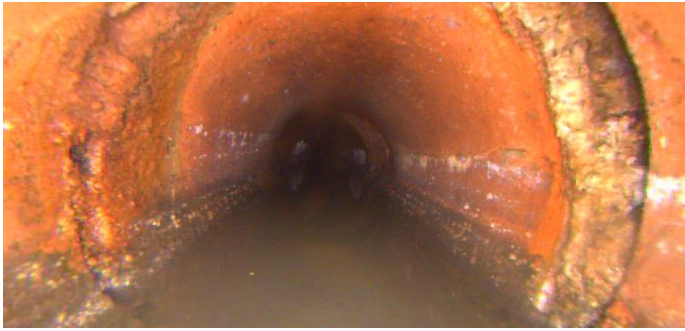
Code: **AMH**
Description: **Manhole**

Distance (ft): **.0**
Structural Grade: **0**
O&M Grade: **0**
Clock Start/From:
Clock To:
1st Value:
2nd Value:
Value Percent:
Continuous Index:
Within 8" of Joint: **NO**
Remarks: **M-209-016**

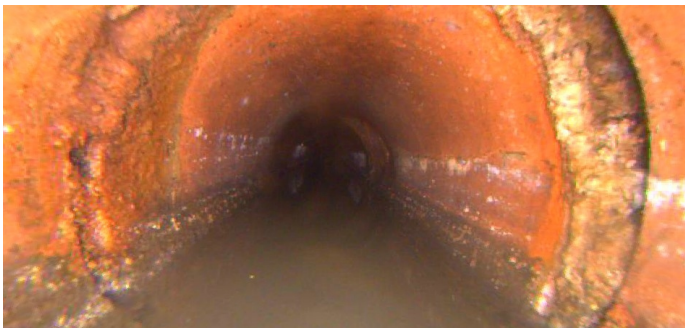
Code: **MWL**
Description: **Water Level**

Distance (ft): **.0**
Structural Grade: **0**
O&M Grade: **0**
Clock Start/From:
Clock To:
1st Value:
2nd Value:
Value Percent: **25.000**
Continuous Index:
Within 8" of Joint: **NO**
Remarks:

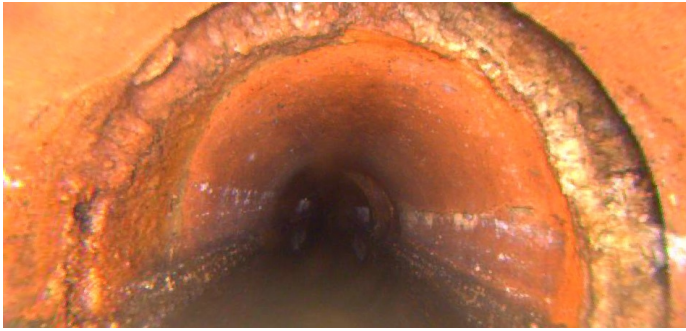
Code: **DAE**
Description: **Deposits Attached Encrustation**

Distance (ft): **.0**
Structural Grade: **0**
O&M Grade: **2**
Clock Start/From: **8**
Clock To: **4**
1st Value:
2nd Value:
Value Percent: **10.000**
Continuous Index:
Within 8" of Joint: **YES**
Remarks:

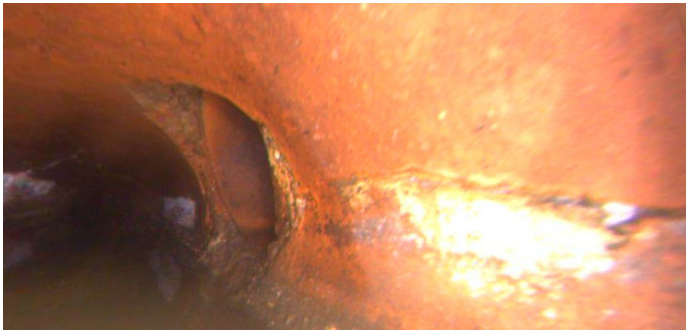
Code: **FL**
Description: **Fracture Longitudinal**

Distance (ft): **2.4**
Structural Grade: **3**
O&M Grade: **0**
Clock Start/From: **3**
Clock To:
1st Value:
2nd Value:
Value Percent:
Continuous Index:
Within 8" of Joint:
Remarks:

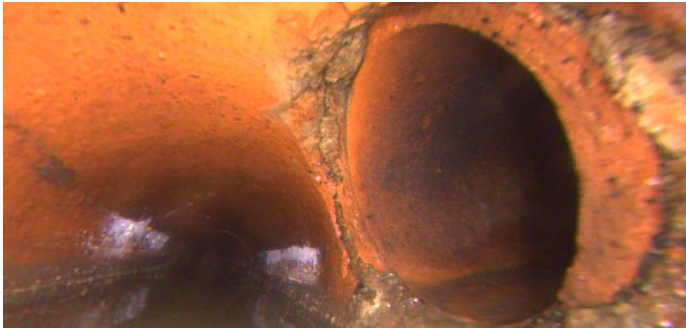
Code: **TB**
Description: **Tap Break-in**

Distance (ft): **2.8**
Structural Grade: **0**
O&M Grade: **0**
Clock Start/From: **2**
Clock To:
1st Value: **4.000**
2nd Value:
Value Percent:
Continuous Index:
Within 8" of Joint:
Remarks:

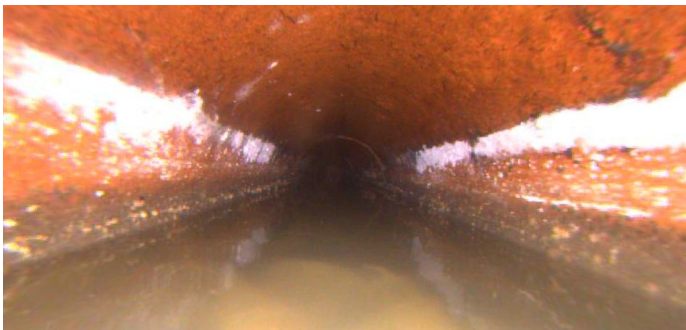
Code: **MWL**
Description: **Water Level**

Distance (ft): **3.7**
Structural Grade: **0**
O&M Grade: **0**
Clock Start/From:
Clock To:
1st Value:
2nd Value:
Value Percent: **35.000**
Continuous Index:
Within 8" of Joint: **NO**
Remarks:

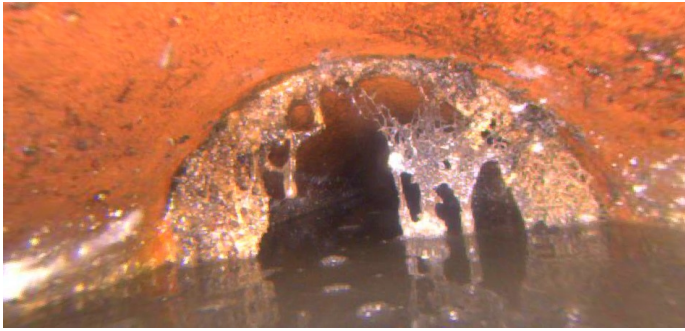
Code: **RMJ**
Description: **Roots Medium Joint**

Distance (ft): **9.7**
Structural Grade: **0**
O&M Grade: **3**
Clock Start/From: **9**
Clock To: **3**
1st Value:
2nd Value:
Value Percent: **20.000**
Continuous Index:
Within 8" of Joint: **YES**
Remarks:

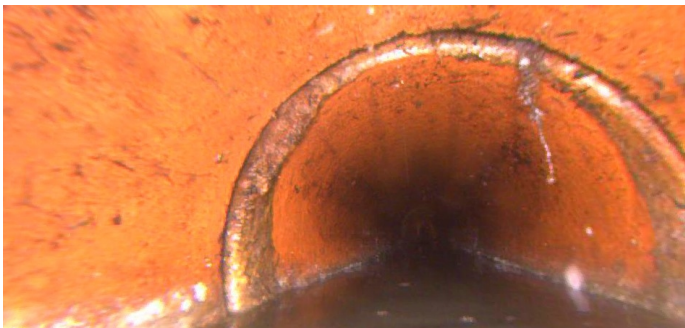
Code: **DAE**
Description: **Deposits Attached Encrustation**

Distance (ft): **13.9**
Structural Grade: **0**
O&M Grade: **2**
Clock Start/From: **9**
Clock To: **11**
1st Value:
2nd Value:
Value Percent: **5.000**
Continuous Index:
Within 8" of Joint: **YES**
Remarks:

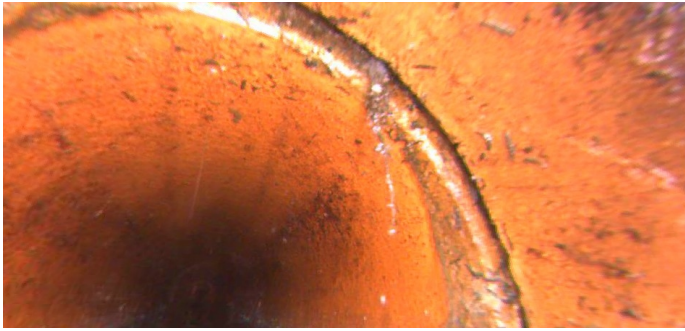
Code: **RFJ**
Description: **Roots Fine Joint**

Distance (ft): **14.1**
Structural Grade: **0**
O&M Grade: **1**
Clock Start/From: **1**
Clock To:
1st Value:
2nd Value:
Value Percent:
Continuous Index:
Within 8" of Joint: **YES**
Remarks:

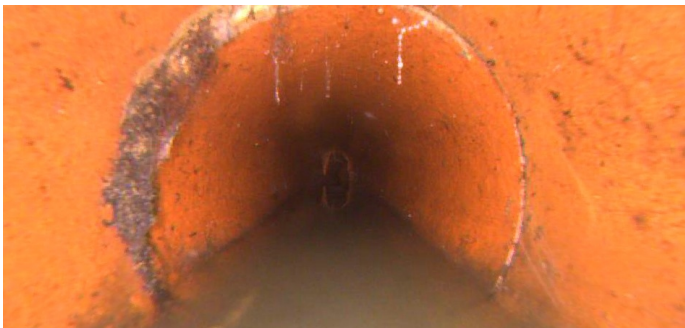
Code: **RFJ**
Description: **Roots Fine Joint**

Distance (ft): **18.1**
Structural Grade: **0**
O&M Grade: **1**
Clock Start/From: **8**
Clock To: **10**
1st Value:
2nd Value:
Value Percent:
Continuous Index:
Within 8" of Joint: **YES**
Remarks:

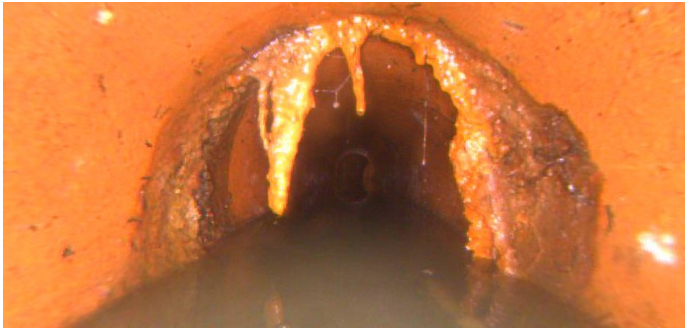
Code: **DAE**
Description: **Deposits Attached Encrustation**

Distance (ft): **22.2**
Structural Grade: **0**
O&M Grade: **4**
Clock Start/From: **8**
Clock To: **4**
1st Value:
2nd Value:
Value Percent: **25.000**
Continuous Index:
Within 8" of Joint: **YES**
Remarks:

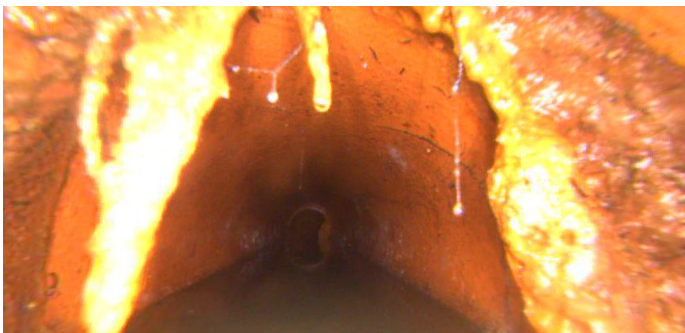
Code: **ID**
Description: **Infil Dripper**

Distance (ft): **22.6**
Structural Grade: **0**
O&M Grade: **3**
Clock Start/From: **11**
Clock To: **1**
1st Value:
2nd Value:
Value Percent:
Continuous Index:
Within 8" of Joint: **YES**
Remarks:

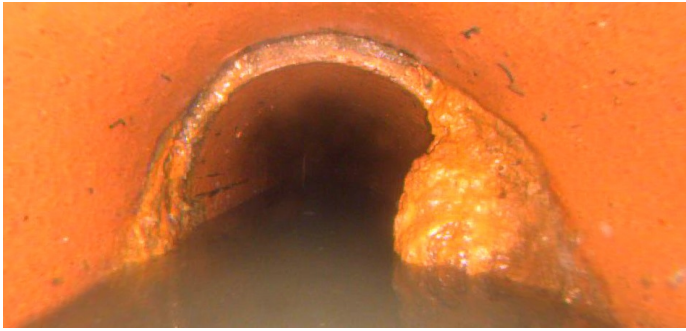
Code: **DAE**
Description: **Deposits Attached Encrustation**

Distance (ft): **26.5**
Structural Grade: **0**
O&M Grade: **4**
Clock Start/From: **2**
Clock To: **10**
1st Value:
2nd Value:
Value Percent: **30.000**
Continuous Index:
Within 8" of Joint: **YES**
Remarks:

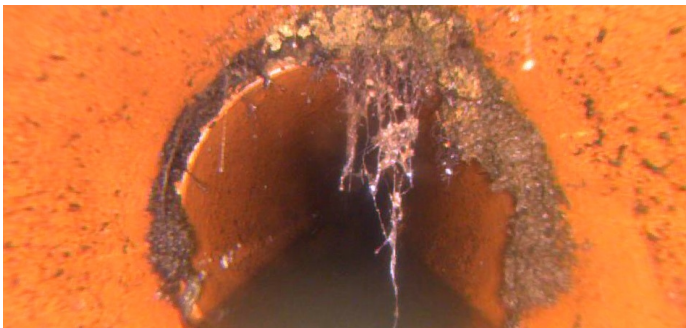
Code: **RMJ**
Description: **Roots Medium Joint**

Distance (ft): **39.4**
Structural Grade: **0**
O&M Grade: **3**
Clock Start/From: **8**
Clock To: **4**
1st Value:
2nd Value:
Value Percent: **15.000**
Continuous Index: **S01**
Within 8" of Joint: **YES**
Remarks:

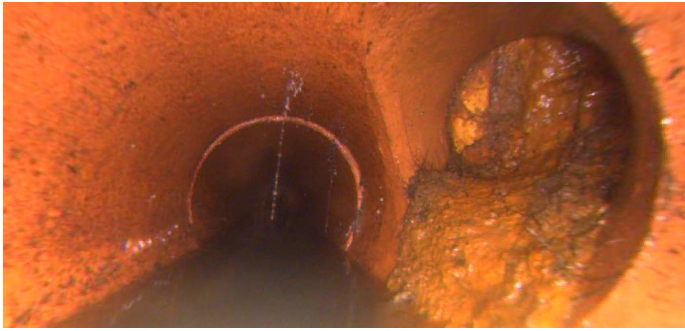
Code: **TFC**
Description: **Tap Factory Capped**

Distance (ft): **40.9**
Structural Grade: **0**
O&M Grade: **0**
Clock Start/From: **2**
Clock To:
1st Value: **4.000**
2nd Value:
Value Percent:
Continuous Index:
Within 8" of Joint:
Remarks:

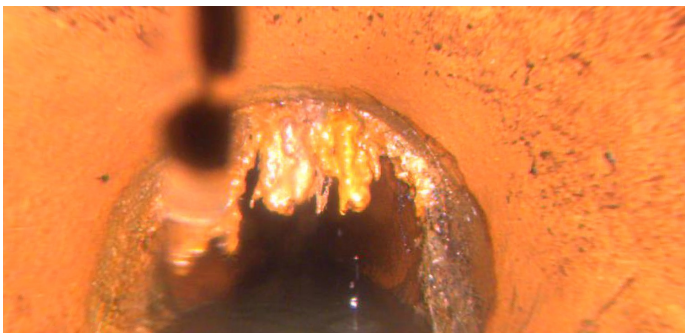
Code: **ID**
Description: **Infil Dripper**

Distance (ft): **50.0**
Structural Grade: **0**
O&M Grade: **3**
Clock Start/From: **11**
Clock To: **1**
1st Value:
2nd Value:
Value Percent:
Continuous Index:
Within 8" of Joint: **YES**
Remarks:

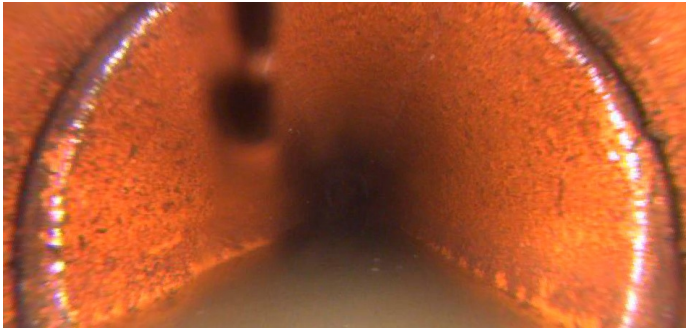
Code: **RMJ**
Description: **Roots Medium Joint**

Distance (ft): **54.6**
Structural Grade: **0**
O&M Grade: **3**
Clock Start/From: **8**
Clock To: **4**
1st Value:
2nd Value:
Value Percent: **15.000**
Continuous Index: **F01**
Within 8" of Joint: **YES**
Remarks: **Clock positions vary**

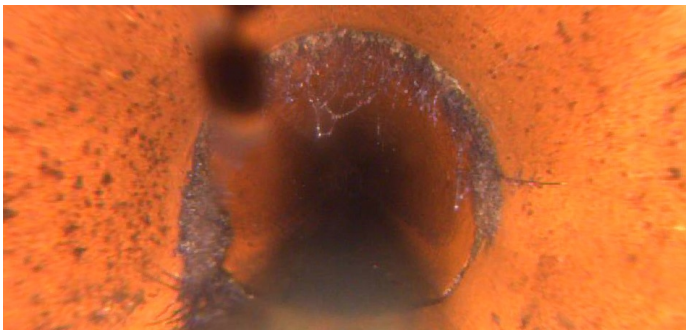
Code: **RMJ**
Description: **Roots Medium Joint**

Distance (ft): **58.6**
Structural Grade: **0**
O&M Grade: **3**
Clock Start/From: **7**
Clock To: **4**
1st Value:
2nd Value:
Value Percent: **10.000**
Continuous Index:
Within 8" of Joint: **YES**
Remarks:

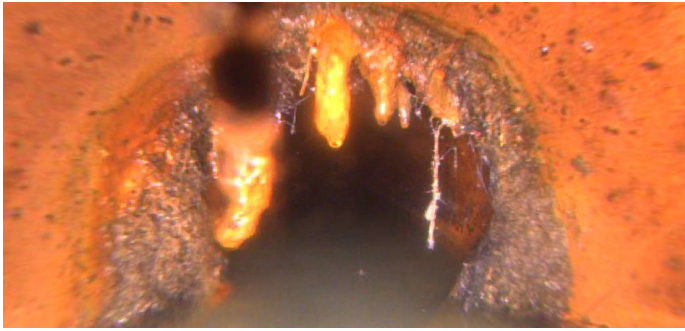
Code: **RMJ**
Description: **Roots Medium Joint**

Distance (ft): **67.3**
Structural Grade: **0**
O&M Grade: **3**
Clock Start/From: **8**
Clock To: **4**
1st Value:
2nd Value:
Value Percent: **25.000**
Continuous Index:
Within 8" of Joint: **YES**
Remarks:

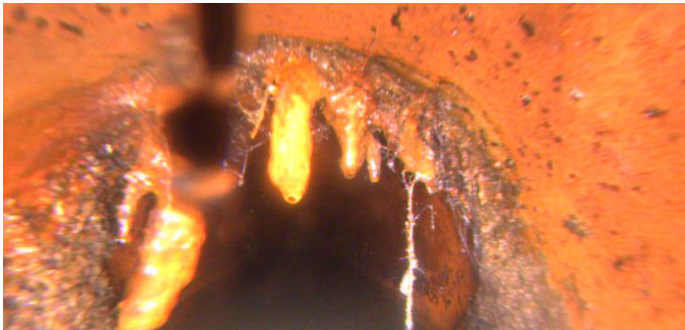
Code: **ID**
Description: **Infil Dripper**

Distance (ft): **67.4**
Structural Grade: **0**
O&M Grade: **3**
Clock Start/From: **11**
Clock To: **1**
1st Value:
2nd Value:
Value Percent:
Continuous Index:
Within 8" of Joint: **YES**
Remarks:

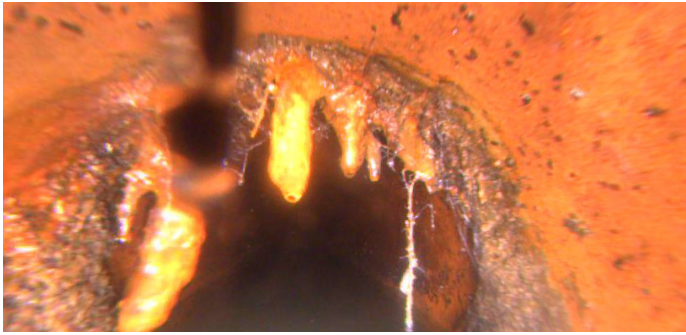
Code: **DAE**
Description: **Deposits Attached Encrustation**

Distance (ft): **67.4**
Structural Grade: **0**
O&M Grade: **3**
Clock Start/From: **10**
Clock To: **1**
1st Value:
2nd Value:
Value Percent: **20.000**
Continuous Index:
Within 8" of Joint: **YES**
Remarks:

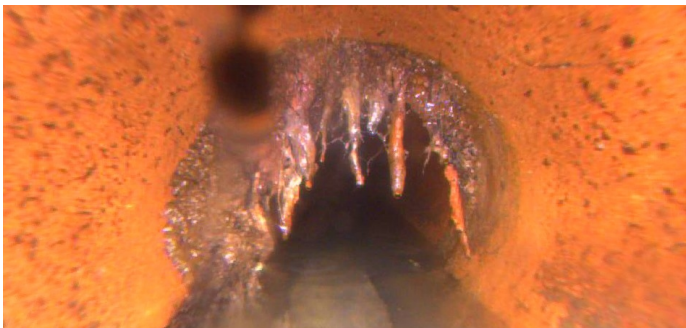
Code: **RMJ**
Description: **Roots Medium Joint**

Distance (ft): **75.5**
Structural Grade: **0**
O&M Grade: **3**
Clock Start/From: **7**
Clock To: **4**
1st Value:
2nd Value:
Value Percent: **45.000**
Continuous Index:
Within 8" of Joint: **YES**
Remarks:

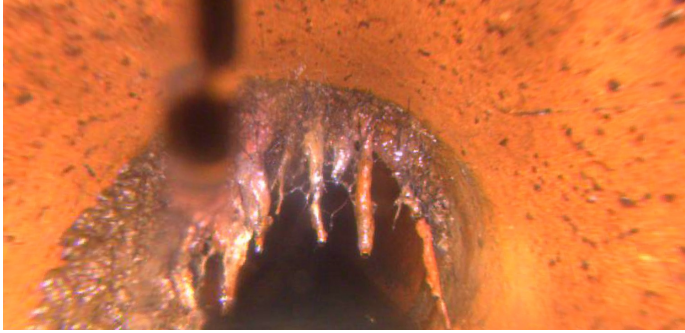
Code: ID
Description: Infil Dripper

Distance (ft): 75.6
Structural Grade: 0
O&M Grade: 3
Clock Start/From: 11
Clock To: 1
1st Value:
2nd Value:
Value Percent:
Continuous Index:
Within 8" of Joint: YES
Remarks:

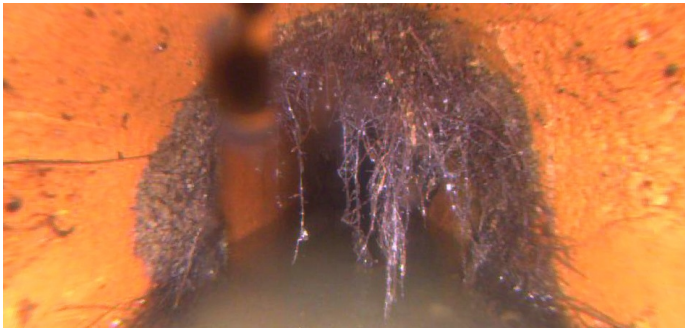
Code: RMJ
Description: Roots Medium Joint

Distance (ft): 79.9
Structural Grade: 0
O&M Grade: 3
Clock Start/From: 8
Clock To: 4
1st Value:
2nd Value:
Value Percent: 35.000
Continuous Index:
Within 8" of Joint: YES
Remarks:

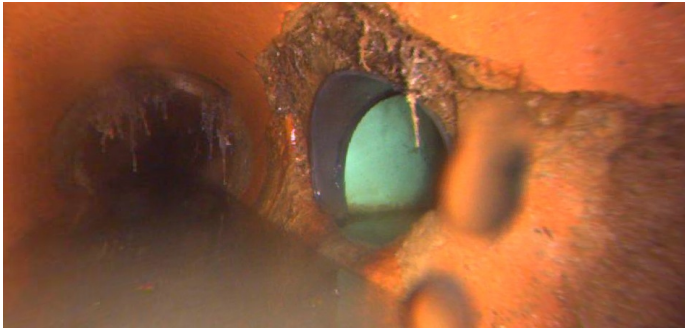
Code: **CL**
Description: **Crack Longitudinal**

Distance (ft): **80.9**
Structural Grade: **2**
O&M Grade: **0**
Clock Start/From: **2**
Clock To:
1st Value:
2nd Value:
Value Percent:
Continuous Index:
Within 8" of Joint: **YES**
Remarks:

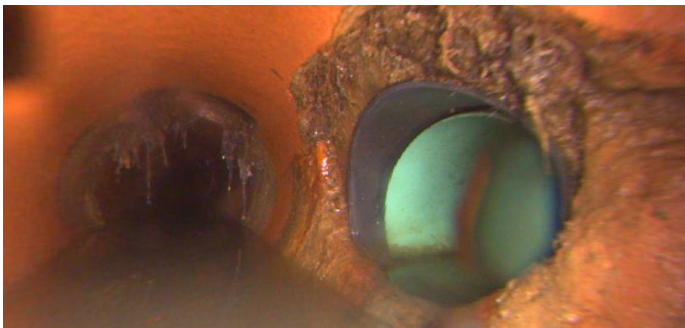
Code: **TSD**
Description: **Tap Saddle Defective**

Distance (ft): **81.0**
Structural Grade: **0**
O&M Grade: **2**
Clock Start/From: **2**
Clock To:
1st Value: **4.000**
2nd Value:
Value Percent:
Continuous Index:
Within 8" of Joint:
Remarks: **RFC**

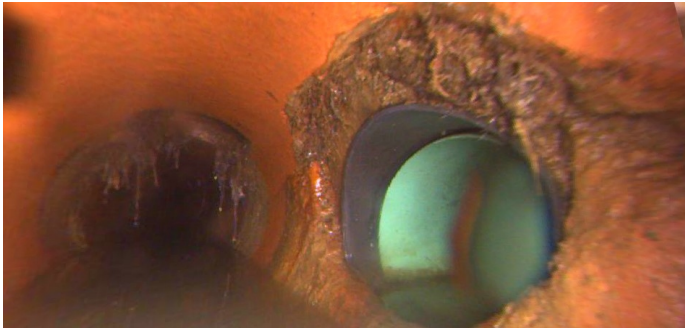
Code: **RFC**
Description: **Roots Fine Connection**

Distance (ft): **81.0**
Structural Grade: **0**
O&M Grade: **1**
Clock Start/From: **2**
Clock To:
1st Value:
2nd Value:
Value Percent:
Continuous Index:
Within 8" of Joint: **NO**
Remarks:

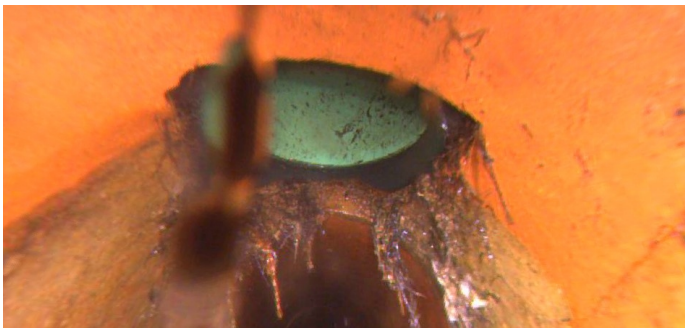
Code: **TSD**
Description: **Tap Saddle Defective**

Distance (ft): **81.8**
Structural Grade: **0**
O&M Grade: **2**
Clock Start/From: **12**
Clock To:
1st Value: **4.000**
2nd Value:
Value Percent:
Continuous Index:
Within 8" of Joint:
Remarks: **RFC**

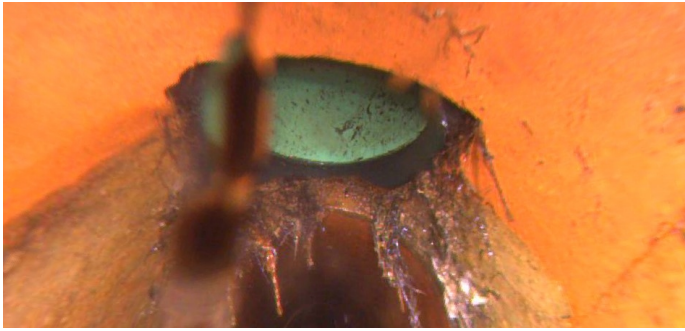
Code: **RFC**
Description: **Roots Fine Connection**

Distance (ft): **81.8**
Structural Grade: **0**
O&M Grade: **1**
Clock Start/From: **12**
Clock To:
1st Value:
2nd Value:
Value Percent:
Continuous Index:
Within 8" of Joint: **NO**
Remarks:

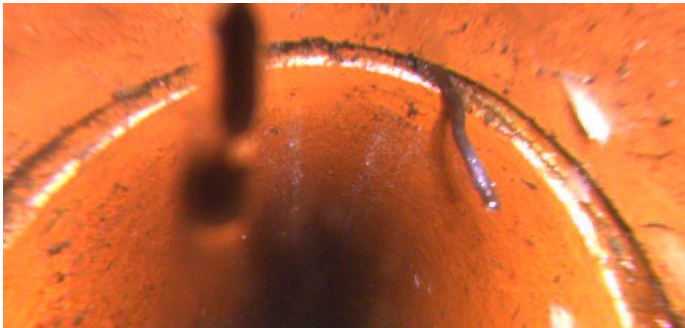
Code: **RFJ**
Description: **Roots Fine Joint**

Distance (ft): **84.5**
Structural Grade: **0**
O&M Grade: **1**
Clock Start/From: **1**
Clock To:
1st Value:
2nd Value:
Value Percent:
Continuous Index:
Within 8" of Joint: **YES**
Remarks:

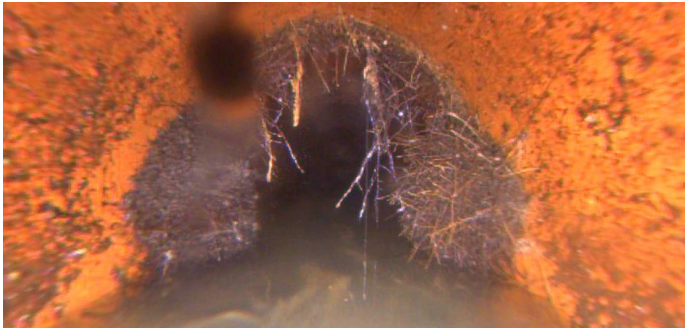
Code: **RMJ**
Description: **Roots Medium Joint**

Distance (ft): **92.6**
Structural Grade: **0**
O&M Grade: **3**
Clock Start/From: **8**
Clock To: **4**
1st Value:
2nd Value:
Value Percent: **40.000**
Continuous Index:
Within 8" of Joint: **YES**
Remarks:

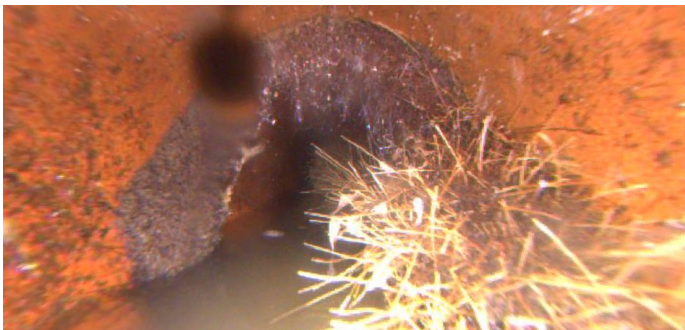
Code: **RMJ**
Description: **Roots Medium Joint**

Distance (ft): **97.1**
Structural Grade: **0**
O&M Grade: **3**
Clock Start/From: **8**
Clock To: **4**
1st Value:
2nd Value:
Value Percent: **50.000**
Continuous Index:
Within 8" of Joint: **YES**
Remarks:

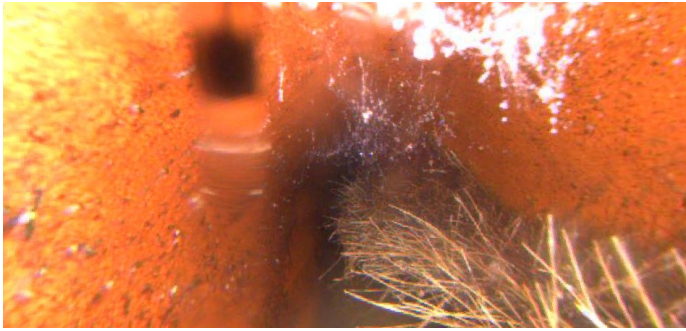
Code: **RBB**
Description: **Roots Ball Barrel**

Distance (ft): **97.9**
Structural Grade: **0**
O&M Grade: **5**
Clock Start/From: **2**
Clock To: **8**
1st Value:
2nd Value:
Value Percent: **60.000**
Continuous Index:
Within 8" of Joint: **NO**
Remarks:

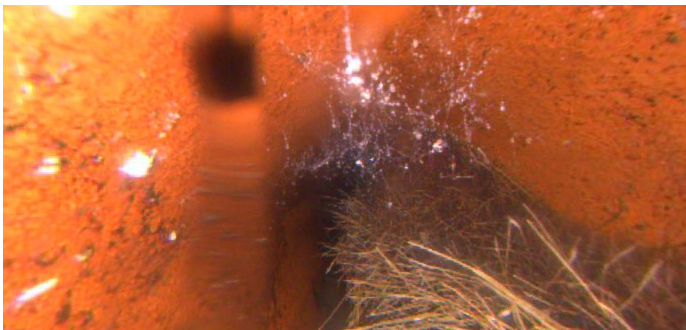
Code: **MSA**
Description: **Abandoned Survey**

Distance (ft): **98.1**
Structural Grade: **0**
O&M Grade: **0**
Clock Start/From:
Clock To:
1st Value:
2nd Value:
Value Percent:
Continuous Index:
Within 8" of Joint: **NO**
Remarks: **RBB**
