Profile/Photo Observation Report

Street:	FOXCROFT STREET	Flow Control:	Not Controlled
City:	Hobart, IN	Year Renewed:	
Location:	Light Highway	Tape/Media #:	
Purpose:	Routine Assessment	Dia/Height:	8"
Use:	Sanitary	Material:	VCP
Drain Area:	NA	Lining:	
Category:	NA		
Comment:	P_C at 63 ft debris . flow direction wrong		
Location Details:		Direction of Survey:	Downstream
US MH:	M-209-017	DS MH:	M-209-016
		Total Length Surveyed (ft):	64.2

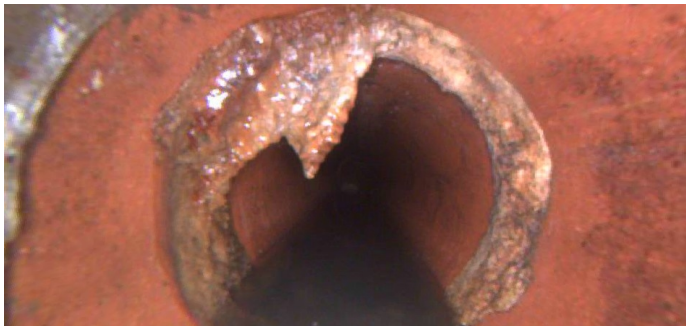
Code: **AMH**
Description: **Manhole**

Distance (ft): **.0**
Structural Grade: **0**
O&M Grade: **0**
Clock Start/From:
Clock To:
1st Value:
2nd Value:
Value Percent:
Continuous Index:
Within 8" of Joint: **NO**
Remarks: **M-209-017**

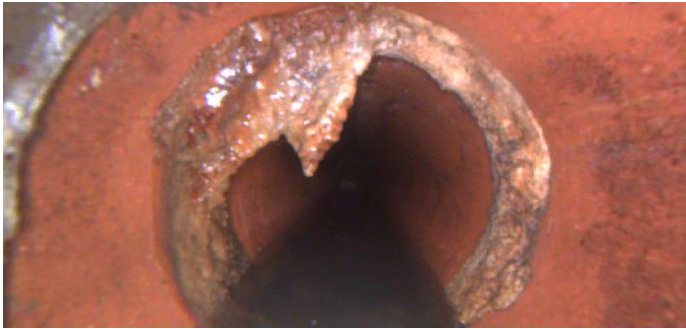
Code:	MWL
Description:	Water Level

Distance (ft):	.0
Structural Grade:	0
O&M Grade:	0
Clock Start/From:	
Clock To:	
1st Value:	
2nd Value:	
Value Percent:	15.000
Continuous Index:	
Within 8" of Joint:	NO
Remarks:

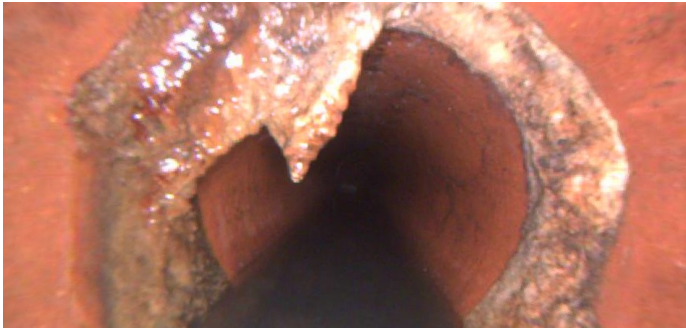
Code: **DAE**
Description: **Deposits Attached Encrustation**

Distance (ft): **.3**
Structural Grade: **0**
O&M Grade: **4**
Clock Start/From: **8**
Clock To: **4**
1st Value:
2nd Value:
Value Percent: **25.000**
Continuous Index: **S01**
Within 8" of Joint: **YES**
Remarks:

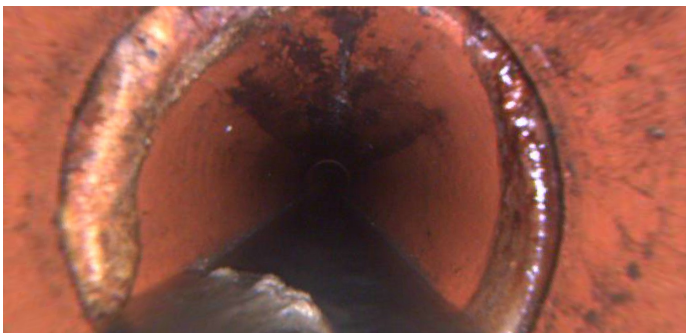
Code: **IW**
Description: **Infil Weeper**

Distance (ft): **5.3**
Structural Grade: **0**
O&M Grade: **2**
Clock Start/From: **12**
Clock To: **4**
1st Value:
2nd Value:
Value Percent:
Continuous Index:
Within 8" of Joint: **YES**
Remarks:

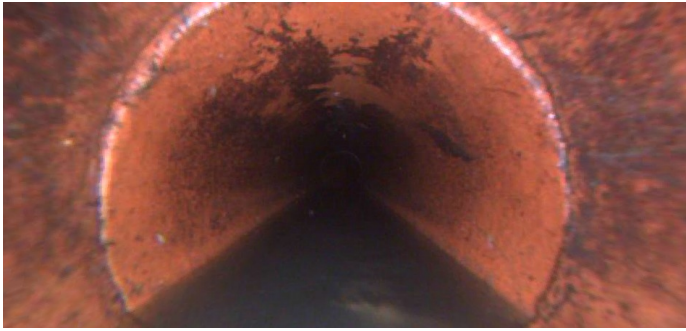
Code: **DAE**
Description: **Deposits Attached Encrustation**

Distance (ft): **13.4**
Structural Grade: **0**
O&M Grade: **4**
Clock Start/From: **8**
Clock To: **4**
1st Value:
2nd Value:
Value Percent: **25.000**
Continuous Index: **F01**
Within 8" of Joint: **YES**
Remarks: **Clock positions vary**

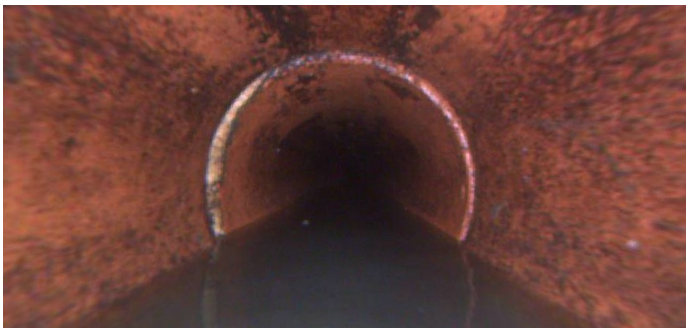
Code: **MWL**
Description: **Water Level**

Distance (ft): **17.2**
Structural Grade: **0**
O&M Grade: **0**
Clock Start/From:
Clock To:
1st Value:
2nd Value:
Value Percent: **30.000**
Continuous Index:
Within 8" of Joint: **NO**
Remarks:

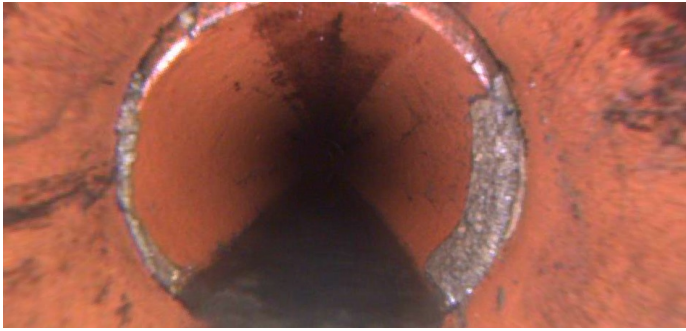
Code: **DAGS**
Description: **Deposits Attached Grease**

Distance (ft): **29.5**
Structural Grade: **0**
O&M Grade: **2**
Clock Start/From: **2**
Clock To: **4**
1st Value:
2nd Value:
Value Percent: **5.000**
Continuous Index:
Within 8" of Joint: **YES**
Remarks:

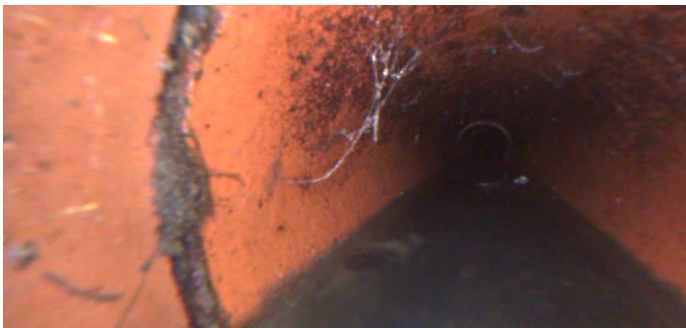
Code: **RFJ**
Description: **Roots Fine Joint**

Distance (ft): **58.1**
Structural Grade: **0**
O&M Grade: **1**
Clock Start/From: **9**
Clock To:
1st Value:
2nd Value:
Value Percent:
Continuous Index:
Within 8" of Joint: **YES**
Remarks:

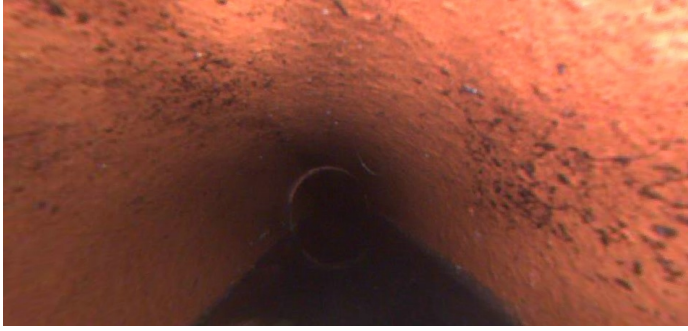
Code:	MSA
Description:	Abandoned Survey
Distance (ft):	64.2
Structural Grade:	0
O&M Grade:	0
Clock Start/From:	
Clock To:	
1st Value:	
2nd Value:	
Value Percent:	
Continuous Index:	
Within 8" of Joint:	NO
Remarks:	Unknown
