Profile/Photo Observation Report

Date:	03/19/2018	Weather:		Coding:	PACP 6.0
Pipe Length (ft):	311.4	Owner:	NA	Pre Clean:	No Pre-Cleaning
P.O.#:		Surveyor:	Byrd Fitzgerald	PSR:	P-209-017-018
Customer:		Clean Date:	01/01/1900	Shape:	C

Street:	ALLEY BETWEEN WISCONSIN ST & C	Flow Control:	Not Controlled
City:	Hobart, IN	Year Renewed:	
Location:	Light Highway	Tape/Media #:	
Purpose:	Routine Assessment	Dia/Height:	8"
Use:	Sanitary	Material:	VCP
Drain Area:	NA	Lining:	
Category:	NA		
Comment:	P_C at 216 ft nothing visible . flow direction wrong		
Location Details:		Direction of Survey:	Upstream
US MH:	M-209-018	DS MH:	M-209-017
		Total Length Surveyed (ft):	217.1

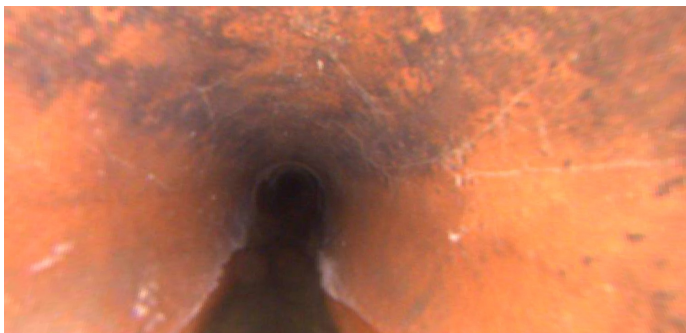
Code: **AMH**
Description: **Manhole**

Distance (ft): **.0**
Structural Grade: **0**
O&M Grade: **0**
Clock Start/From:
Clock To:
1st Value:
2nd Value:
Value Percent:
Continuous Index:
Within 8" of Joint: **NO**
Remarks: **M-209-017**

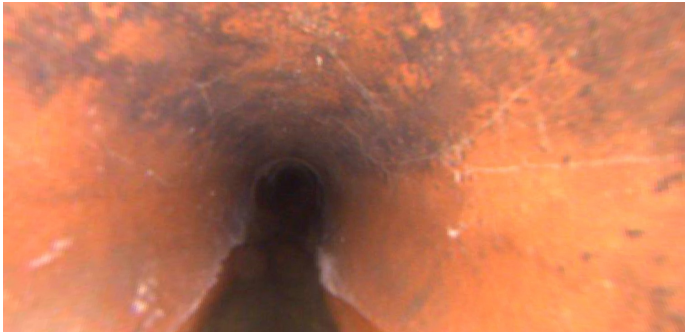
Code:	MWL
Description:	Water Level

Distance (ft):	.0
Structural Grade:	0
O&M Grade:	0
Clock Start/From:	
Clock To:	
1st Value:	
2nd Value:	
Value Percent:	5.000
Continuous Index:	
Within 8" of Joint:	NO
Remarks:

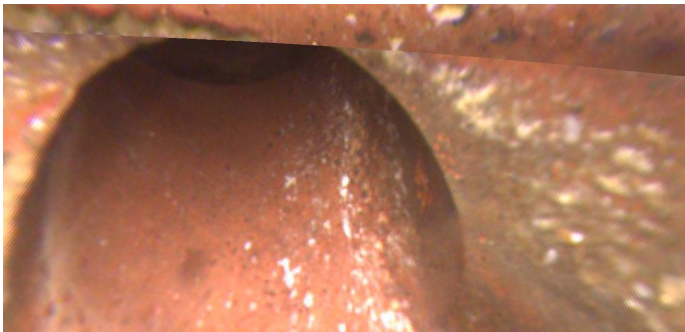
Code:	TF
Description:	Tap Factory

Distance (ft):	4.3
Structural Grade:	0
O&M Grade:	0
Clock Start/From:	11
Clock To:	
1st Value:	4.000
2nd Value:	
Value Percent:	
Continuous Index:	
Within 8" of Joint:	YES
Remarks:

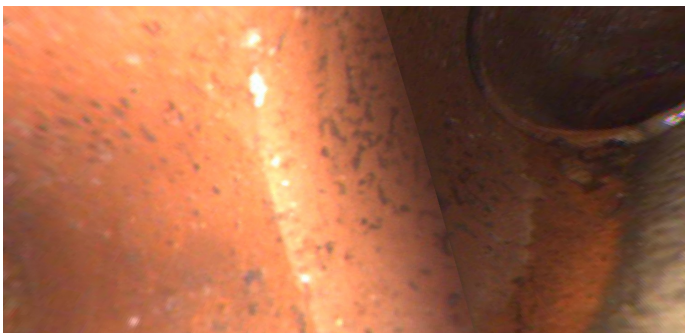
Code: **TF**
Description: **Tap Factory**

Distance (ft): **6.8**
Structural Grade: **0**
O&M Grade: **0**
Clock Start/From: **2**
Clock To:
1st Value: **4.000**
2nd Value:
Value Percent:
Continuous Index:
Within 8" of Joint: **YES**
Remarks:

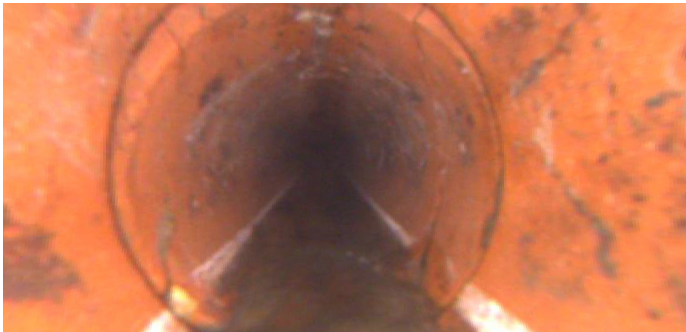
Code: **FM**
Description: **Fracture Multiple**

Distance (ft): **36.4**
Structural Grade: **4**
O&M Grade: **0**
Clock Start/From: **7**
Clock To: **5**
1st Value:
2nd Value:
Value Percent:
Continuous Index:
Within 8" of Joint: **YES**
Remarks:

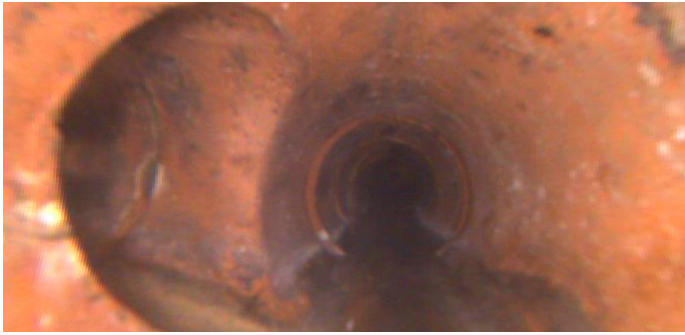
Code: **TF**
Description: **Tap Factory**

Distance (ft): **43.1**
Structural Grade: **0**
O&M Grade: **0**
Clock Start/From: **9**
Clock To:
1st Value: **4.000**
2nd Value:
Value Percent:
Continuous Index:
Within 8" of Joint: **YES**
Remarks:

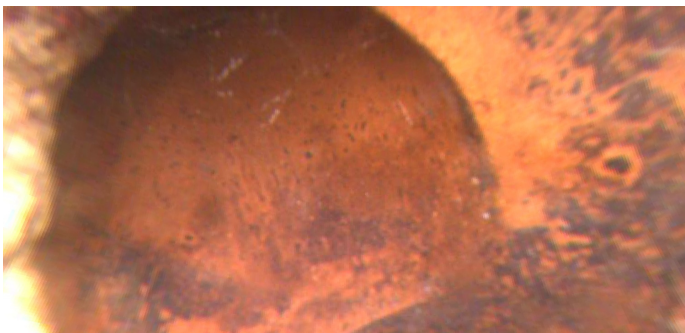
Code: **TF**
Description: **Tap Factory**

Distance (ft): **45.6**
Structural Grade: **0**
O&M Grade: **0**
Clock Start/From: **11**
Clock To:
1st Value: **4.000**
2nd Value:
Value Percent:
Continuous Index:
Within 8" of Joint: **YES**
Remarks:

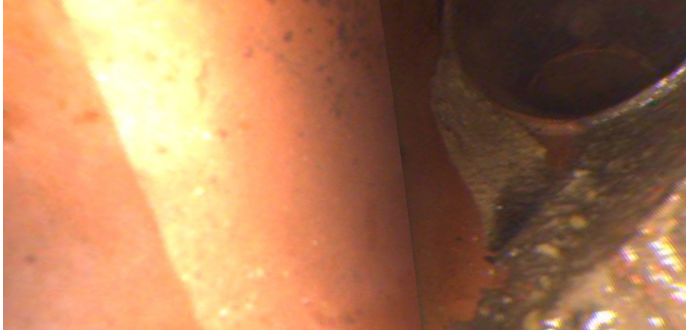
Code: **TF**
Description: **Tap Factory**

Distance (ft): **48.1**
Structural Grade: **0**
O&M Grade: **0**
Clock Start/From: **2**
Clock To:
1st Value: **4.000**
2nd Value:
Value Percent:
Continuous Index:
Within 8" of Joint: **YES**
Remarks:

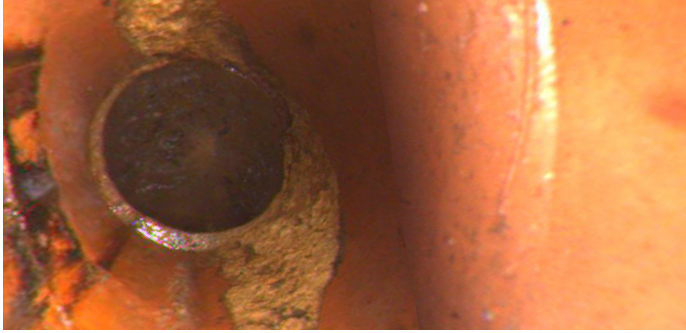
Code: **TF**
Description: **Tap Factory**

Distance (ft): **108.3**
Structural Grade: **0**
O&M Grade: **0**
Clock Start/From: **10**
Clock To:
1st Value: **4.000**
2nd Value:
Value Percent:
Continuous Index:
Within 8" of Joint:
Remarks:

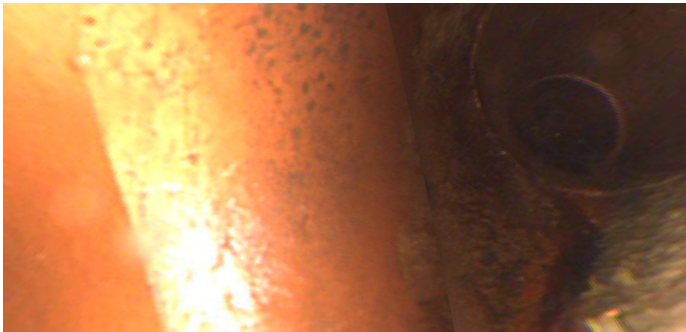
Code: **TF**
Description: **Tap Factory**

Distance (ft): **110.2**
Structural Grade: **0**
O&M Grade: **0**
Clock Start/From: **2**
Clock To:
1st Value: **4.000**
2nd Value:
Value Percent:
Continuous Index:
Within 8" of Joint: **YES**
Remarks:

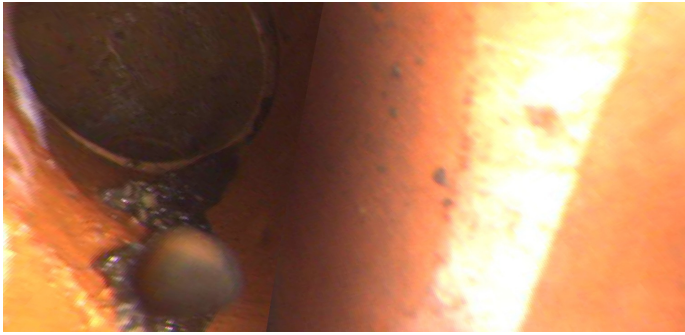
Code: **TF**
Description: **Tap Factory**

Distance (ft): **166.4**
Structural Grade: **0**
O&M Grade: **0**
Clock Start/From: **10**
Clock To:
1st Value: **4.000**
2nd Value:
Value Percent:
Continuous Index:
Within 8" of Joint: **YES**
Remarks:

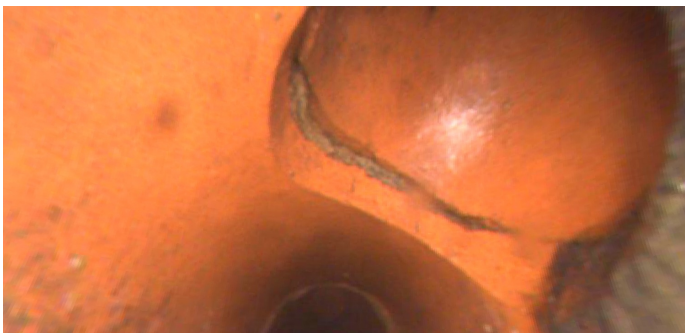
Code: **TF**
Description: **Tap Factory**

Distance (ft): **168.1**
Structural Grade: **0**
O&M Grade: **0**
Clock Start/From: **1**
Clock To:
1st Value: **6.000**
2nd Value:
Value Percent:
Continuous Index:
Within 8" of Joint:
Remarks:

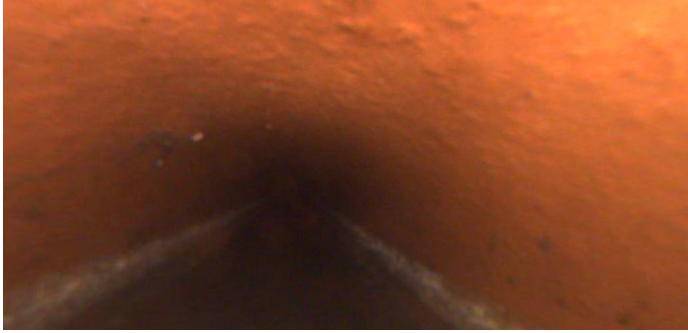
Code:	DAE
Description:	Deposits Attached Encrustation
Distance (ft):	217.1
Structural Grade:	0
O&M Grade:	2
Clock Start/From:	7
Clock To:	5
1st Value:	
2nd Value:	
Value Percent:	5.000
Continuous Index:	F01
Within 8" of Joint:	YES
Remarks:	wandering
