Profile/Photo Observation Report

Date:	03/19/2018	Weather:		Coding:	PACP 6.0
Pipe Length (ft):	311.4	Owner:	NA	Pre Clean:	No Pre-Cleaning
P.O.#:		Surveyor:	Byrd Fitzgerald	PSR:	P-209-017-018
Customer:		Clean Date:	01/01/1900	Shape:	C

Street:	FOXCROFT STREET	Flow Control:	Not Controlled
City:	Hobart, IN	Year Renewed:	
Location:	Light Highway	Tape/Media #:	
Purpose:	Routine Assessment	Dia/Height:	8"
Use:	Sanitary	Material:	VCP
Drain Area:	NA	Lining:	
Category:	NA		
Comment:	P_C at 216 ft nothing visible . flow direction wrong		
Location Details:		Direction of Survey:	Upstream
US MH:	M-209-018	DS MH:	M-209-017
		Total Length Surveyed (ft):	217.1

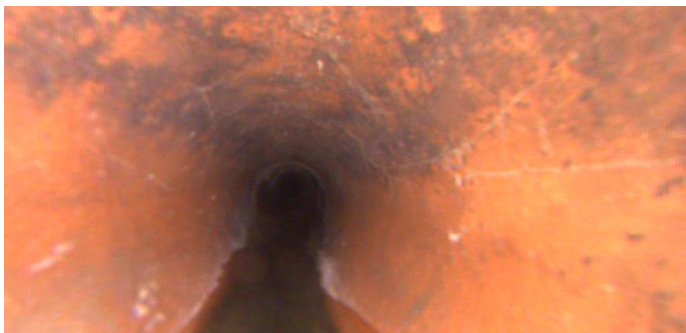
Code: **AMH**
Description: **Manhole**

Distance (ft): **.0**
Structural Grade: **0**
O&M Grade: **0**
Clock Start/From:
Clock To:
1st Value:
2nd Value:
Value Percent:
Continuous Index:
Within 8" of Joint: **NO**
Remarks: **M-209-017**

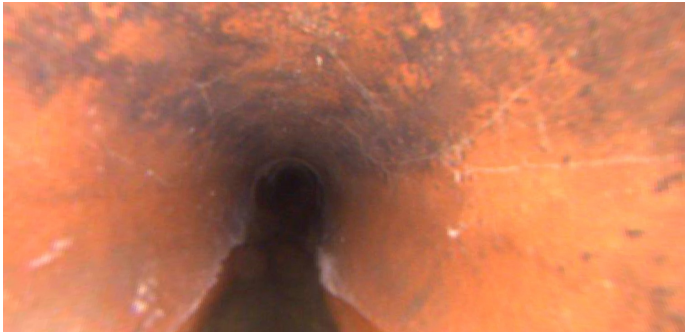
Code:	MWL
Description:	Water Level

Distance (ft):	.0
Structural Grade:	0
O&M Grade:	0
Clock Start/From:	
Clock To:	
1st Value:	
2nd Value:	
Value Percent:	5.000
Continuous Index:	
Within 8" of Joint:	NO
Remarks:

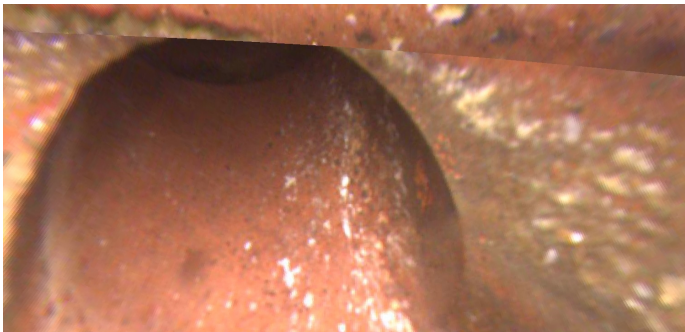
Code:	TF
Description:	Tap Factory

Distance (ft):	4.3
Structural Grade:	0
O&M Grade:	0
Clock Start/From:	11
Clock To:	
1st Value:	4.000
2nd Value:	
Value Percent:	
Continuous Index:	
Within 8" of Joint:	YES
Remarks:

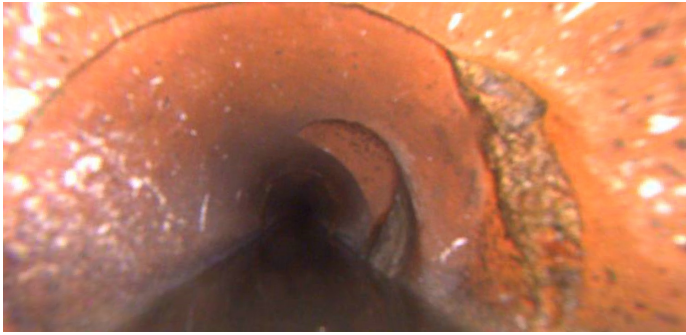
Code: **IW**
Description: **Infil Weeper**

Distance (ft): **5.6**
Structural Grade: **0**
O&M Grade: **2**
Clock Start/From: **8**
Clock To: **4**
1st Value:
2nd Value:
Value Percent:
Continuous Index: **S02**
Within 8" of Joint: **YES**
Remarks:

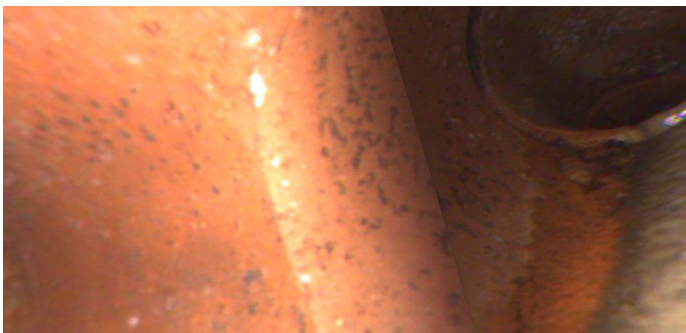
Code: **TF**
Description: **Tap Factory**

Distance (ft): **6.8**
Structural Grade: **0**
O&M Grade: **0**
Clock Start/From: **2**
Clock To:
1st Value: **4.000**
2nd Value:
Value Percent:
Continuous Index:
Within 8" of Joint: **YES**
Remarks:

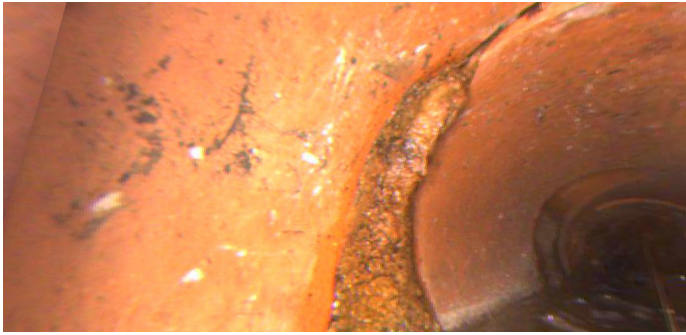
Code: **DAE**
Description: **Deposits Attached Encrustation**

Distance (ft): **8.5**
Structural Grade: **0**
O&M Grade: **2**
Clock Start/From: **7**
Clock To: **5**
1st Value:
2nd Value:
Value Percent: **5.000**
Continuous Index: **S01**
Within 8" of Joint: **YES**
Remarks: **wandering**

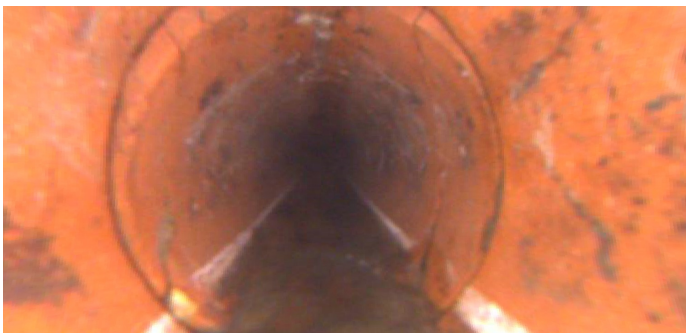
Code: **FM**
Description: **Fracture Multiple**

Distance (ft): **36.4**
Structural Grade: **4**
O&M Grade: **0**
Clock Start/From: **7**
Clock To: **5**
1st Value:
2nd Value:
Value Percent:
Continuous Index:
Within 8" of Joint: **YES**
Remarks:

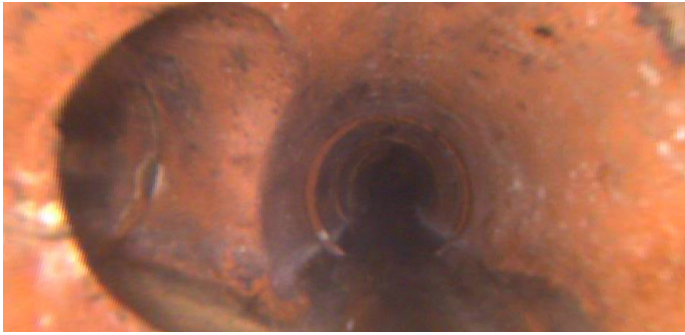
Code: **TF**
Description: **Tap Factory**

Distance (ft): **43.1**
Structural Grade: **0**
O&M Grade: **0**
Clock Start/From: **9**
Clock To:
1st Value: **4.000**
2nd Value:
Value Percent:
Continuous Index:
Within 8" of Joint: **YES**
Remarks:

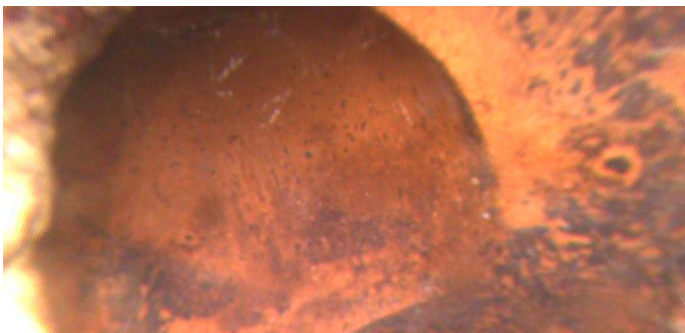
Code: **TF**
Description: **Tap Factory**

Distance (ft): **45.6**
Structural Grade: **0**
O&M Grade: **0**
Clock Start/From: **11**
Clock To:
1st Value: **4.000**
2nd Value:
Value Percent:
Continuous Index:
Within 8" of Joint: **YES**
Remarks:

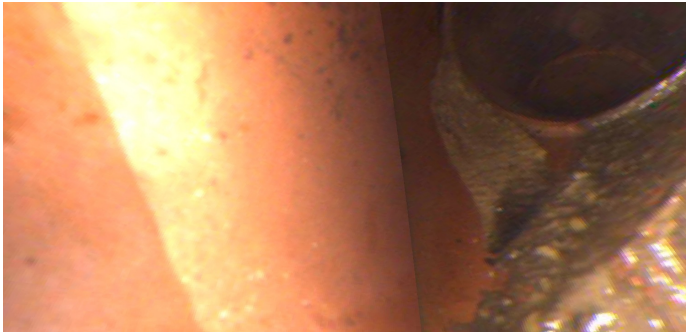
Code: **TF**
Description: **Tap Factory**

Distance (ft): **48.1**
Structural Grade: **0**
O&M Grade: **0**
Clock Start/From: **2**
Clock To:
1st Value: **4.000**
2nd Value:
Value Percent:
Continuous Index:
Within 8" of Joint: **YES**
Remarks:

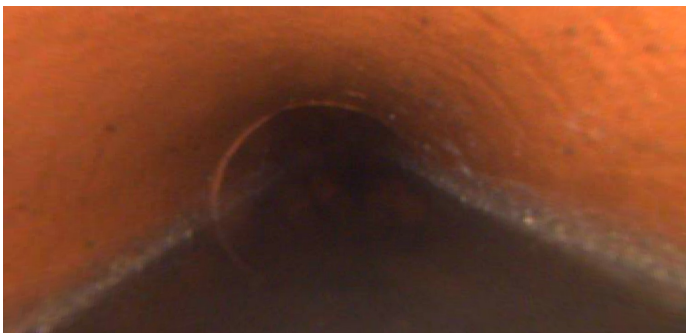
Code: **MWL**
Description: **Water Level**

Distance (ft): **77.4**
Structural Grade: **0**
O&M Grade: **0**
Clock Start/From:
Clock To:
1st Value:
2nd Value:
Value Percent: **50.000**
Continuous Index:
Within 8" of Joint: **NO**
Remarks:

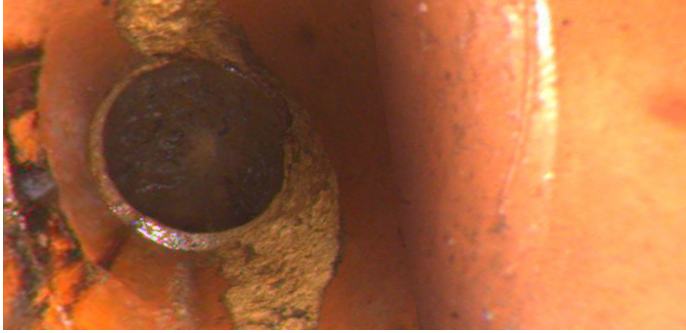
Code: **TF**
Description: **Tap Factory**

Distance (ft): **108.3**
Structural Grade: **0**
O&M Grade: **0**
Clock Start/From: **10**
Clock To:
1st Value: **4.000**
2nd Value:
Value Percent:
Continuous Index:
Within 8" of Joint:
Remarks:

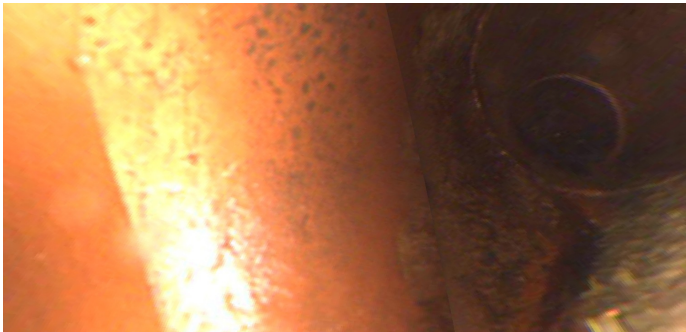
Code: **TF**
Description: **Tap Factory**

Distance (ft): **110.2**
Structural Grade: **0**
O&M Grade: **0**
Clock Start/From: **2**
Clock To:
1st Value: **4.000**
2nd Value:
Value Percent:
Continuous Index:
Within 8" of Joint: **YES**
Remarks:

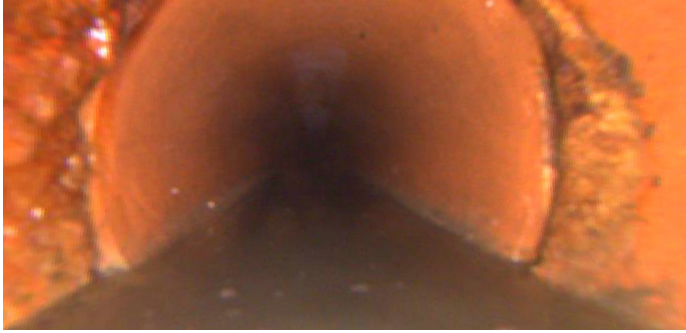
Code: **MWL**
Description: **Water Level**

Distance (ft): **115.2**
Structural Grade: **0**
O&M Grade: **0**
Clock Start/From:
Clock To:
1st Value:
2nd Value:
Value Percent: **5.000**
Continuous Index:
Within 8" of Joint: **NO**
Remarks:

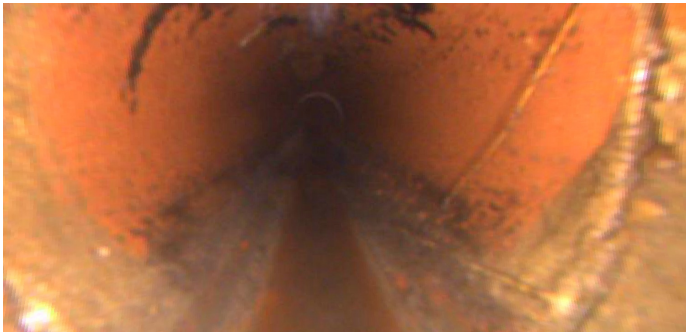
Code: **RFJ**
Description: **Roots Fine Joint**

Distance (ft): **144.6**
Structural Grade: **0**
O&M Grade: **1**
Clock Start/From: **2**
Clock To: **5**
1st Value:
2nd Value:
Value Percent:
Continuous Index:
Within 8" of Joint: **YES**
Remarks:

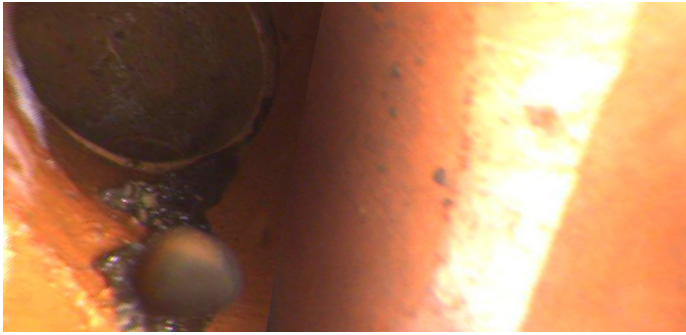
Code: **TF**
Description: **Tap Factory**

Distance (ft): **166.4**
Structural Grade: **0**
O&M Grade: **0**
Clock Start/From: **10**
Clock To:
1st Value: **4.000**
2nd Value:
Value Percent:
Continuous Index:
Within 8" of Joint: **YES**
Remarks:

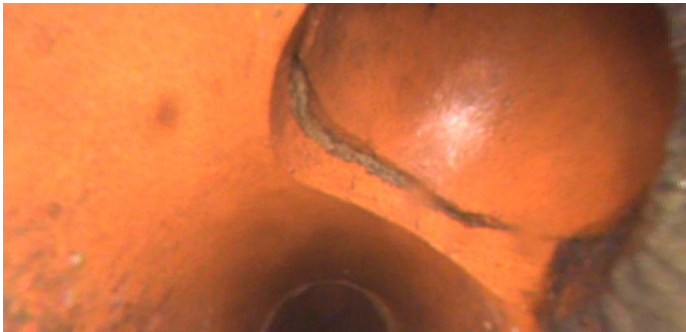
Code: **TF**
Description: **Tap Factory**

Distance (ft): **168.1**
Structural Grade: **0**
O&M Grade: **0**
Clock Start/From: **1**
Clock To:
1st Value: **6.000**
2nd Value:
Value Percent:
Continuous Index:
Within 8" of Joint:
Remarks:

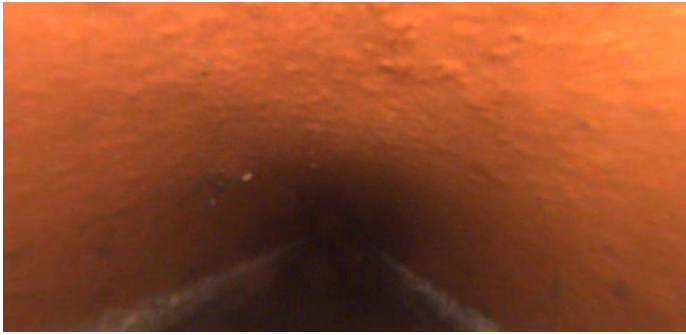
Code: **IW**
Description: **Infil Weeper**

Distance (ft): **217.1**
Structural Grade: **0**
O&M Grade: **2**
Clock Start/From: **8**
Clock To: **4**
1st Value:
2nd Value:
Value Percent:
Continuous Index: **F02**
Within 8" of Joint: **YES**
Remarks:

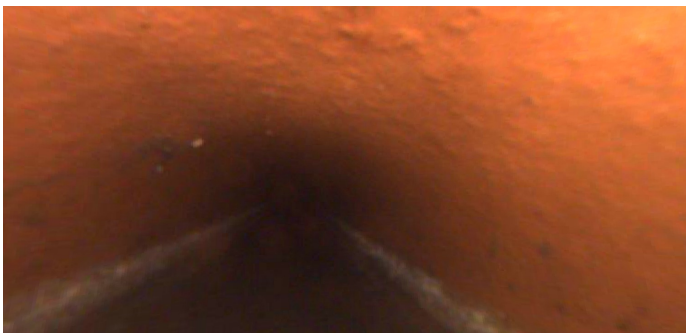
Code: **MSA**
Description: **Abandoned Survey**

Distance (ft): **217.1**
Structural Grade: **0**
O&M Grade: **0**
Clock Start/From:
Clock To:
1st Value:
2nd Value:
Value Percent:
Continuous Index:
Within 8" of Joint: **NO**
Remarks: **no blockage**

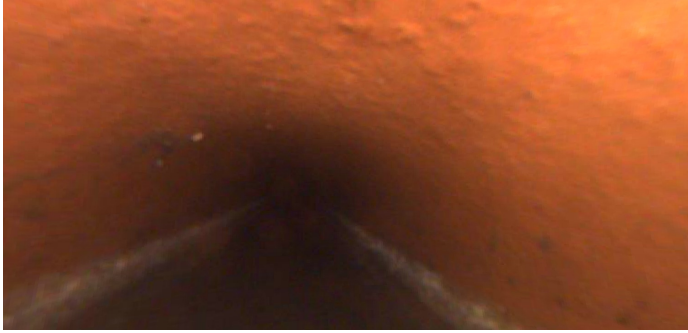
Code:	DAE
Description:	Deposits Attached Encrustation
Distance (ft):	217.1
Structural Grade:	0
O&M Grade:	2
Clock Start/From:	7
Clock To:	5
1st Value:	
2nd Value:	
Value Percent:	5.000
Continuous Index:	F01
Within 8" of Joint:	YES
Remarks:	wandering
