## Profile/Photo Observation Report

Date:	<b>03/19/2018</b>	Weather:		Coding:	<b>PACP 6.0</b>
Pipe Length (ft):	<b>289.0</b>	Owner:	<b>NA</b>	Pre Clean:	<b>No Pre-Cleaning</b>
P.O.#:		Surveyor:	<b>John Kuglmaier</b>	PSR:	<b>P-209-014-020</b>
Customer:		Clean Date:	<b>01/01/1900</b>	Shape:	<b>C</b>

Street:	<b>E 61ST PL</b>	Flow Control:	<b>Not Controlled</b>
City:	<b>Hobart, IN</b>	Year Renewed:	
Location:	<b>Light Highway</b>	Tape/Media #:	
Purpose:	<b>Routine Assessment</b>	Dia/Height:	<b>8"</b>
Use:	<b>Sanitary</b>	Material:	<b>VCP</b>
Drain Area:	<b>NA</b>	Lining:	
Category:	<b>NA</b>		
Comment:	<b>P_C at 40 ft CU .Flow direction wrong</b>		
Location Details:		Direction of Survey:	<b>Downstream</b>
US MH:	<b>M-209-020</b>	DS MH:	<b>M-209-014</b>
		Total Length Surveyed (ft):	<b>41.5</b>

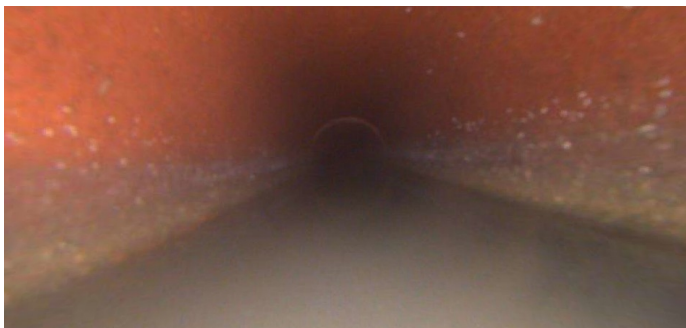
Code: **AMH**  
Description: **Manhole**

Distance (ft): **.0**  
Structural Grade: **0**  
O&M Grade: **0**  
Clock Start/From:  
Clock To:  
1st Value:  
2nd Value:  
Value Percent:  
Continuous Index:  
Within 8" of Joint: **NO**  
Remarks: **M-209-020**

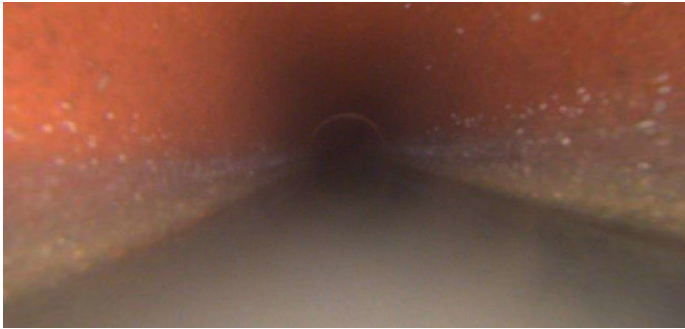
Code:	<b>MWL</b>
Description:	<b>Water Level</b>

Distance (ft):	<b>.0</b>
Structural Grade:	<b>0</b>
O&M Grade:	<b>0</b>
Clock Start/From:	
Clock To:	
1st Value:	
2nd Value:	
Value Percent:	<b>30.000</b>
Continuous Index:	
Within 8" of Joint:	<b>NO</b>
Remarks:

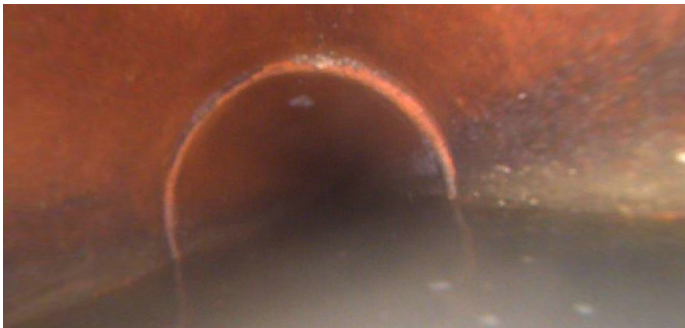
Code:	<b>MWL</b>
Description:	<b>Water Level</b>

Distance (ft):	<b>8.5</b>
Structural Grade:	<b>0</b>
O&M Grade:	<b>0</b>
Clock Start/From:	
Clock To:	
1st Value:	
2nd Value:	
Value Percent:	<b>40.000</b>
Continuous Index:	
Within 8" of Joint:	<b>NO</b>
Remarks:

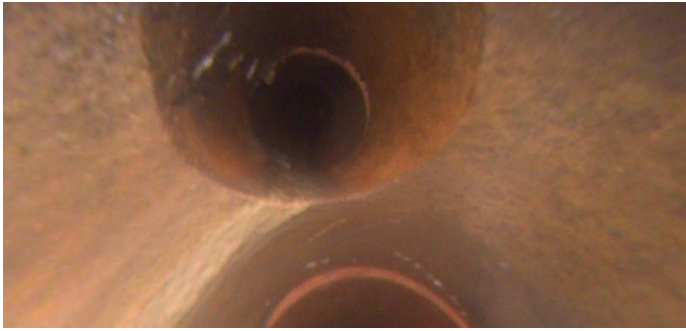
Code: **TF**  
Description: **Tap Factory**

Distance (ft): **20.3**  
Structural Grade: **0**  
O&M Grade: **0**  
Clock Start/From: **11**  
Clock To:  
1st Value: **4.000**  
2nd Value:  
Value Percent:  
Continuous Index:  
Within 8" of Joint:  
Remarks:

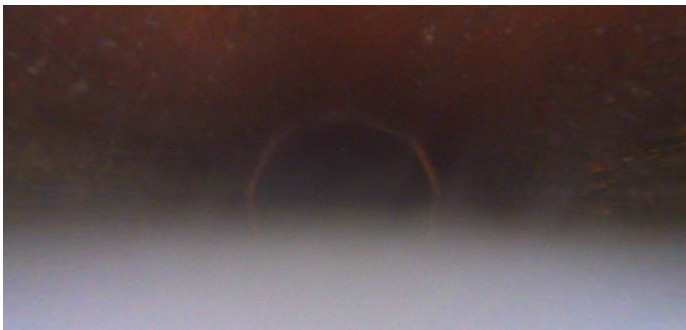
Code: **MWL**  
Description: **Water Level**

Distance (ft): **40.7**  
Structural Grade: **0**  
O&M Grade: **0**  
Clock Start/From:  
Clock To:  
1st Value:  
2nd Value:  
Value Percent: **50.000**  
Continuous Index:  
Within 8" of Joint: **NO**  
Remarks:

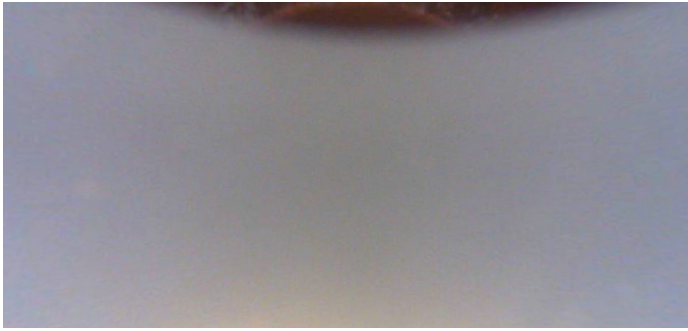
Code:	<b>MSA</b>
Description:	<b>Abandoned Survey</b>
Distance (ft):	<b>41.5</b>
Structural Grade:	<b>0</b>
O&M Grade:	<b>0</b>
Clock Start/From:	
Clock To:	
1st Value:	
2nd Value:	
Value Percent:	
Continuous Index:	
Within 8" of Joint:	<b>NO</b>
Remarks:	<b>Unknown</b>
