Profile/Photo Observation Report

Street:	FOXCROFT STREET	Flow Control:	Not Controlled
City:	Hobart, IN	Year Renewed:	
Location:	Light Highway	Tape/Media #:	
Purpose:	Routine Assessment	Dia/Height:	12"
Use:	Sanitary	Material:	VCP
Drain Area:	NA	Lining:	
Category:	NA		
Comment:

Location Details:		Direction of Survey:	Upstream
US MH:	M-209-020	DS MH:	M-209-014
		Total Length Surveyed (ft):	10.8

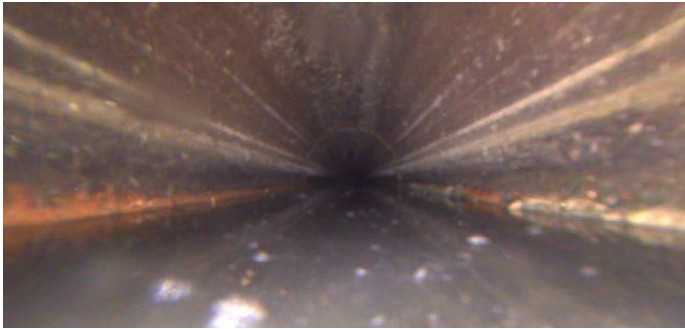
Code:	MWL
Description:	Water Level

Distance (ft):	.0
Structural Grade:	0
O&M Grade:	0
Clock Start/From:	
Clock To:	
1st Value:	
2nd Value:	
Value Percent:	30.000
Continuous Index:	
Within 8" of Joint:	NO
Remarks:

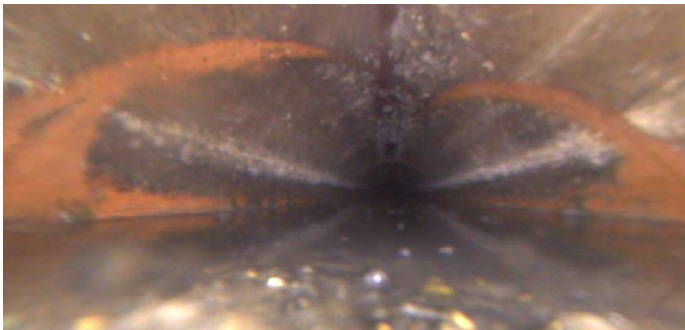
Code:	CM
Description:	Crack Multiple

Distance (ft):	8.3
Structural Grade:	3
O&M Grade:	0
Clock Start/From:	9
Clock To:	3
1st Value:	
2nd Value:	
Value Percent:	
Continuous Index:	
Within 8" of Joint:	
Remarks:

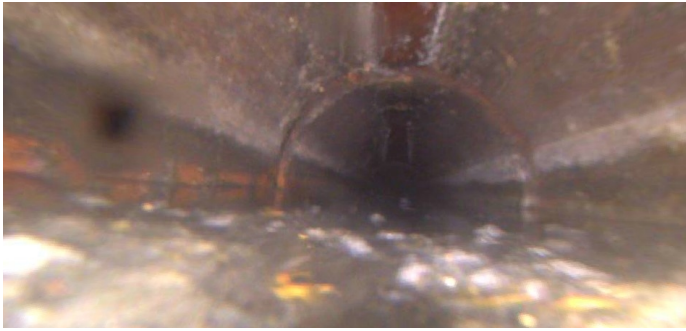
Code: **MSA**
Description: **Abandoned Survey**

Distance (ft): **10.8**
Structural Grade: **0**
O&M Grade: **0**
Clock Start/From:
Clock To:
1st Value:
2nd Value:
Value Percent:
Continuous Index:
Within 8" of Joint: **NO**
Remarks: **Unknown**

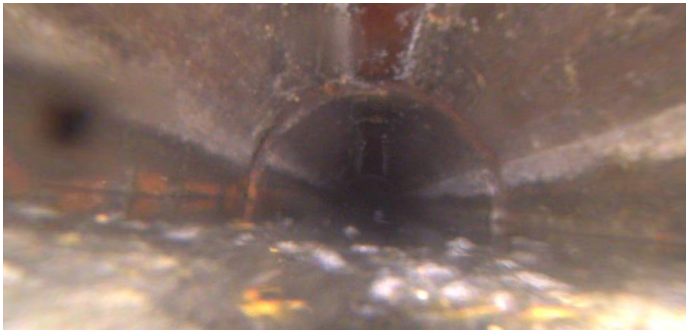
Code: **DAGS**
Description: **Deposits Attached Grease**

Distance (ft): **10.8**
Structural Grade: **0**
O&M Grade: **2**
Clock Start/From: **8**
Clock To: **4**
1st Value:
2nd Value:
Value Percent: **5.000**
Continuous Index:
Within 8" of Joint: **NO**
Remarks:
