Profile/Photo Observation Report

Street:	Off Wisconsin Street	Flow Control:	
City:	Hobart, IN	Year Renewed:	
Location:	Yard	Tape/Media #:	987
Purpose:	Routine Assessment	Dia/Height:	15"
Use:	Sanitary	Material:	VCP
Drain Area:		Lining:	
Category:	NA		
Comment:

Location Details:		Direction of Survey:	Upstream
US MH:	M-209-23	DS MH:	M-209-22
		Total Length Surveyed (ft):	278.9

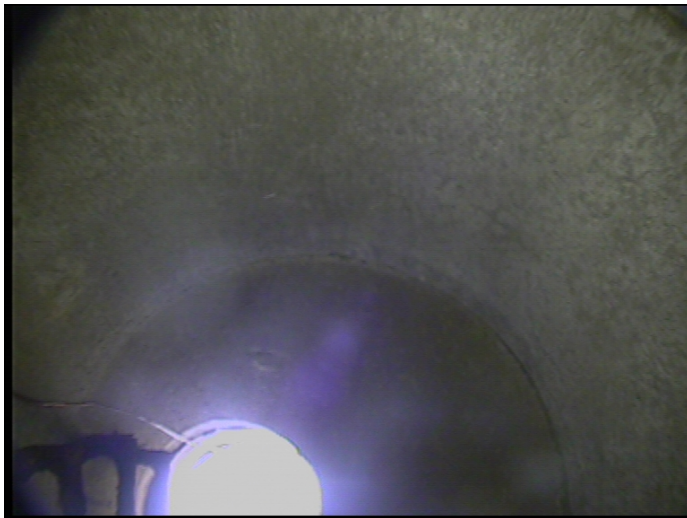
Code: **AMH**
 Description: **Manhole**

Distance (ft): **.0**
 Structural Grade: **0**
 O&M Grade: **0**
 Clock Start/From:
 Clock To:
 1st Value:
 2nd Value:
 Value Percent:
 Continuous Index:
 Within 8" of Joint: **NO**
 Remarks: **M-209-22**

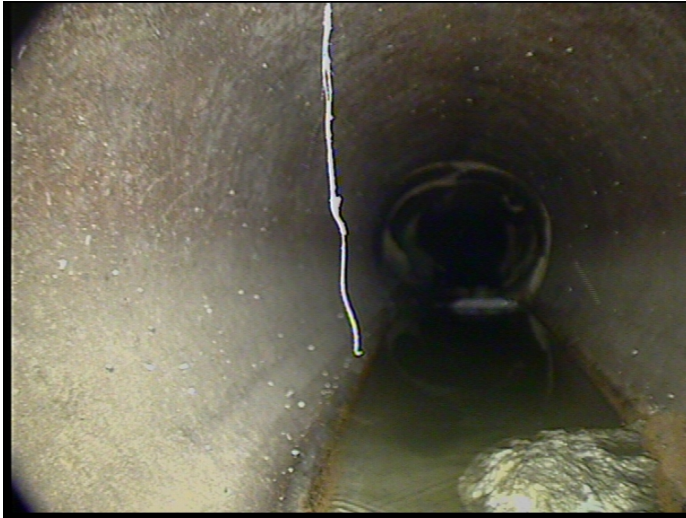
Code: **MWL**
Description: **Water Level**

Distance (ft): **.0**
Structural Grade: **0**
O&M Grade: **0**
Clock Start/From:
Clock To:
1st Value:
2nd Value:
Value Percent: **5.000**
Continuous Index:
Within 8" of Joint: **NO**
Remarks:

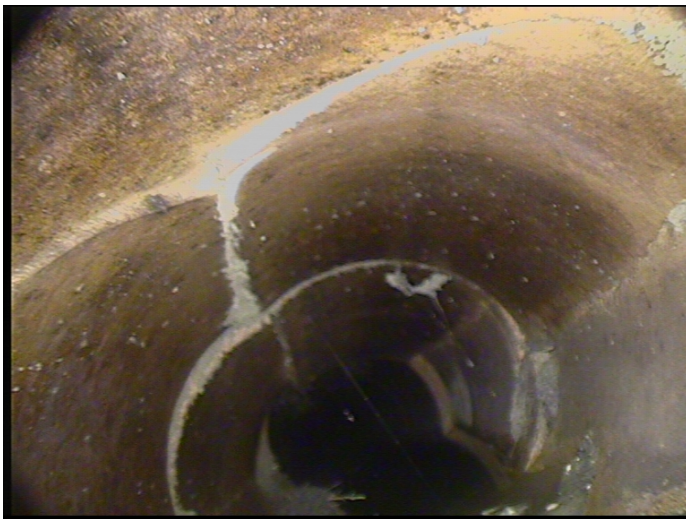
Code: **FH2**
Description: **Fracture Longitudinal Hinge, 2**

Distance (ft): **5.5**
Structural Grade: **4**
O&M Grade: **0**
Clock Start/From: **12**
Clock To: **6**
1st Value:
2nd Value:
Value Percent:
Continuous Index:
Within 8" of Joint: **YES**
Remarks:

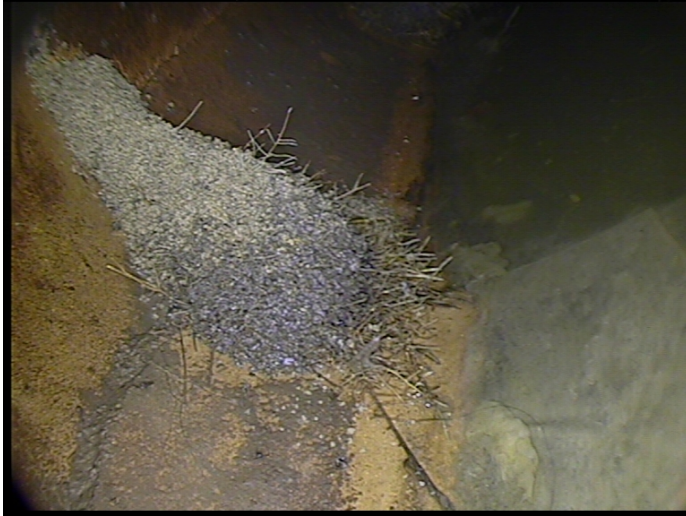
Code: **RMJ**
Description: **Roots Medium Joint**

Distance (ft): **8.8**
Structural Grade: **0**
O&M Grade: **3**
Clock Start/From: **7**
Clock To: **11**
1st Value:
2nd Value:
Value Percent: **5.000**
Continuous Index: **S01**
Within 8" of Joint: **YES**
Remarks:

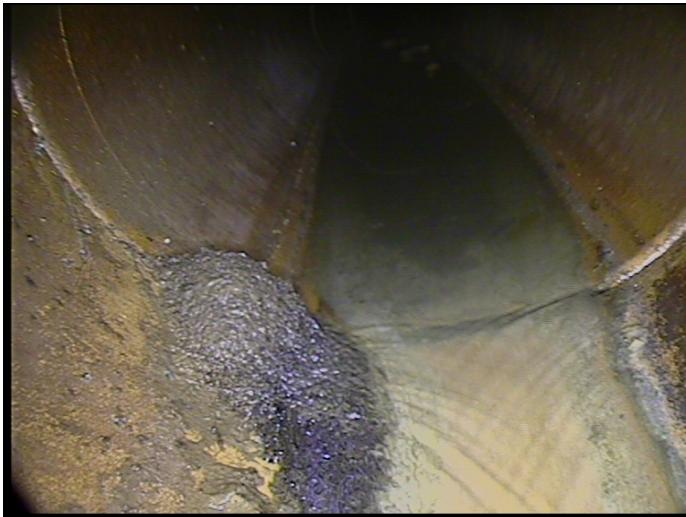
Code: **RMJ**
Description: **Roots Medium Joint**

Distance (ft): **29.6**
Structural Grade: **0**
O&M Grade: **3**
Clock Start/From: **7**
Clock To: **8**
1st Value:
2nd Value:
Value Percent: **5.000**
Continuous Index:
Within 8" of Joint: **YES**
Remarks:

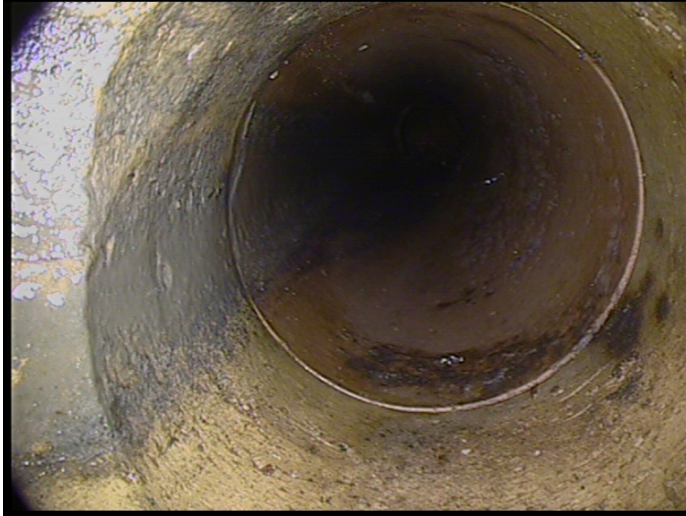
Code: **TF**
Description: **Tap Factory**

Distance (ft): **43.7**
Structural Grade: **0**
O&M Grade: **0**
Clock Start/From: **10**
Clock To:
1st Value: **4.000**
2nd Value:
Value Percent:
Continuous Index:
Within 8" of Joint: **NO**
Remarks:

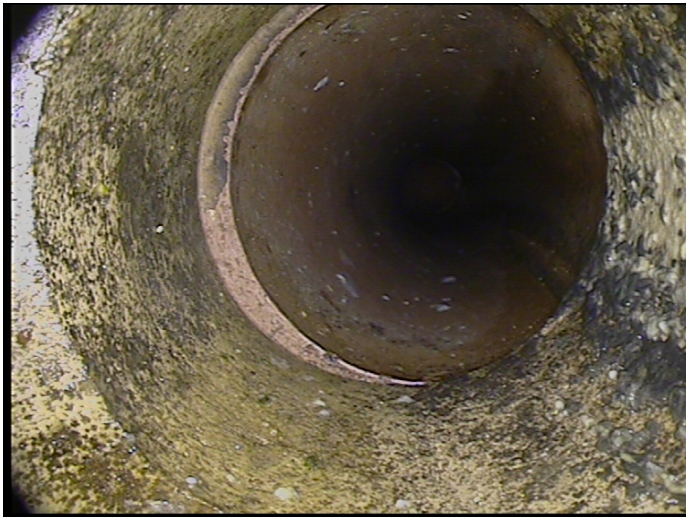
Code: **TF**
Description: **Tap Factory**

Distance (ft): **47.1**
Structural Grade: **0**
O&M Grade: **0**
Clock Start/From: **2**
Clock To:
1st Value: **4.000**
2nd Value:
Value Percent:
Continuous Index:
Within 8" of Joint: **NO**
Remarks:

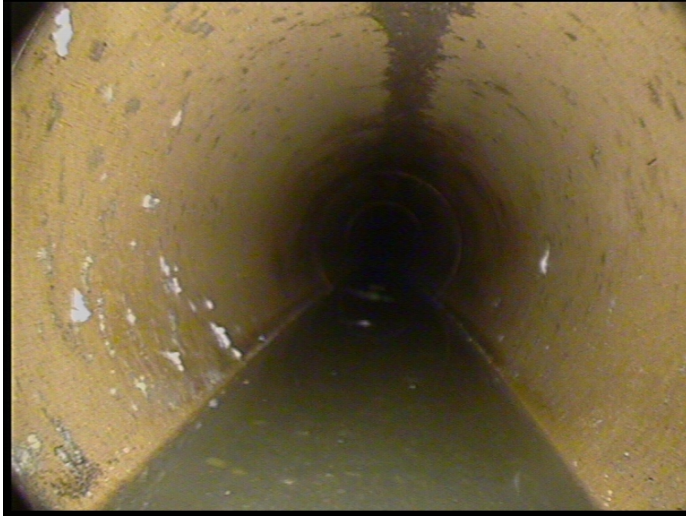
Code: **RMJ**
Description: **Roots Medium Joint**

Distance (ft): **47.3**
Structural Grade: **0**
O&M Grade: **3**
Clock Start/From: **7**
Clock To: **11**
1st Value:
2nd Value:
Value Percent: **5.000**
Continuous Index: **F01**
Within 8" of Joint: **YES**
Remarks:

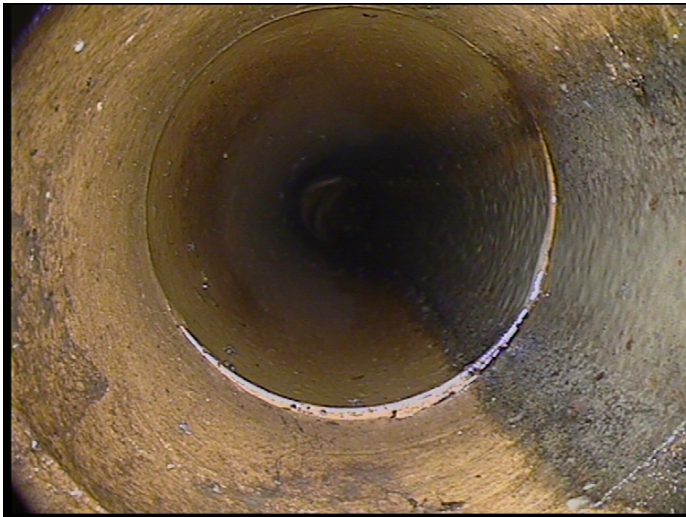
Code: **TF**
Description: **Tap Factory**

Distance (ft): **103.5**
Structural Grade: **0**
O&M Grade: **0**
Clock Start/From: **2**
Clock To:
1st Value: **4.000**
2nd Value:
Value Percent:
Continuous Index:
Within 8" of Joint: **NO**
Remarks:

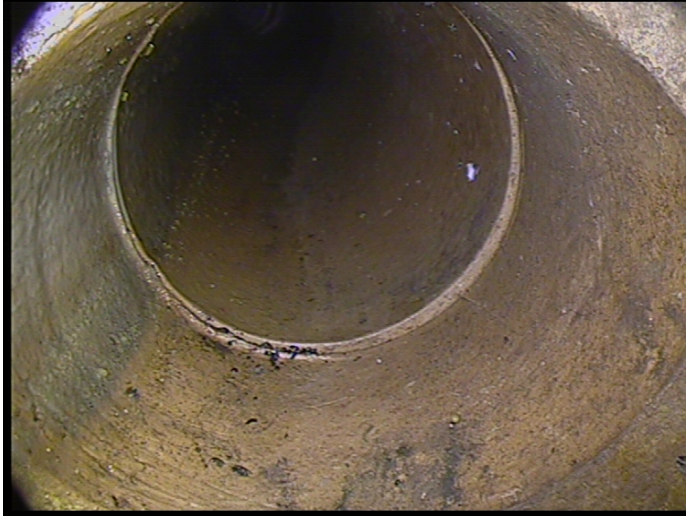
Code: **TF**
Description: **Tap Factory**

Distance (ft): **106.4**
Structural Grade: **0**
O&M Grade: **0**
Clock Start/From: **10**
Clock To:
1st Value: **4.000**
2nd Value:
Value Percent:
Continuous Index:
Within 8" of Joint: **NO**
Remarks:

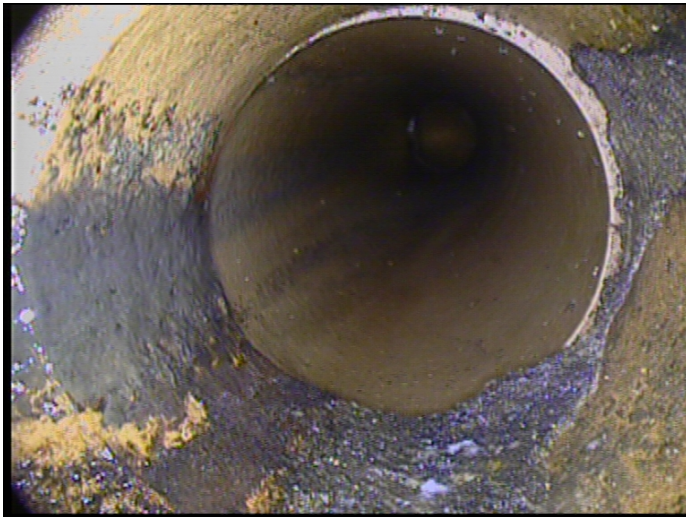
Code: **TF**
Description: **Tap Factory**

Distance (ft): **170.8**
Structural Grade: **0**
O&M Grade: **0**
Clock Start/From: **10**
Clock To:
1st Value: **4.000**
2nd Value:
Value Percent:
Continuous Index:
Within 8" of Joint: **NO**
Remarks:

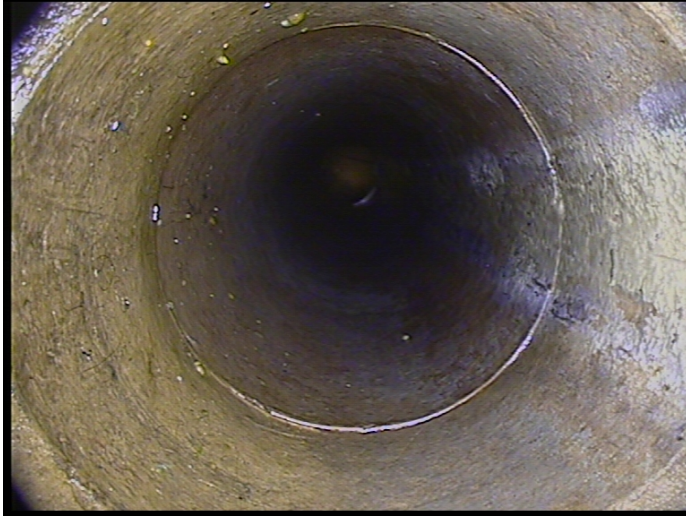
Code: **TF**
Description: **Tap Factory**

Distance (ft): **171.2**
Structural Grade: **0**
O&M Grade: **0**
Clock Start/From: **2**
Clock To:
1st Value: **4.000**
2nd Value:
Value Percent:
Continuous Index:
Within 8" of Joint: **NO**
Remarks:

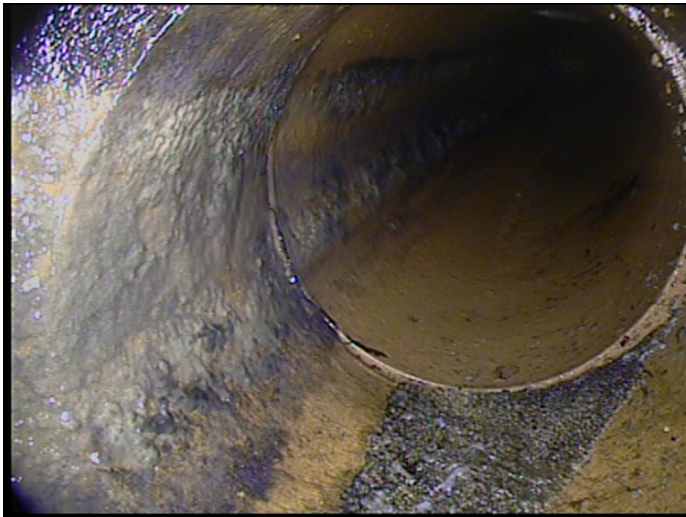
Code: **TF**
Description: **Tap Factory**

Distance (ft): **222.1**
Structural Grade: **0**
O&M Grade: **0**
Clock Start/From: **10**
Clock To:
1st Value: **4.000**
2nd Value:
Value Percent:
Continuous Index:
Within 8" of Joint: **NO**
Remarks:

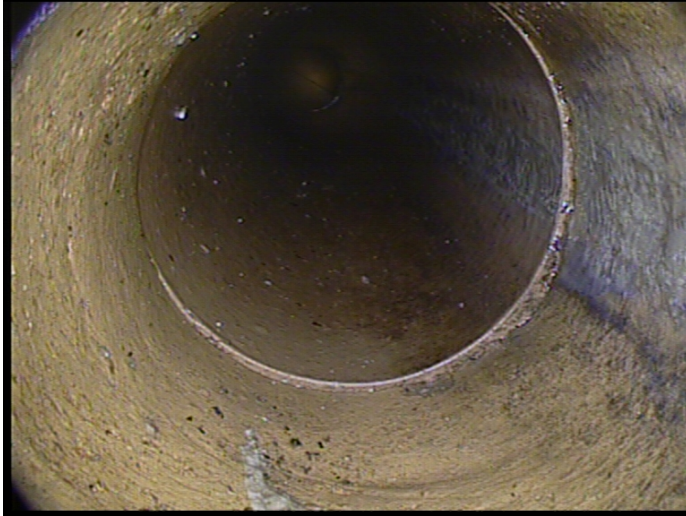
Code: **TF**
Description: **Tap Factory**

Distance (ft): **225.8**
Structural Grade: **0**
O&M Grade: **0**
Clock Start/From: **2**
Clock To:
1st Value: **4.000**
2nd Value:
Value Percent:
Continuous Index:
Within 8" of Joint: **NO**
Remarks:

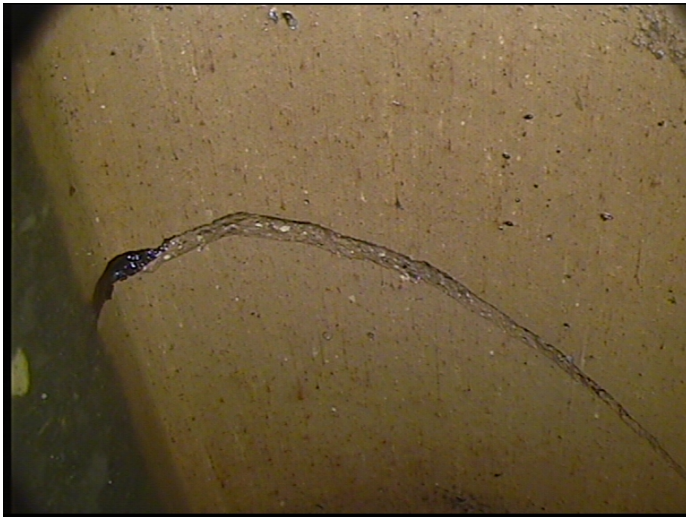
Code: **FC**
Description: **Fracture Circumferential**

Distance (ft): **237.1**
Structural Grade: **2**
O&M Grade: **0**
Clock Start/From: **7**
Clock To: **5**
1st Value:
2nd Value:
Value Percent:
Continuous Index:
Within 8" of Joint: **YES**
Remarks:

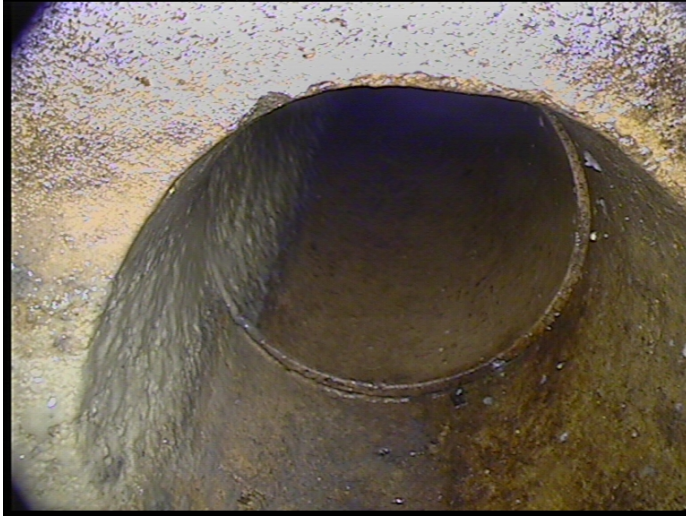
Code: **TF**
Description: **Tap Factory**

Distance (ft): **266.6**
Structural Grade: **0**
O&M Grade: **0**
Clock Start/From: **10**
Clock To:
1st Value: **4.000**
2nd Value:
Value Percent:
Continuous Index:
Within 8" of Joint: **NO**
Remarks:

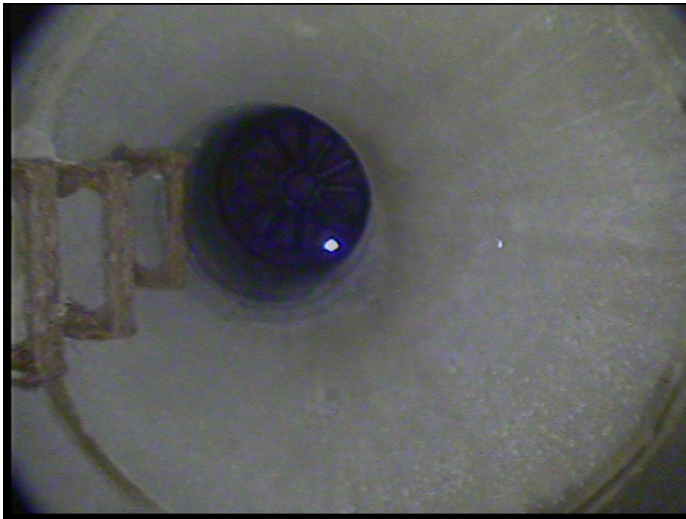
Code:	AMH
Description:	Manhole
Distance (ft):	278.4
Structural Grade:	0
O&M Grade:	0
Clock Start/From:	
Clock To:	
1st Value:	
2nd Value:	
Value Percent:	
Continuous Index:	
Within 8" of Joint:	NO
Remarks:	M-209-23
