## Profile/Photo Observation Report

Date:	<b>04/12/2018</b>	Weather:		Coding:	<b>PACP 6.0</b>
Pipe Length (ft):		Owner:	<b>City of Hobart</b>	Pre Clean:	<b>Not Known</b>
P.O.#:	<b>245</b>	Surveyor:	<b>B. Helbling</b>	PSR:	<b>P-209-023-024</b>
Customer:	<b>City of Hobart</b>	Clean Date:		Shape:	<b>C</b>

Street:	<b>Wisconsin Street</b>	Flow Control:	<b>Not Controlled</b>
City:	<b>Hobart, IN</b>	Year Renewed:	
Location:	<b>Yard</b>	Tape/Media #:	<b>DEP245</b>
Purpose:	<b>Routine Assessment</b>	Dia/Height:	<b>15"</b>
Use:	<b>Sanitary</b>	Material:	<b>VCP</b>
Drain Area:		Lining:	
Category:	<b>NA</b>		
Comment:	<b>YES501824 Submittal 2</b>		
Location Details:		Direction of Survey:	<b>Downstream</b>
US MH:	<b>M-209-024</b>	DS MH:	<b>M-209-023</b>
		Total Length Surveyed (ft):	<b>282.4</b>

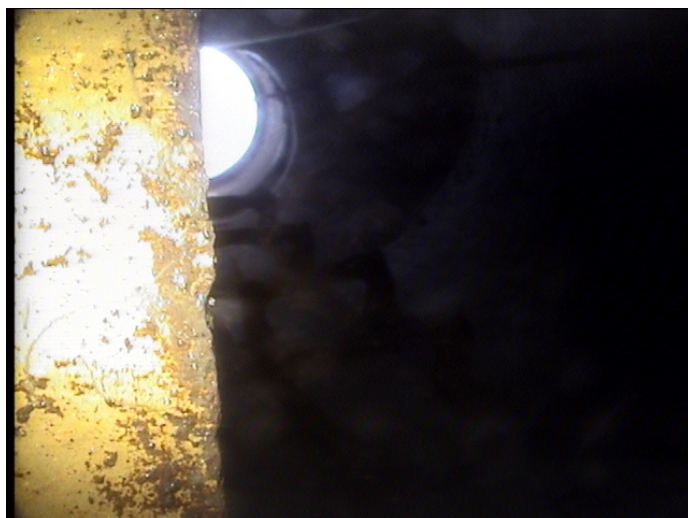
Code: **AMH**  
Description: **Manhole**

Distance (ft): **.0**  
Structural Grade: **0**  
O&M Grade: **0**  
Clock Start/From:  
Clock To:  
1st Value:  
2nd Value:  
Value Percent:  
Continuous Index:  
Within 8" of Joint: **NO**  
Remarks: **M-209-023**

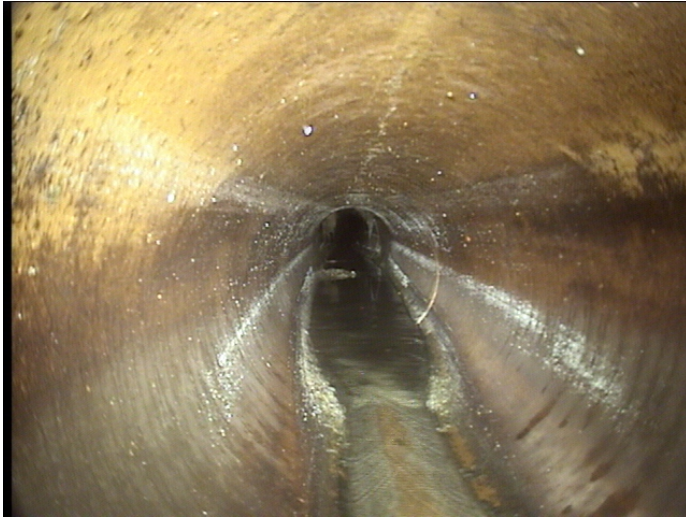
Code: **MWL**  
Description: **Water Level**

Distance (ft): **.0**  
Structural Grade: **0**  
O&M Grade: **0**  
Clock Start/From:  
Clock To:  
1st Value:  
2nd Value:  
Value Percent: **5.000**  
Continuous Index:  
Within 8" of Joint: **NO**  
Remarks:

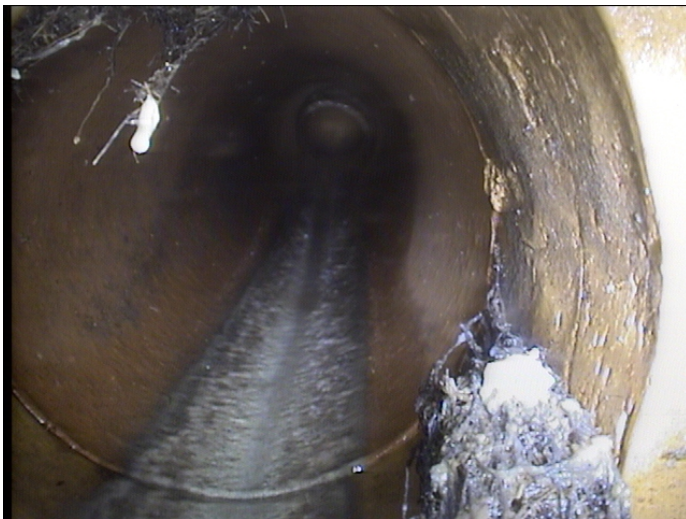
Code: **TF**  
Description: **Tap Factory**

Distance (ft): **13.0**  
Structural Grade: **0**  
O&M Grade: **0**  
Clock Start/From: **2**  
Clock To:  
1st Value: **4.000**  
2nd Value:  
Value Percent:  
Continuous Index:  
Within 8" of Joint: **NO**  
Remarks:

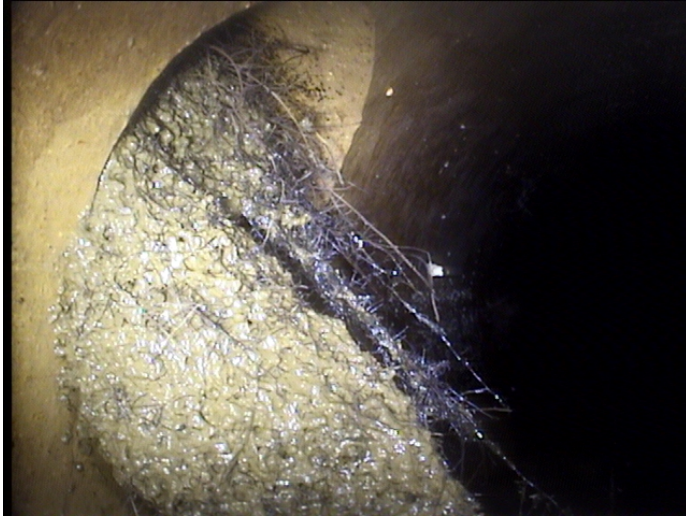
Code:	<b>TFD</b>
Description:	<b>Tap Factory Defective</b>
Distance (ft):	<b>16.2</b>
Structural Grade:	<b>0</b>
O&M Grade:	<b>2</b>
Clock Start/From:	<b>10</b>
Clock To:	
1st Value:	<b>4.000</b>
2nd Value:	
Value Percent:	
Continuous Index:	
Within 8" of Joint:	<b>NO</b>
Remarks:	<b>Defective</b>

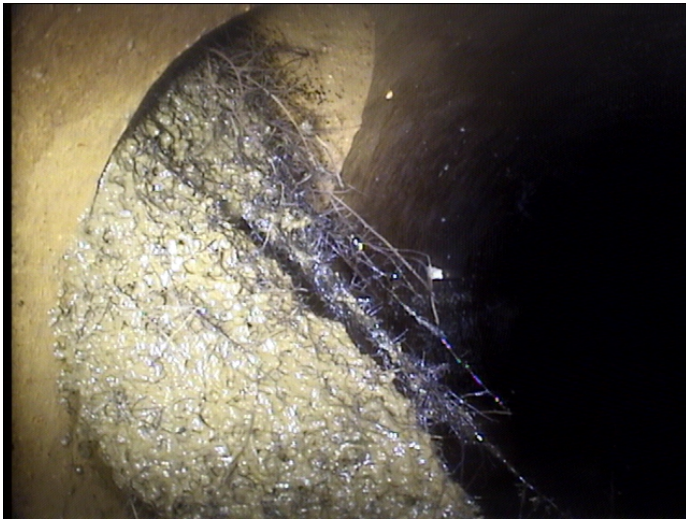
Code:	<b>RFL</b>
Description:	<b>Roots Fine Lateral</b>
Distance (ft):	<b>16.2</b>
Structural Grade:	<b>0</b>
O&M Grade:	<b>1</b>
Clock Start/From:	<b>8</b>
Clock To:	<b>10</b>
1st Value:	
2nd Value:	
Value Percent:	
Continuous Index:	
Within 8" of Joint:	<b>NO</b>
Remarks:

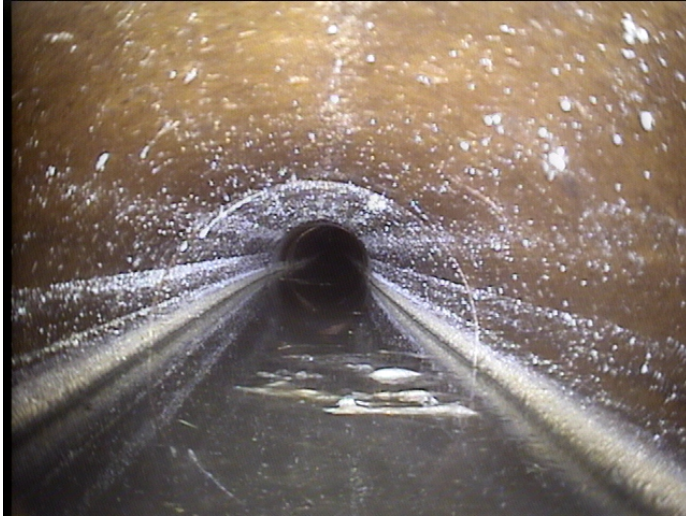
Code: **MWL**  
Description: **Water Level**

Distance (ft): **65.0**  
Structural Grade: **0**  
O&M Grade: **0**  
Clock Start/From:  
Clock To:  
1st Value:  
2nd Value:  
Value Percent: **35.000**  
Continuous Index:  
Within 8" of Joint: **NO**  
Remarks:

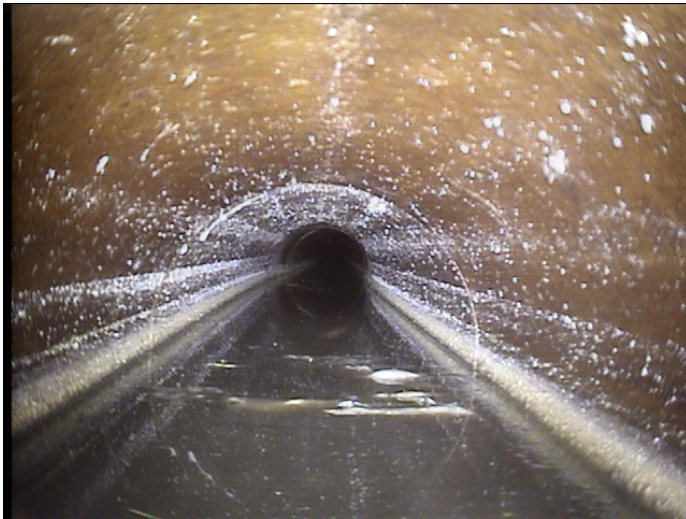
Code: **DSF**  
Description: **Deposits Settled Fine**

Distance (ft): **65.0**  
Structural Grade: **0**  
O&M Grade: **2**  
Clock Start/From: **5**  
Clock To: **7**  
1st Value:  
2nd Value:  
Value Percent: **10.000**  
Continuous Index: **S01**  
Within 8" of Joint: **NO**  
Remarks:

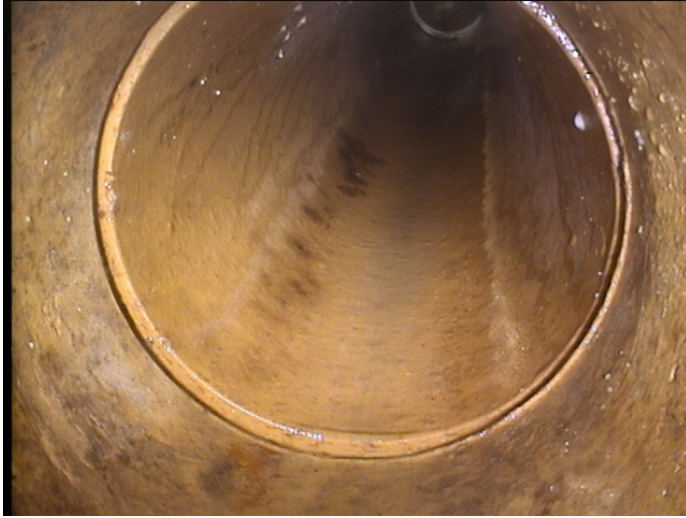
Code: **TFA**  
Description: **Tap Factory Active**

Distance (ft): **76.2**  
Structural Grade: **0**  
O&M Grade: **0**  
Clock Start/From: **2**  
Clock To:  
1st Value: **6.000**  
2nd Value:  
Value Percent:  
Continuous Index:  
Within 8" of Joint: **NO**  
Remarks:

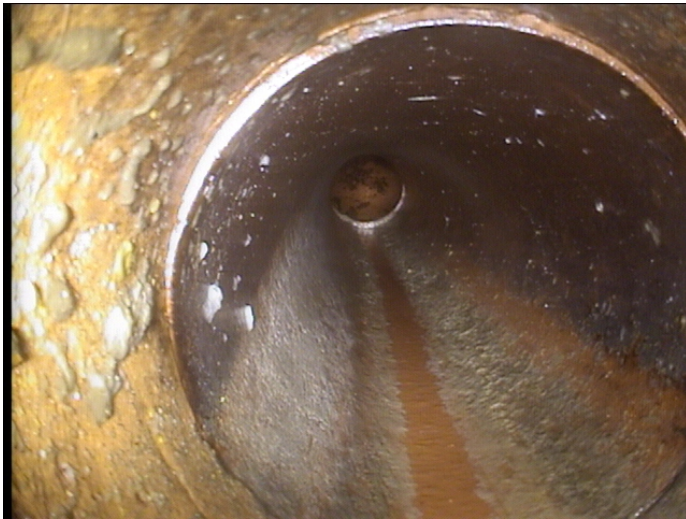
Code: **TF**  
Description: **Tap Factory**

Distance (ft): **78.9**  
Structural Grade: **0**  
O&M Grade: **0**  
Clock Start/From: **10**  
Clock To:  
1st Value: **6.000**  
2nd Value:  
Value Percent:  
Continuous Index:  
Within 8" of Joint: **NO**  
Remarks:

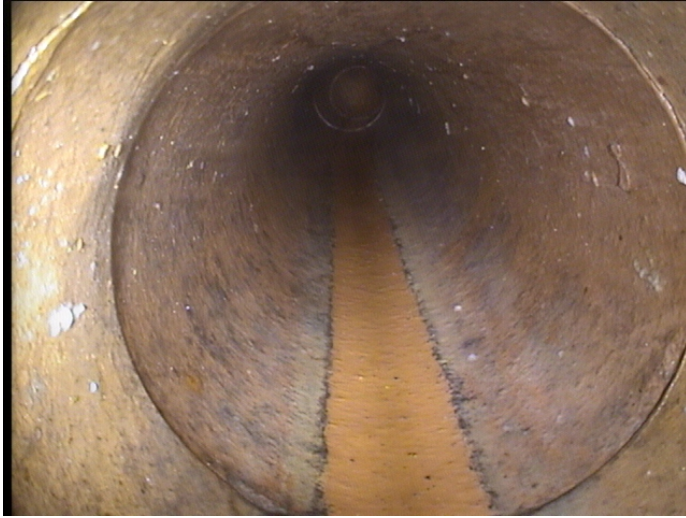
Code: **TF**  
Description: **Tap Factory**

Distance (ft): **130.6**  
Structural Grade: **0**  
O&M Grade: **0**  
Clock Start/From: **11**  
Clock To:  
1st Value: **4.000**  
2nd Value:  
Value Percent:  
Continuous Index:  
Within 8" of Joint: **NO**  
Remarks:

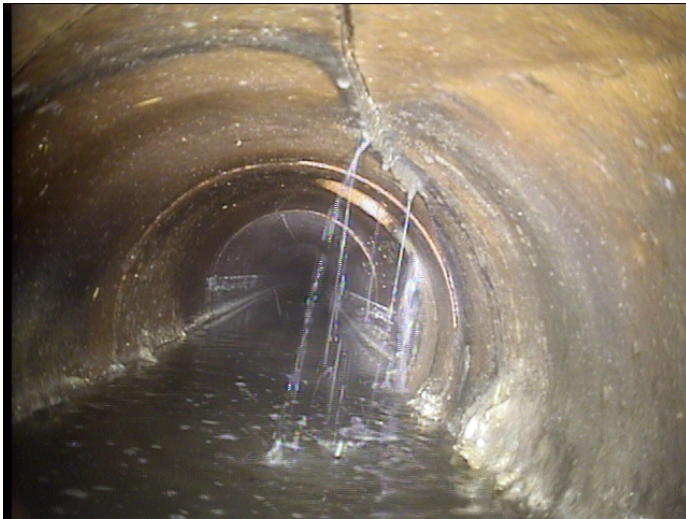
Code: **FM**  
Description: **Fracture Multiple**

Distance (ft): **130.9**  
Structural Grade: **4**  
O&M Grade: **0**  
Clock Start/From: **9**  
Clock To: **3**  
1st Value:  
2nd Value:  
Value Percent:  
Continuous Index:  
Within 8" of Joint: **NO**  
Remarks:

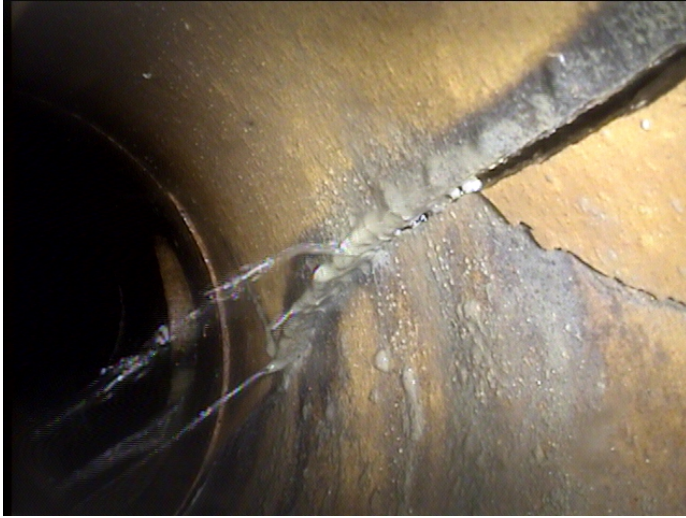
Code: **IR**  
Description: **Infil Runner**

Distance (ft): **132.1**  
Structural Grade: **0**  
O&M Grade: **4**  
Clock Start/From: **2**  
Clock To:  
1st Value:  
2nd Value:  
Value Percent:  
Continuous Index:  
Within 8" of Joint: **NO**  
Remarks:

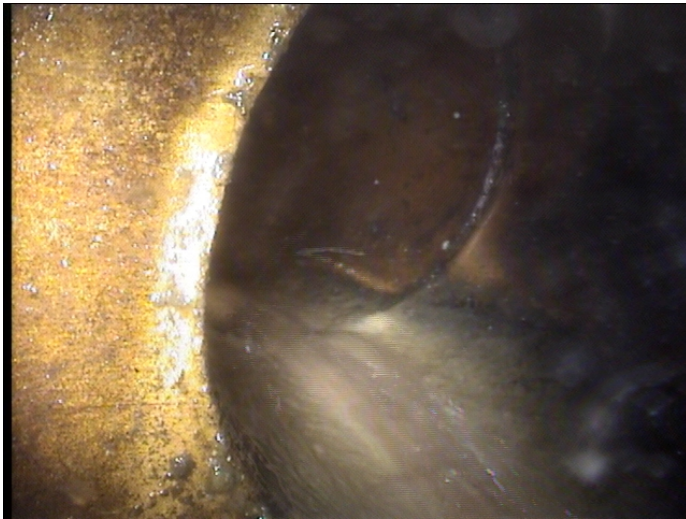
Code: **TFA**  
Description: **Tap Factory Active**

Distance (ft): **133.9**  
Structural Grade: **0**  
O&M Grade: **0**  
Clock Start/From: **2**  
Clock To:  
1st Value: **4.000**  
2nd Value:  
Value Percent:  
Continuous Index:  
Within 8" of Joint: **NO**  
Remarks:

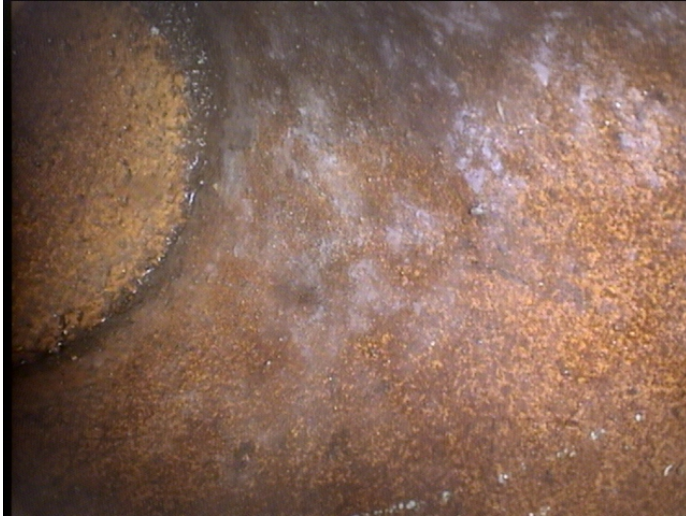
Code:	<b>TFC</b>
Description:	<b>Tap Factory Capped</b>
Distance (ft):	<b>179.1</b>
Structural Grade:	<b>0</b>
O&M Grade:	<b>0</b>
Clock Start/From:	<b>10</b>
Clock To:	
1st Value:	<b>4.000</b>
2nd Value:	
Value Percent:	
Continuous Index:	
Within 8" of Joint:	<b>NO</b>
Remarks:

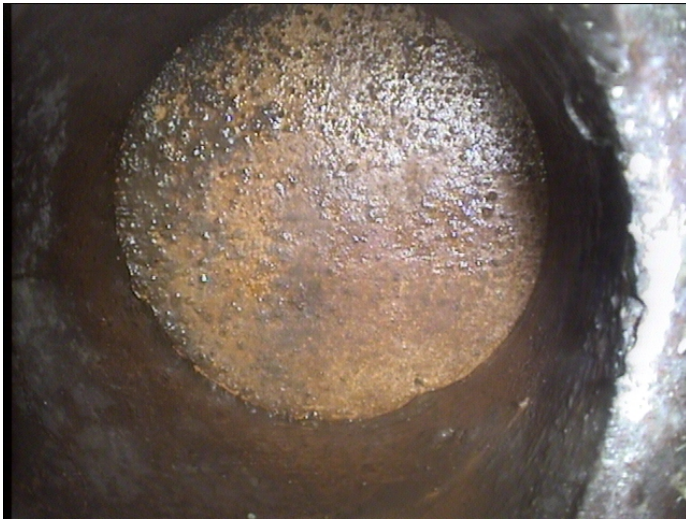
Code:	<b>TFC</b>
Description:	<b>Tap Factory Capped</b>
Distance (ft):	<b>181.8</b>
Structural Grade:	<b>0</b>
O&M Grade:	<b>0</b>
Clock Start/From:	<b>2</b>
Clock To:	
1st Value:	<b>4.000</b>
2nd Value:	
Value Percent:	
Continuous Index:	
Within 8" of Joint:	<b>NO</b>
Remarks:

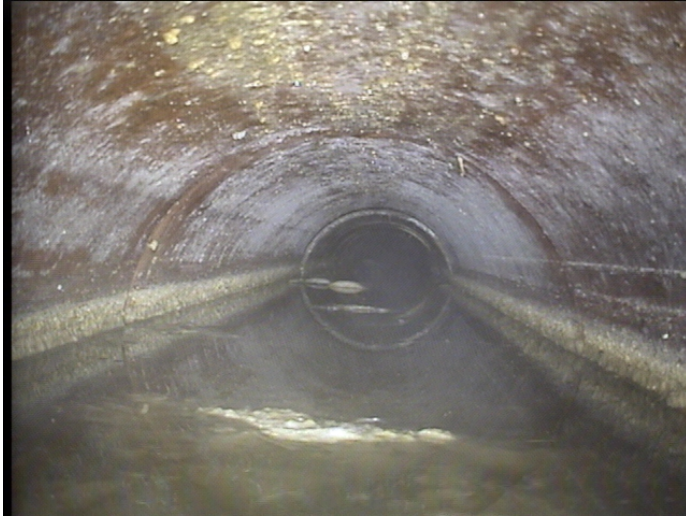
Code: **DSF**  
Description: **Deposits Settled Fine**

Distance (ft): **197.4**  
Structural Grade: **0**  
O&M Grade: **2**  
Clock Start/From: **5**  
Clock To: **7**  
1st Value:  
2nd Value:  
Value Percent: **10.000**  
Continuous Index: **F01**  
Within 8" of Joint: **NO**  
Remarks:

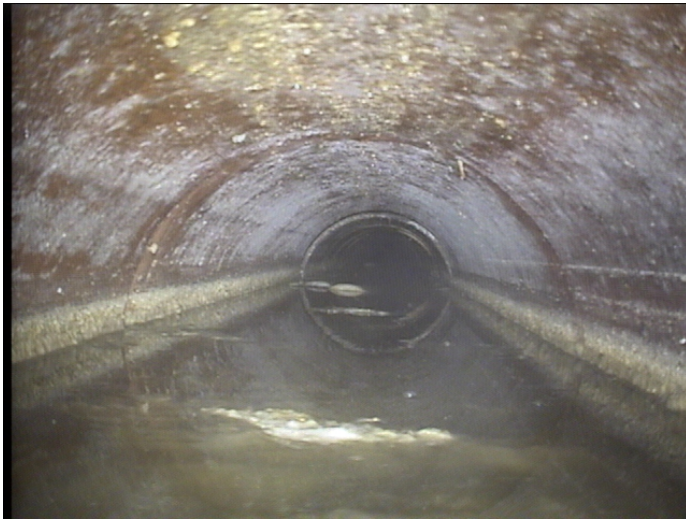
Code: **MWL**  
Description: **Water Level**

Distance (ft): **197.4**  
Structural Grade: **0**  
O&M Grade: **0**  
Clock Start/From:  
Clock To:  
1st Value:  
2nd Value:  
Value Percent: **40.000**  
Continuous Index:  
Within 8" of Joint: **NO**  
Remarks:

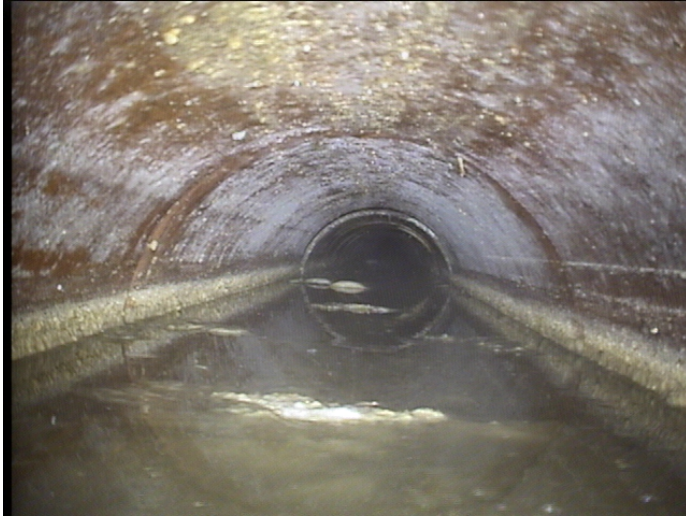
Code: **DSF**  
Description: **Deposits Settled Fine**

Distance (ft): **197.4**  
Structural Grade: **0**  
O&M Grade: **4**  
Clock Start/From: **4**  
Clock To: **8**  
1st Value:  
2nd Value:  
Value Percent: **25.000**  
Continuous Index: **S02**  
Within 8" of Joint: **NO**  
Remarks:

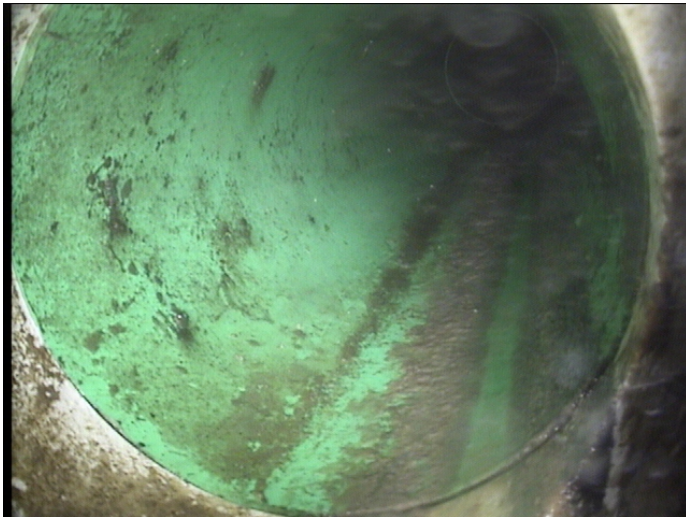
Code: **TF**  
Description: **Tap Factory**

Distance (ft): **207.7**  
Structural Grade: **0**  
O&M Grade: **0**  
Clock Start/From: **2**  
Clock To:  
1st Value: **4.000**  
2nd Value:  
Value Percent:  
Continuous Index:  
Within 8" of Joint: **NO**  
Remarks:
