## Profile/Photo Observation Report

Date:	<b>03/22/2018</b>	Weather:		Coding:	<b>PACP 6.0</b>
Pipe Length (ft):	<b>347.0</b>	Owner:	<b>NA</b>	Pre Clean:	<b>No Pre-Cleaning</b>
P.O.#:		Surveyor:	<b>Selasie Honu</b>	PSR:	<b>P-209-028-029</b>
Customer:		Clean Date:	<b>01/01/1900</b>	Shape:	<b>C</b>

Street:	<b>FOXCROFT STREET</b>	Flow Control:	<b>Not Controlled</b>
City:	<b>Hobart, IN</b>	Year Renewed:	
Location:	<b>Light Highway</b>	Tape/Media #:	
Purpose:	<b>Routine Assessment</b>	Dia/Height:	<b>10"</b>
Use:	<b>Sanitary</b>	Material:	<b>PVC</b>
Drain Area:	<b>NA</b>	Lining:	
Category:	<b>NA</b>		
Comment:	<b>P_C at 243 ft nothing visible .Flow direction</b>		
Location Details:		Direction of Survey:	<b>Downstream</b>
US MH:	<b>M-209-029</b>	DS MH:	<b>M-209-028</b>
		Total Length Surveyed (ft):	<b>244.4</b>

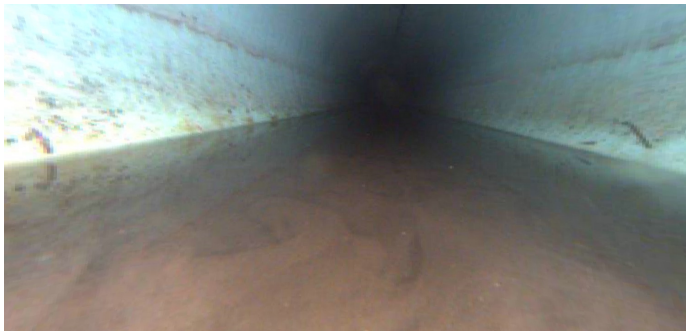
Code: **AMH**  
Description: **Manhole**

Distance (ft): **.0**  
Structural Grade: **0**  
O&M Grade: **0**  
Clock Start/From:  
Clock To:  
1st Value:  
2nd Value:  
Value Percent:  
Continuous Index:  
Within 8" of Joint: **NO**  
Remarks: **M-209-029**

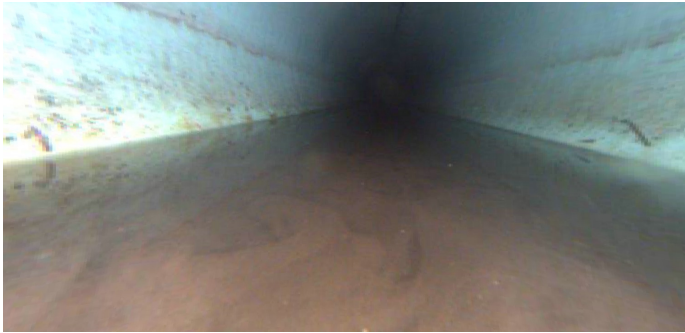
Code: **MWL**  
Description: **Water Level**

Distance (ft): **.0**  
Structural Grade: **0**  
O&M Grade: **0**  
Clock Start/From:  
Clock To:  
1st Value:  
2nd Value:  
Value Percent: **30.000**  
Continuous Index:  
Within 8" of Joint: **NO**  
Remarks:

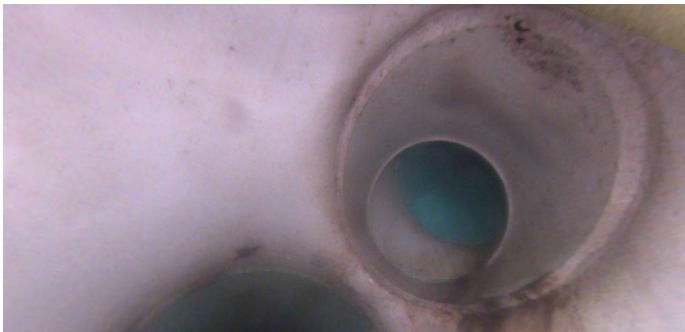
Code: **TF**  
Description: **Tap Factory**

Distance (ft): **25.3**  
Structural Grade: **0**  
O&M Grade: **0**  
Clock Start/From: **2**  
Clock To:  
1st Value: **4.000**  
2nd Value:  
Value Percent:  
Continuous Index:  
Within 8" of Joint:  
Remarks:

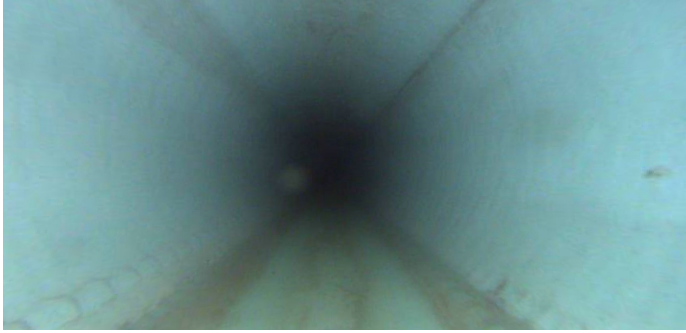
Code: **MWL**  
Description: **Water Level**

Distance (ft): **48.1**  
Structural Grade: **0**  
O&M Grade: **0**  
Clock Start/From:  
Clock To:  
1st Value:  
2nd Value:  
Value Percent: **10.000**  
Continuous Index:  
Within 8" of Joint: **NO**  
Remarks:

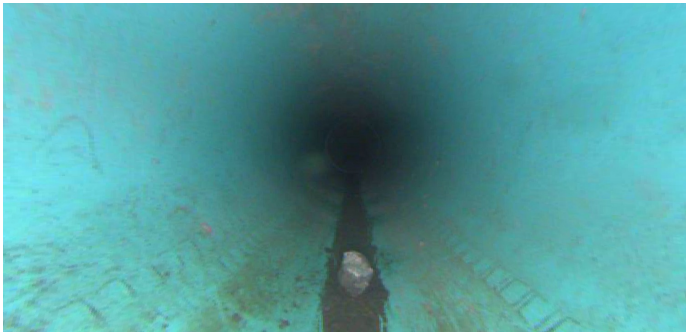
Code: **MSA**  
Description: **Abandoned Survey**

Distance (ft): **244.4**  
Structural Grade: **0**  
O&M Grade: **0**  
Clock Start/From:  
Clock To:  
1st Value:  
2nd Value:  
Value Percent:  
Continuous Index:  
Within 8" of Joint: **NO**  
Remarks: **camera stopped**
