Profile/Photo Observation Report

Street:	Off Old Ridge Road	Flow Control:	Not Controlled
City:	Hobart, IN	Year Renewed:	
Location:	Light Highway	Tape/Media #:	DEP 27
Purpose:	Routine Assessment	Dia/Height:	18"
Use:	Sanitary	Material:	VCP
Drain Area:		Lining:	Other
Category:	NA

US MH:	M-303-002	DS MH:	M-303-001	Total Length Surveyed (ft):	.1
--------	------------------	--------	------------------	-----------------------------	-----------

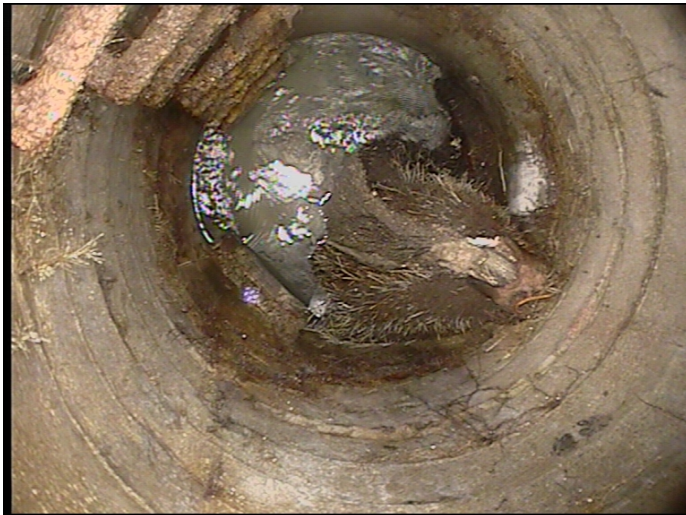
Code: **AMH**
Description: **Manhole**

Distance (ft): **.0**
Structural Grade: **0**
O&M Grade: **0**
Clock Start/From:
Clock To:
1st Value:
2nd Value:
Value Percent:
Continuous Index:
Within 8" of Joint: **NO**
Remarks: **M-303-002**

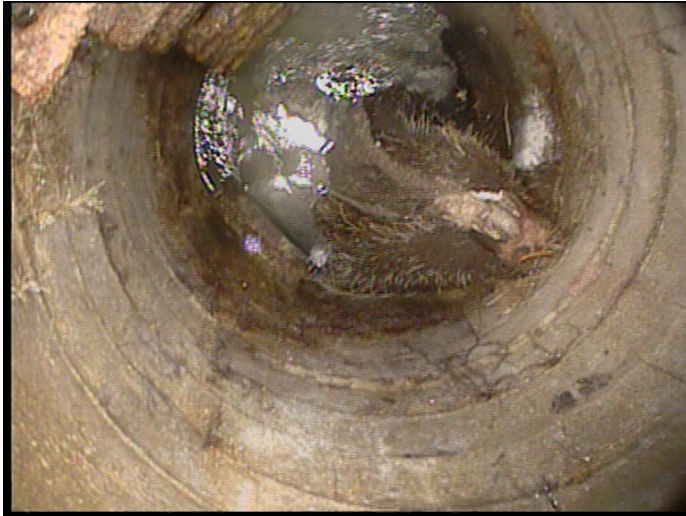
Code: **MWL**
Description: **Water Level**

Distance (ft): **.0**
Structural Grade: **0**
O&M Grade: **0**
Clock Start/From:
Clock To:
1st Value:
2nd Value:
Value Percent: **50.000**
Continuous Index:
Within 8" of Joint: **NO**
Remarks:

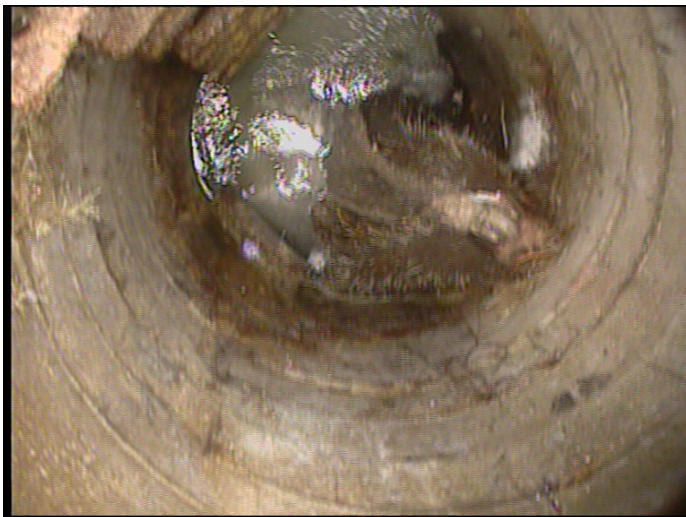
Code: **MSA**
Description: **Abandoned Survey**

Distance (ft): **.0**
Structural Grade: **0**
O&M Grade: **0**
Clock Start/From:
Clock To:
1st Value:
2nd Value:
Value Percent:
Continuous Index:
Within 8" of Joint: **NO**
Remarks: **roots and debris**
