Profile/Photo Observation Report

Date:	04/07/2018	Weather:		Coding:	PACP 6.0
Pipe Length (ft):		Owner:	City of Hobart	Pre Clean:	No Pre-Cleaning
P.O.#:	8-1	Surveyor:	M. Pielacha	PSR:	M-303-004-M-303-073
Customer:	City of Hobart	Clean Date:		Shape:	C

Street:	Ridgelawn Drive	Flow Control:	Not Controlled
City:	Hobart, IN	Year Renewed:	
Location:	Light Highway	Tape/Media #:	DEP 8
Purpose:	Routine Assessment	Dia/Height:	18"
Use:	Sanitary	Material:	VCP
Drain Area:		Lining:	
Category:	NA		
Comment:			
Location Details:		Direction of Survey:	Downstream
US MH:	M-303-004	DS MH:	M-303-073
		Total Length Surveyed (ft):	5.2

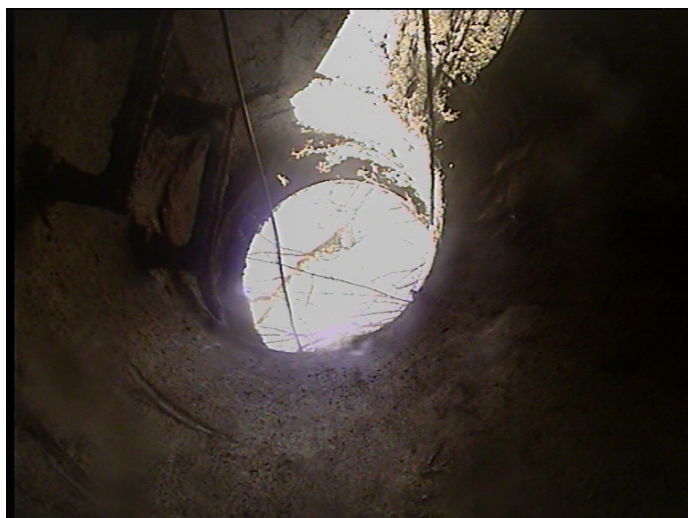
Code: **AMH**
 Description: **Manhole**

Distance (ft): **.0**
 Structural Grade: **0**
 O&M Grade: **0**
 Clock Start/From:
 Clock To:
 1st Value:
 2nd Value:
 Value Percent:
 Continuous Index:
 Within 8" of Joint: **NO**
 Remarks: **M-303-004**

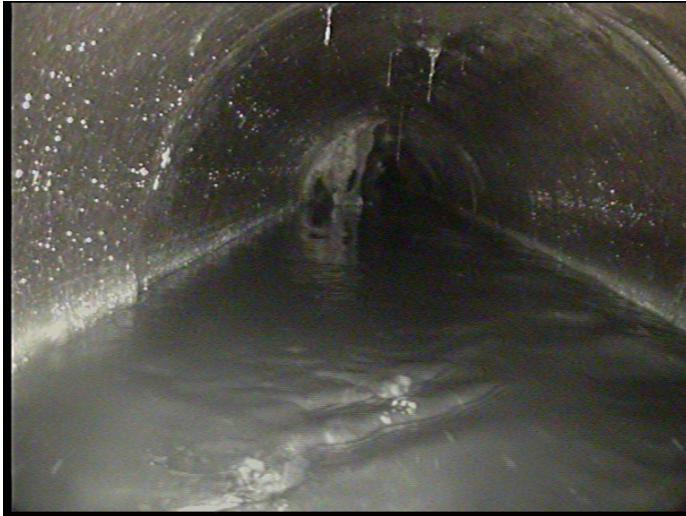
Code: **MWL**
Description: **Water Level**

Distance (ft): **.0**
Structural Grade: **0**
O&M Grade: **0**
Clock Start/From:
Clock To:
1st Value:
2nd Value:
Value Percent: **15.000**
Continuous Index:
Within 8" of Joint: **NO**
Remarks:

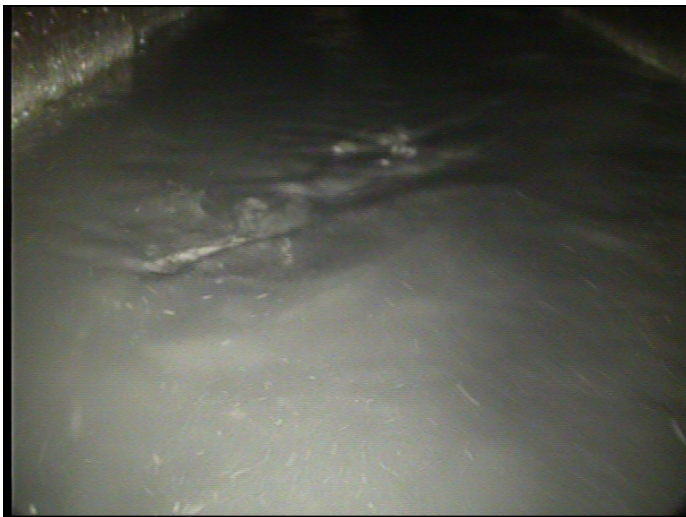
Code: **DSF**
Description: **Deposits Settled Fine**

Distance (ft): **.0**
Structural Grade: **0**
O&M Grade: **3**
Clock Start/From: **5**
Clock To: **7**
1st Value:
2nd Value:
Value Percent: **15.000**
Continuous Index: **S01**
Within 8" of Joint: **YES**
Remarks:

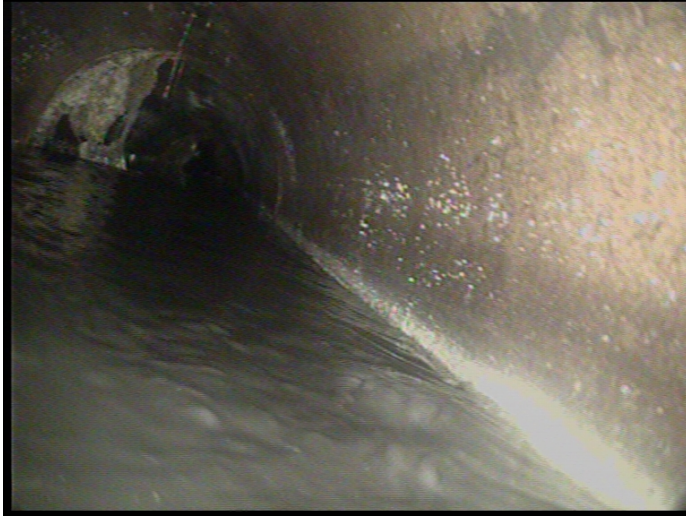
Code: **DSF**
Description: **Deposits Settled Fine**

Distance (ft): **5.2**
Structural Grade: **0**
O&M Grade: **3**
Clock Start/From: **5**
Clock To: **7**
1st Value:
2nd Value:
Value Percent: **20.000**
Continuous Index: **F01**
Within 8" of Joint: **NO**
Remarks:
