Profile/Photo Observation Report

Date:	09/29/2018	Weather:		Coding:	PACP 6.0
Pipe Length (ft):	18.4	Owner:	NA	Pre Clean:	Not Known
P.O.#:		Surveyor:	Selasie Honu	PSR:	P-303-010-009
Customer:		Clean Date:	01/01/1900	Shape:	C

Location Details:		Direction of Survey:	Downstream
US MH:	M-303-010	DS MH:	M-303-009
		Total Length Surveyed (ft):	9.7

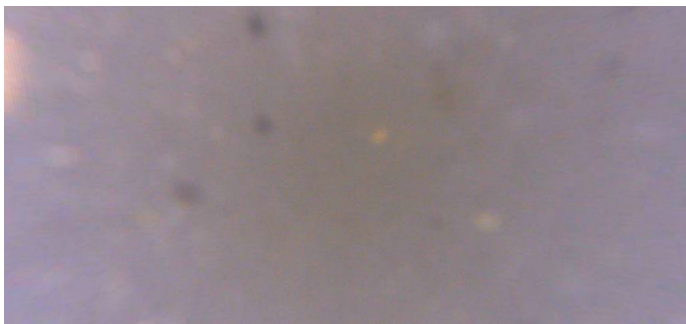
Code: **AMH**
Description: **Manhole**

Distance (ft): **.0**
Structural Grade: **0**
O&M Grade: **0**
Clock Start/From:
Clock To:
1st Value:
2nd Value:
Value Percent:
Continuous Index:
Within 8" of Joint: **NO**
Remarks: **M-303-010**

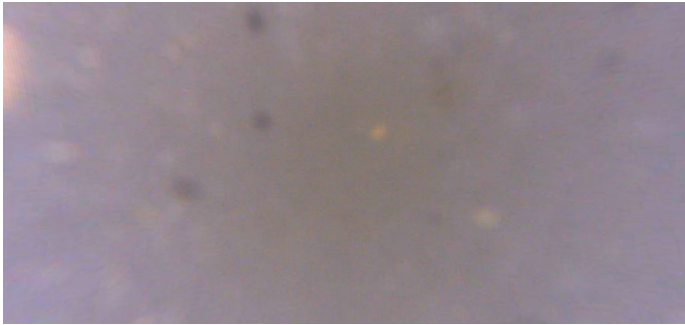
Code:	MWL
Description:	Water Level

Distance (ft):	.0
Structural Grade:	0
O&M Grade:	0
Clock Start/From:	
Clock To:	
1st Value:	
2nd Value:	
Value Percent:	5.000
Continuous Index:	
Within 8" of Joint:	NO
Remarks:

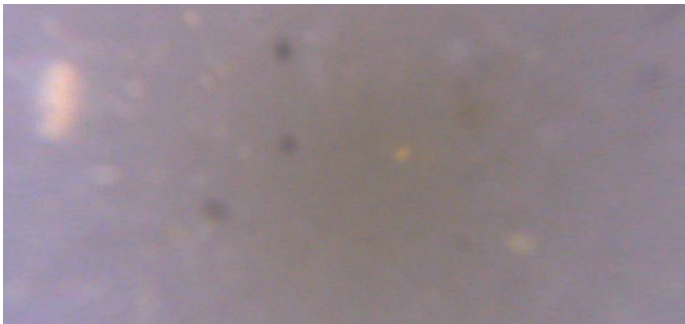
Code:	MWLS
Description:	Water Level Sag

Distance (ft):	.0
Structural Grade:	4
O&M Grade:	3
Clock Start/From:	
Clock To:	
1st Value:	
2nd Value:	
Value Percent:	60.000
Continuous Index:	S01
Within 8" of Joint:	NO
Remarks:

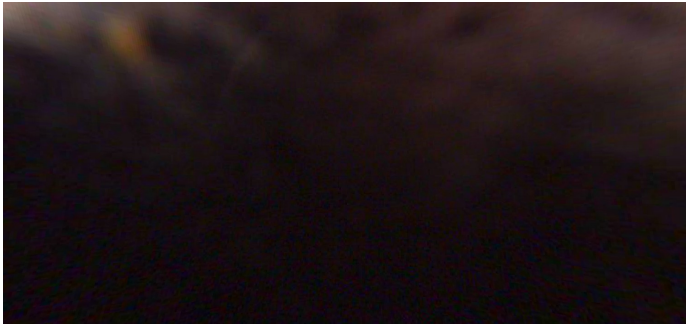
Code: **MWLS**
Description: **Water Level Sag**

Distance (ft): **6.3**
Structural Grade: **4**
O&M Grade: **3**
Clock Start/From:
Clock To:
1st Value:
2nd Value:
Value Percent: **60.000**
Continuous Index: **F01**
Within 8" of Joint: **NO**
Remarks:
