Profile/Photo Observation Report

Date:	09/29/2018	Weather:		Coding:	PACP 6.0
Pipe Length (ft):	47.3	Owner:	NA	Pre Clean:	Not Known
P.O.#:		Surveyor:	Selasie Honu	PSR:	P-303-016-015
Customer:		Clean Date:	01/01/1900	Shape:	C

Street:	W OLD RIDGE RD	Flow Control:	Not Controlled
City:	Hobart, IN	Year Renewed:	
Location:	Light Highway	Tape/Media #:	
Purpose:	Routine Assessment	Dia/Height:	10"
Use:	Sanitary	Material:	VCP
Drain Area:	NA	Lining:	
Category:	NA		
Comment:

Location Details:		Direction of Survey:	Upstream
US MH:	M-303-015	DS MH:	M-303-016
		Total Length Surveyed (ft):	11.8

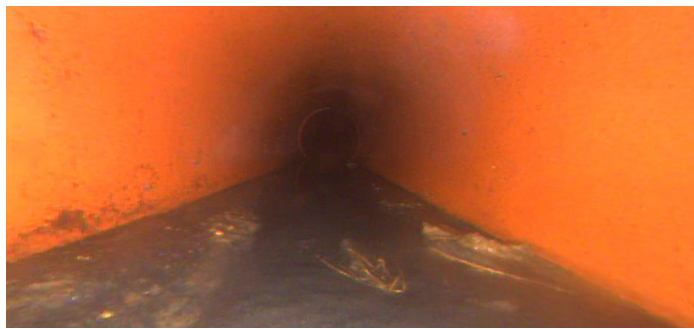
Code: **AMH**
Description: **Manhole**

Distance (ft): **.0**
Structural Grade: **0**
O&M Grade: **0**
Clock Start/From:
Clock To:
1st Value:
2nd Value:
Value Percent:
Continuous Index:
Within 8" of Joint: **NO**
Remarks: **M-303-016**

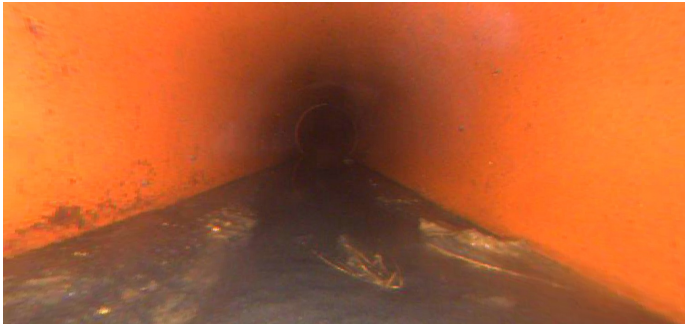
Code:	MWL
Description:	Water Level

Distance (ft):	.0
Structural Grade:	0
O&M Grade:	0
Clock Start/From:	
Clock To:	
1st Value:	
2nd Value:	
Value Percent:	5.000
Continuous Index:	
Within 8" of Joint:	NO
Remarks:

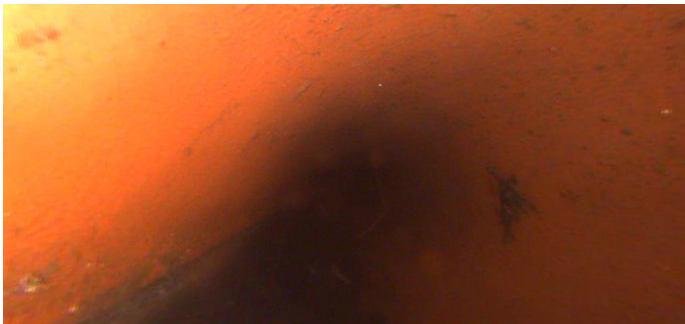
Code:	MSA
Description:	Abandoned Survey

Distance (ft):	11.8
Structural Grade:	0
O&M Grade:	0
Clock Start/From:	
Clock To:	
1st Value:	
2nd Value:	
Value Percent:	
Continuous Index:	
Within 8" of Joint:	NO
Remarks:	camera stopped
