Profile/Photo Observation Report

Date:	10/25/2021	Weather:		Coding:	PACP 6.0
Pipe Length (ft):		Owner:	Hobart, IN	Pre Clean:	Not Known
P.O.#:	1005_1	Surveyor:	M. Pielacha	PSR:	P-303-019-018
Customer:	Hobart, IN	Clean Date:		Shape:	C

Street:	Off 40th Avenue	Flow Control:	
City:	Hobart, IN	Year Renewed:	
Location:	Yard	Tape/Media #:	1005
Purpose:	Routine Assessment	Dia/Height:	8"
Use:	Sanitary	Material:	VCP
Drain Area:		Lining:	
Category:	NA		
Comment:			
Location Details:		Direction of Survey:	Downstream
US MH:	M-303-18	DS MH:	M-303-19
		Total Length Surveyed (ft):	268.5

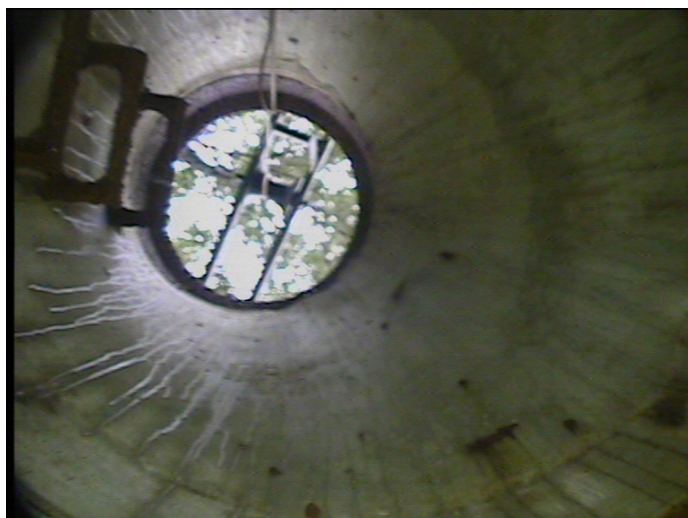
Code: **AMH**
Description: **Manhole**

Distance (ft): **.0**
Structural Grade: **0**
O&M Grade: **0**
Clock Start/From:
Clock To:
1st Value:
2nd Value:
Value Percent:
Continuous Index:
Within 8" of Joint: **NO**
Remarks: **M-303-18**

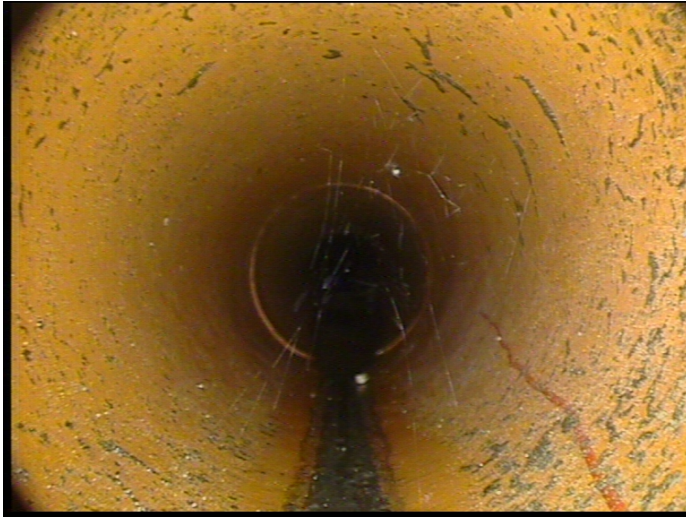
Code:	MWL
Description:	Water Level
Distance (ft):	.0
Structural Grade:	0
O&M Grade:	0
Clock Start/From:	
Clock To:	
1st Value:	
2nd Value:	
Value Percent:	0.000
Continuous Index:	
Within 8" of Joint:	NO
Remarks:

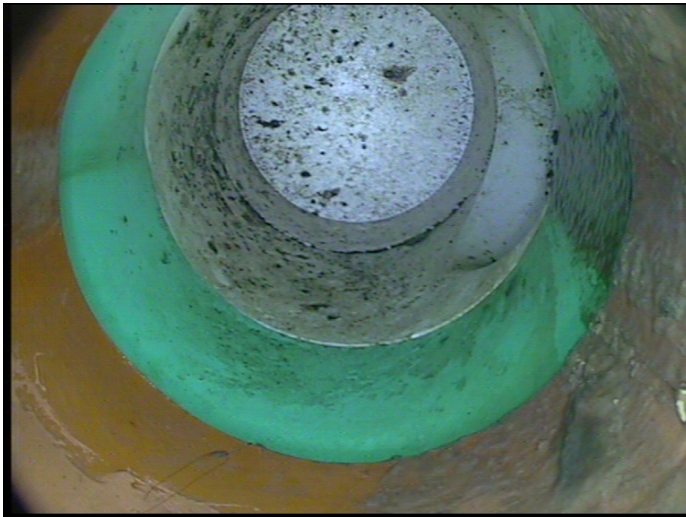
Code:	TF
Description:	Tap Factory
Distance (ft):	35.8
Structural Grade:	0
O&M Grade:	0
Clock Start/From:	11
Clock To:	
1st Value:	4.000
2nd Value:	
Value Percent:	
Continuous Index:	
Within 8" of Joint:	NO
Remarks:

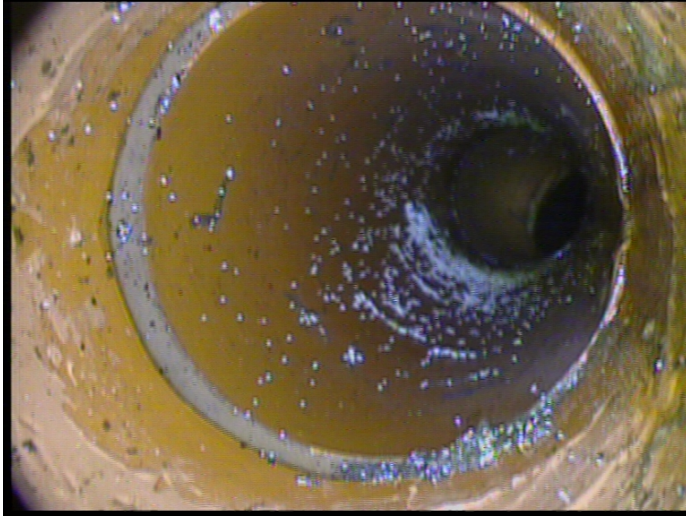
Code: **TFA**
Description: **Tap Factory Active**

Distance (ft): **58.3**
Structural Grade: **0**
O&M Grade: **0**
Clock Start/From: **2**
Clock To:
1st Value: **4.000**
2nd Value:
Value Percent:
Continuous Index:
Within 8" of Joint: **NO**
Remarks:

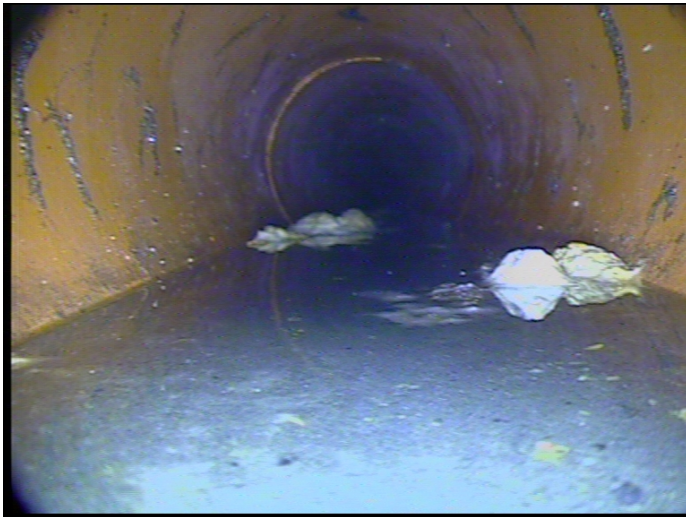
Code: **DSF**
Description: **Deposits Settled Fine**

Distance (ft): **87.7**
Structural Grade: **0**
O&M Grade: **2**
Clock Start/From: **4**
Clock To: **8**
1st Value:
2nd Value:
Value Percent: **10.000**
Continuous Index:
Within 8" of Joint: **NO**
Remarks:

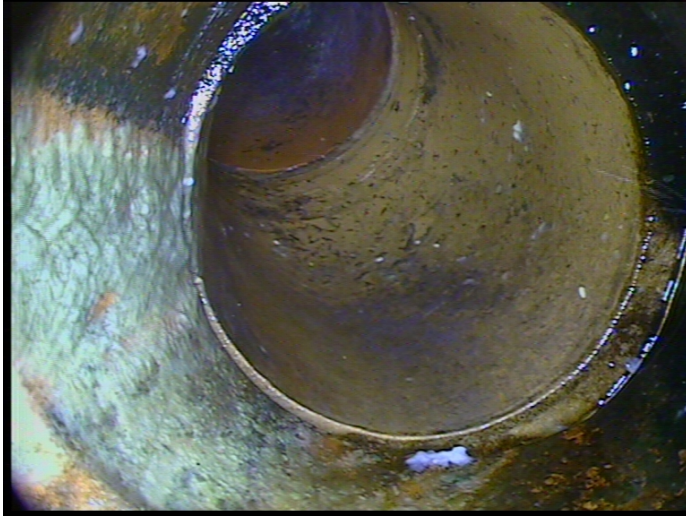
Code: **TF**
Description: **Tap Factory**

Distance (ft): **106.2**
Structural Grade: **0**
O&M Grade: **0**
Clock Start/From: **10**
Clock To:
1st Value: **4.000**
2nd Value:
Value Percent:
Continuous Index:
Within 8" of Joint: **NO**
Remarks:

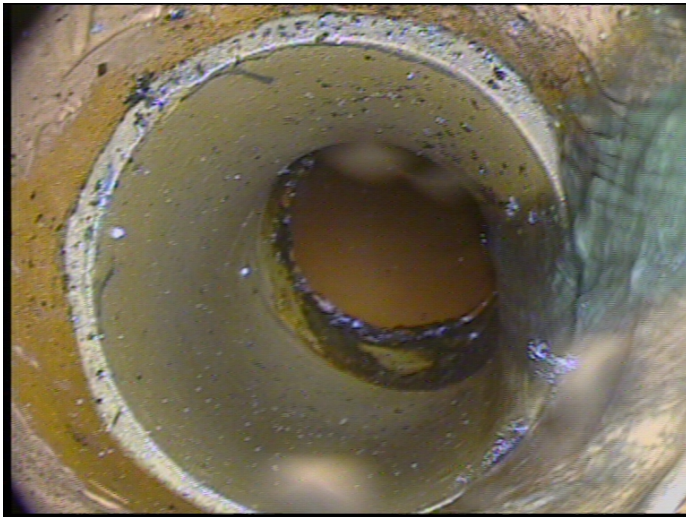
Code: **TFA**
Description: **Tap Factory Active**

Distance (ft): **113.5**
Structural Grade: **0**
O&M Grade: **0**
Clock Start/From: **3**
Clock To:
1st Value: **4.000**
2nd Value:
Value Percent:
Continuous Index:
Within 8" of Joint: **NO**
Remarks:

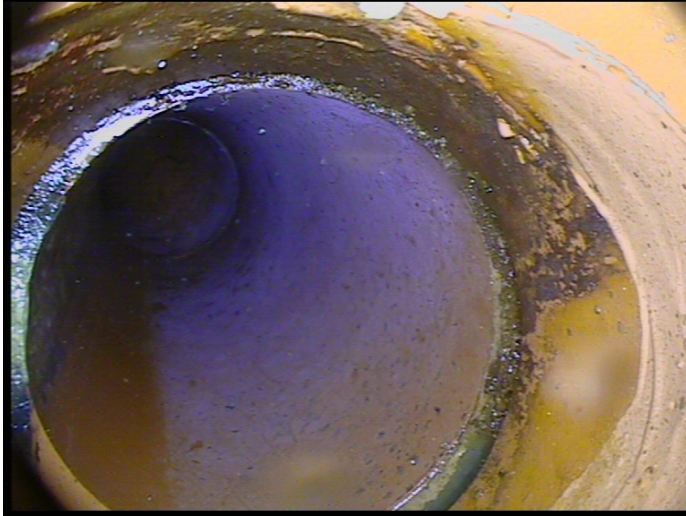
Code: **TF**
Description: **Tap Factory**

Distance (ft): **145.5**
Structural Grade: **0**
O&M Grade: **0**
Clock Start/From: **10**
Clock To:
1st Value: **4.000**
2nd Value:
Value Percent:
Continuous Index:
Within 8" of Joint: **NO**
Remarks:

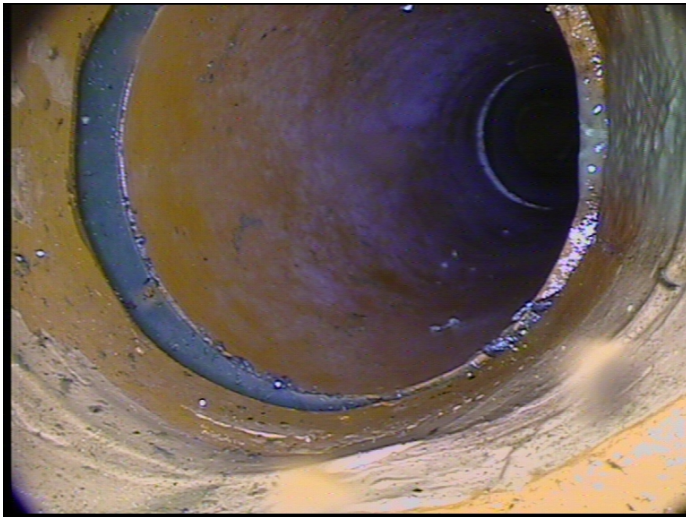
Code: **TFA**
Description: **Tap Factory Active**

Distance (ft): **152.9**
Structural Grade: **0**
O&M Grade: **0**
Clock Start/From: **2**
Clock To:
1st Value: **4.000**
2nd Value:
Value Percent:
Continuous Index:
Within 8" of Joint: **NO**
Remarks:

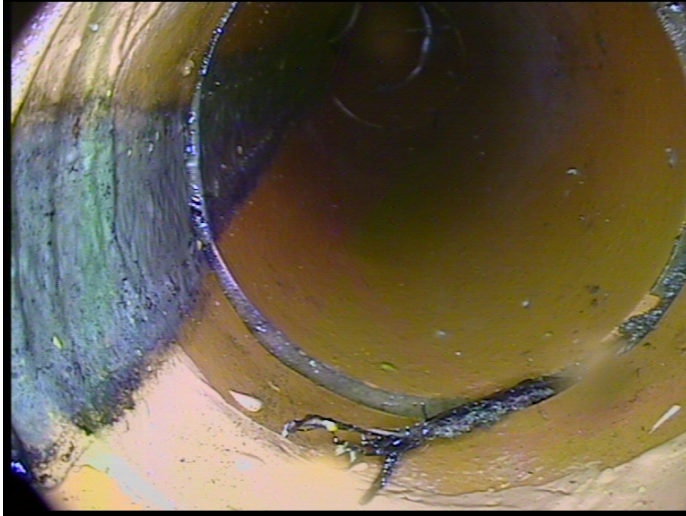
Code: **TFA**
Description: **Tap Factory Active**

Distance (ft): **180.4**
Structural Grade: **0**
O&M Grade: **0**
Clock Start/From: **10**
Clock To:
1st Value: **4.000**
2nd Value:
Value Percent:
Continuous Index:
Within 8" of Joint: **NO**
Remarks:

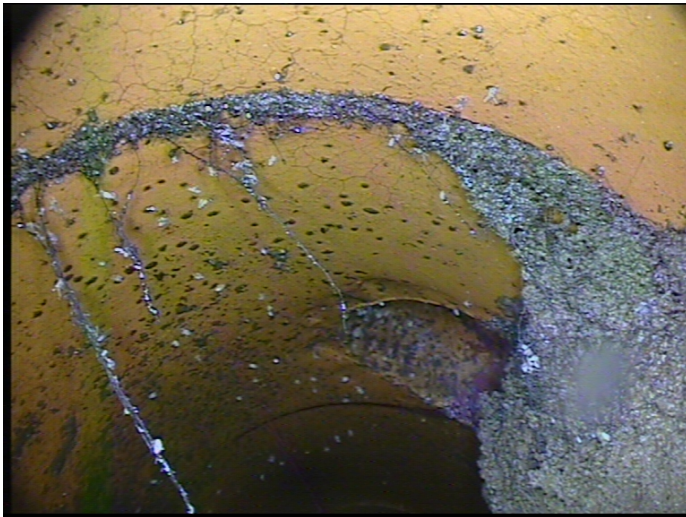
Code: **RMJ**
Description: **Roots Medium Joint**

Distance (ft): **206.2**
Structural Grade: **0**
O&M Grade: **3**
Clock Start/From: **11**
Clock To: **5**
1st Value:
2nd Value:
Value Percent: **10.000**
Continuous Index:
Within 8" of Joint: **YES**
Remarks:

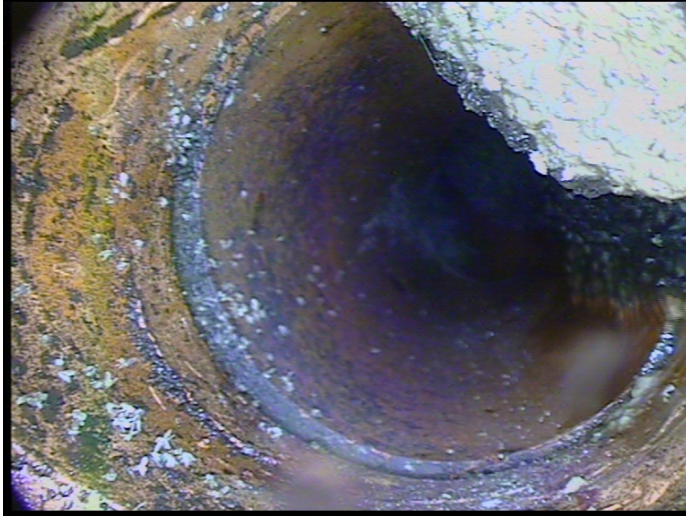
Code: **TFD**
Description: **Tap Factory Defective**

Distance (ft): **207.7**
Structural Grade: **0**
O&M Grade: **2**
Clock Start/From: **3**
Clock To:
1st Value: **4.000**
2nd Value:
Value Percent:
Continuous Index:
Within 8" of Joint: **NO**
Remarks: **roots**

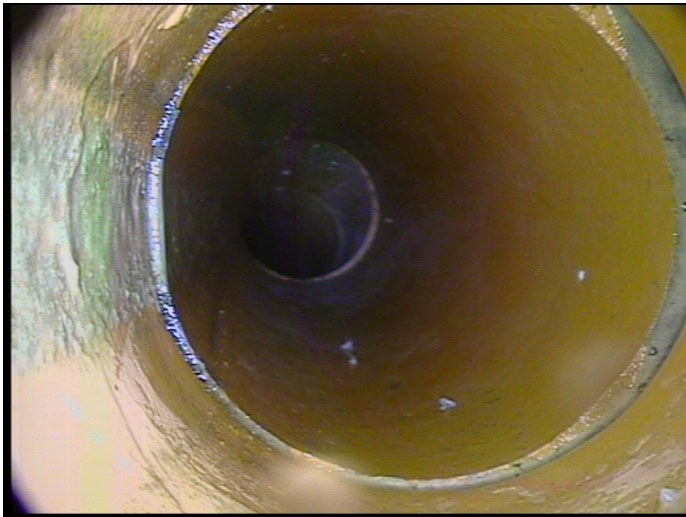
Code: **TF**
Description: **Tap Factory**

Distance (ft): **235.5**
Structural Grade: **0**
O&M Grade: **0**
Clock Start/From: **10**
Clock To:
1st Value: **4.000**
2nd Value:
Value Percent:
Continuous Index:
Within 8" of Joint: **NO**
Remarks:

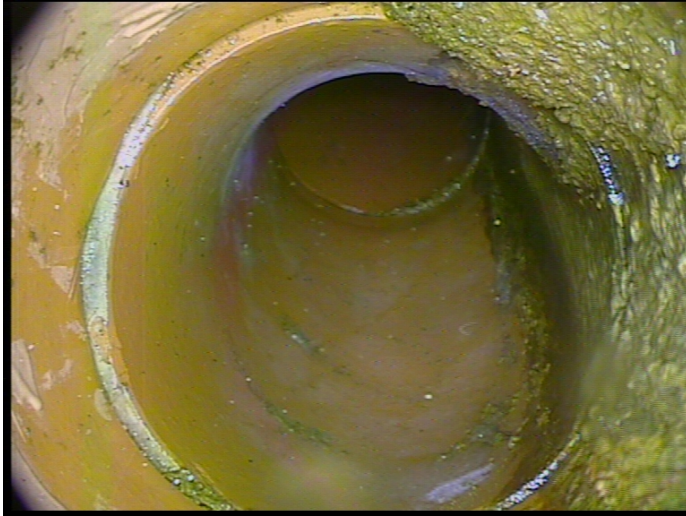
Code:	TFA
Description:	Tap Factory Active
Distance (ft):	257.8
Structural Grade:	0
O&M Grade:	0
Clock Start/From:	3
Clock To:	
1st Value:	4.000
2nd Value:	
Value Percent:	
Continuous Index:	
Within 8" of Joint:	NO
Remarks:

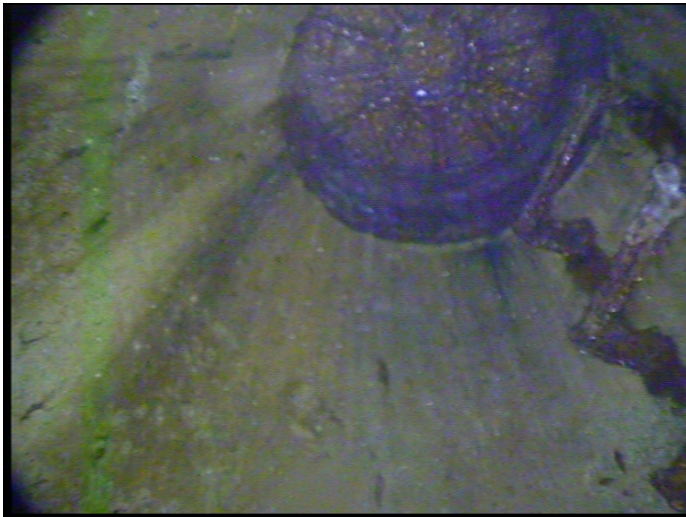
Code:	AMH
Description:	Manhole
Distance (ft):	268.5
Structural Grade:	0
O&M Grade:	0
Clock Start/From:	
Clock To:	
1st Value:	
2nd Value:	
Value Percent:	
Continuous Index:	
Within 8" of Joint:	NO
Remarks:	M-303-19
