Profile/Photo Observation Report

Date:	04/07/2018	Weather:		Coding:	PACP 6.0
Pipe Length (ft):		Owner:	City of Hobart	Pre Clean:	No Pre-Cleaning
P.O.#:	1-1	Surveyor:	M. Pielacha	PSR:	M-303-021-M-303-027
Customer:	City of Hobart	Clean Date:		Shape:	C

Street:	Ridgelawn Drive	Flow Control:	Not Controlled
City:	Hobart, IN	Year Renewed:	
Location:	Light Highway	Tape/Media #:	DEP 1
Purpose:	Routine Assessment	Dia/Height:	18"
Use:	Sanitary	Material:	VCP
Drain Area:		Lining:

US MH: **M-303-021** DS MH: **M-303-027** Total Length Surveyed (ft): **312.4**

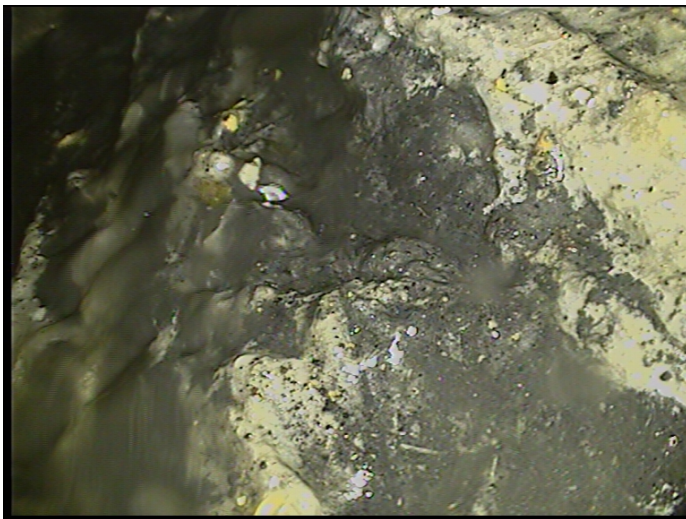
Code: **DSF**
Description: **Deposits Settled Fine**

Distance (ft): **6.4**
Structural Grade: **0**
O&M Grade: **3**
Clock Start/From: **5**
Clock To: **7**
1st Value:
2nd Value:
Value Percent: **15.000**
Continuous Index: **S01**
Within 8" of Joint: **YES**
Remarks:

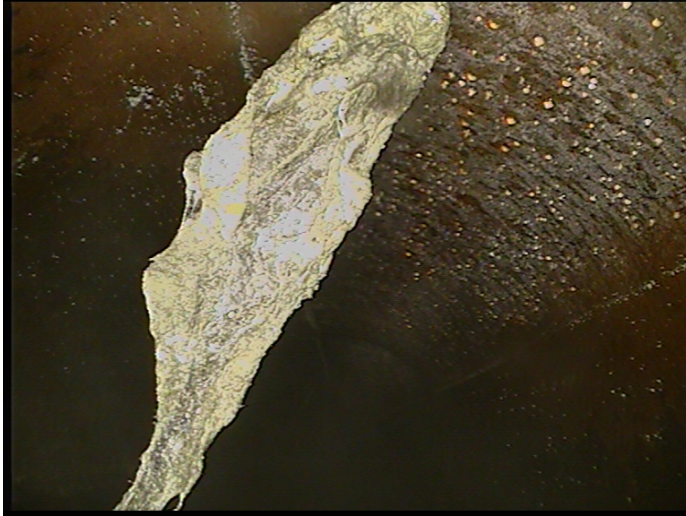
Code: **DAR**
Description: **Deposits Attached Ragging**

Distance (ft): **30.8**
Structural Grade: **0**
O&M Grade: **2**
Clock Start/From: **12**
Clock To:
1st Value:
2nd Value:
Value Percent: **10.000**
Continuous Index:
Within 8" of Joint: **YES**
Remarks:

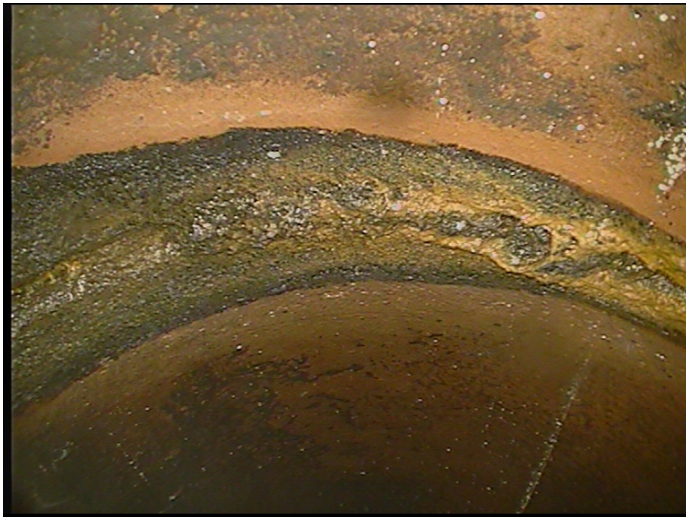
Code:	DAE
Description:	Deposits Attached Encrustation
Distance (ft):	44.8
Structural Grade:	0
O&M Grade:	2
Clock Start/From:	7
Clock To:	5
1st Value:	
2nd Value:	
Value Percent:	5.000
Continuous Index:	
Within 8" of Joint:	YES
Remarks:

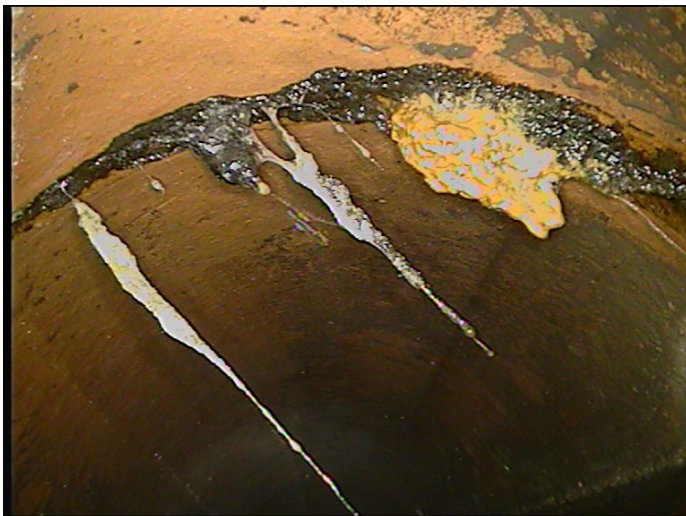
Code:	ID
Description:	Infil Dropper
Distance (ft):	175.1
Structural Grade:	0
O&M Grade:	3
Clock Start/From:	11
Clock To:	1
1st Value:	
2nd Value:	
Value Percent:	
Continuous Index:	
Within 8" of Joint:	YES
Remarks:

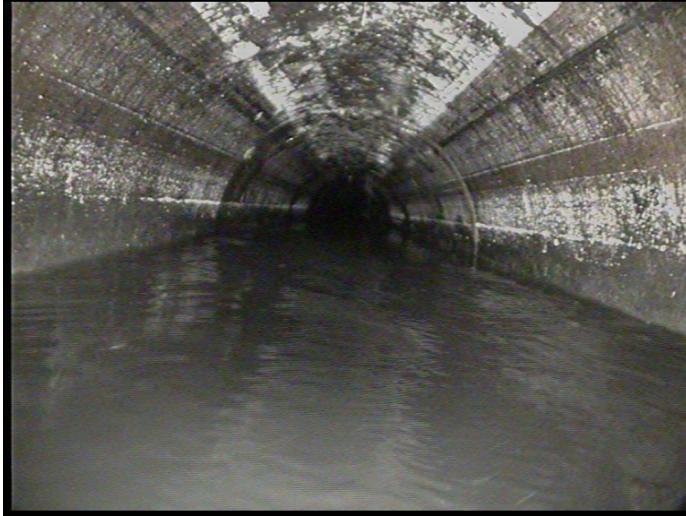
Code: **DSF**
Description: **Deposits Settled Fine**

Distance (ft): **312.4**
Structural Grade: **0**
O&M Grade: **3**
Clock Start/From: **4**
Clock To: **8**
1st Value:
2nd Value:
Value Percent: **20.000**
Continuous Index: **F02**
Within 8" of Joint: **YES**
Remarks:

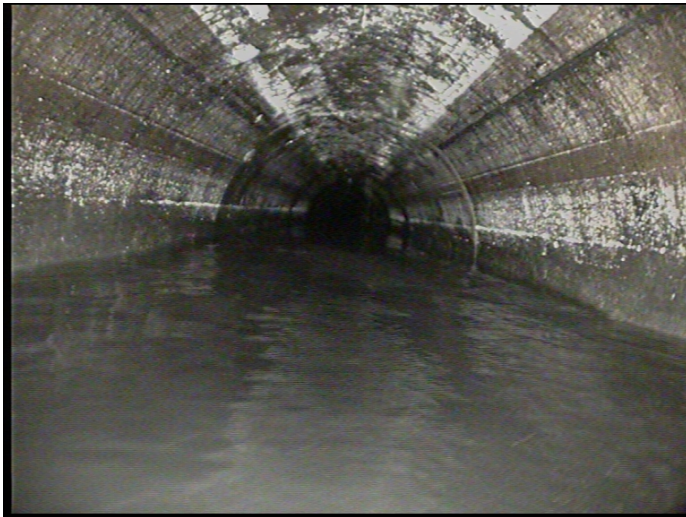
Code: **MSA**
Description: **Abandoned Survey**

Distance (ft): **312.4**
Structural Grade: **0**
O&M Grade: **0**
Clock Start/From:
Clock To:
1st Value:
2nd Value:
Value Percent:
Continuous Index:
Within 8" of Joint: **NO**
Remarks: **deep sediment**
