## Profile/Photo Observation Report

Street:	<b>Ridgelawn Drive</b>	Flow Control:	<b>Not Controlled</b>
City:	<b>Hobart, IN</b>	Year Renewed:	
Location:	<b>Light Highway</b>	Tape/Media #:	<b>DEP 4</b>
Purpose:	<b>Reversal</b>	Dia/Height:	<b>18"</b>
Use:	<b>Sanitary</b>	Material:	<b>VCP</b>
Drain Area:		Lining:	
Category:	<b>NA</b>

US MH:	<b>M-303-021</b>	DS MH:	<b>M-303-027</b>	Total Length Surveyed (ft):	<b>4.8</b>
--------	------------------	--------	------------------	-----------------------------	------------

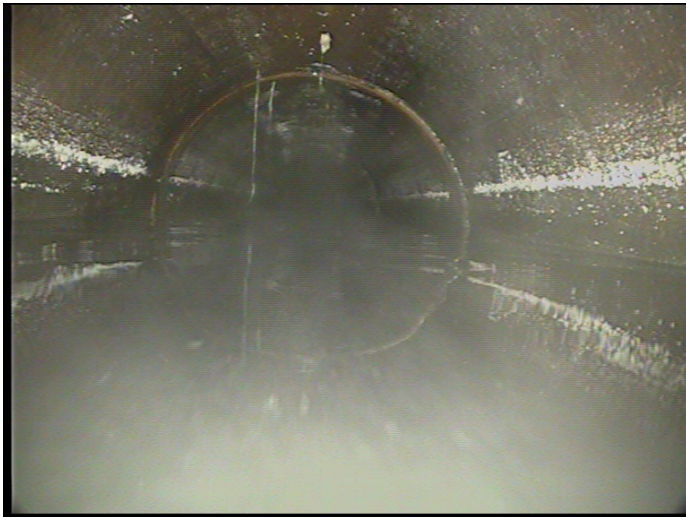
Code: **DSF**  
Description: **Deposits Settled Fine**

Distance (ft): **4.4**  
Structural Grade: **0**  
O&M Grade: **3**  
Clock Start/From: **4**  
Clock To: **8**  
1st Value:  
2nd Value:  
Value Percent: **15.000**  
Continuous Index:  
Within 8" of Joint: **YES**  
Remarks:
