Profile/Photo Observation Report

Date:	09/24/2018	Weather:		Coding:	PACP 6.0
Pipe Length (ft):	313.9	Owner:	NA	Pre Clean:	Not Known
P.O.#:		Surveyor:	Justin Gonzales	PSR:	P-303-023-022
Customer:		Clean Date:	01/01/1900	Shape:	C

Street:	KENWOOD ST	Flow Control:	Not Controlled
City:	Hobart, IN	Year Renewed:	
Location:	Light Highway	Tape/Media #:	
Purpose:	Routine Assessment	Dia/Height:	10"
Use:	Sanitary	Material:	VCP
Drain Area:	NA	Lining:	
Category:	NA		
Comment:

Location Details:		Direction of Survey:	Upstream
US MH:	M-303-022	DS MH:	M-303-023
		Total Length Surveyed (ft):	306.3

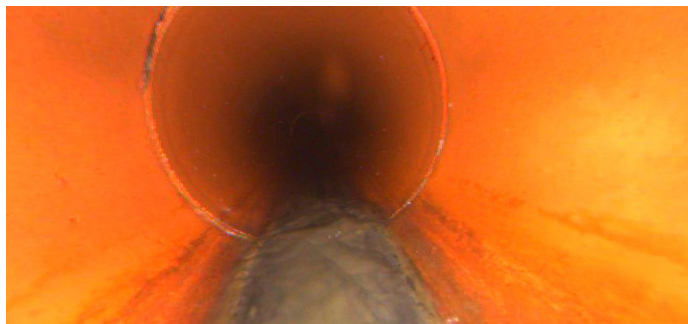
Code: **AMH**
Description: **Manhole**

Distance (ft): **.0**
Structural Grade: **0**
O&M Grade: **0**
Clock Start/From:
Clock To:
1st Value:
2nd Value:
Value Percent:
Continuous Index:
Within 8" of Joint: **NO**
Remarks: **M-303-023**

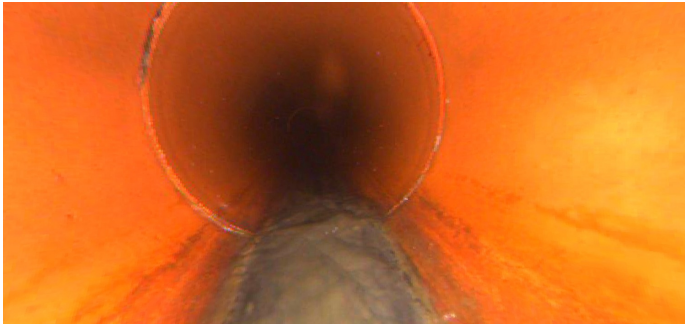
Code:	MWL
Description:	Water Level

Distance (ft):	.0
Structural Grade:	0
O&M Grade:	0
Clock Start/From:	
Clock To:	
1st Value:	
2nd Value:	
Value Percent:	5.000
Continuous Index:	
Within 8" of Joint:	NO
Remarks:

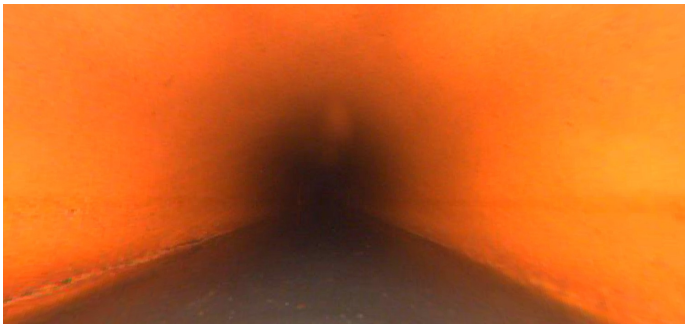
Code:	MWLS
Description:	Water Level Sag

Distance (ft):	32.3
Structural Grade:	2
O&M Grade:	3
Clock Start/From:	
Clock To:	
1st Value:	
2nd Value:	
Value Percent:	10.000
Continuous Index:	
Within 8" of Joint:	NO
Remarks:

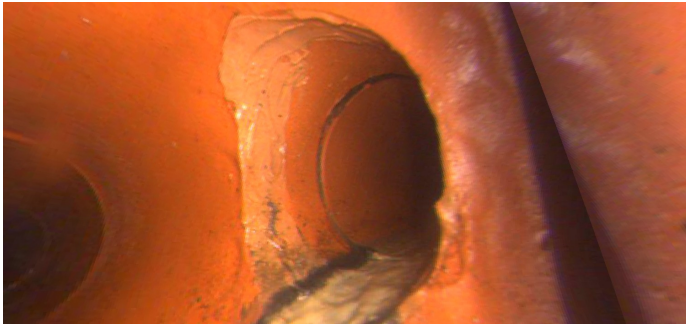
Code: **TF**
Description: **Tap Factory**

Distance (ft): **57.0**
Structural Grade: **0**
O&M Grade: **0**
Clock Start/From: **2**
Clock To:
1st Value: **4.000**
2nd Value:
Value Percent:
Continuous Index:
Within 8" of Joint:
Remarks:

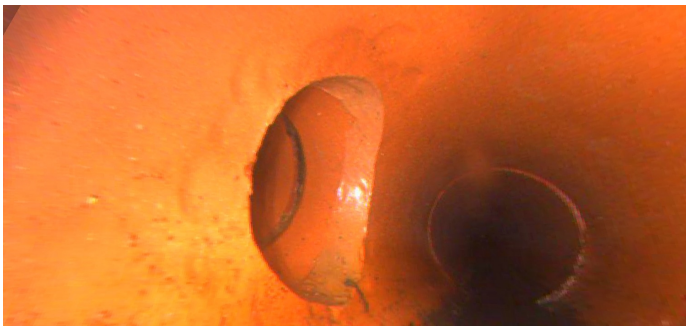
Code: **TF**
Description: **Tap Factory**

Distance (ft): **58.8**
Structural Grade: **0**
O&M Grade: **0**
Clock Start/From: **10**
Clock To:
1st Value: **4.000**
2nd Value:
Value Percent:
Continuous Index:
Within 8" of Joint:
Remarks:

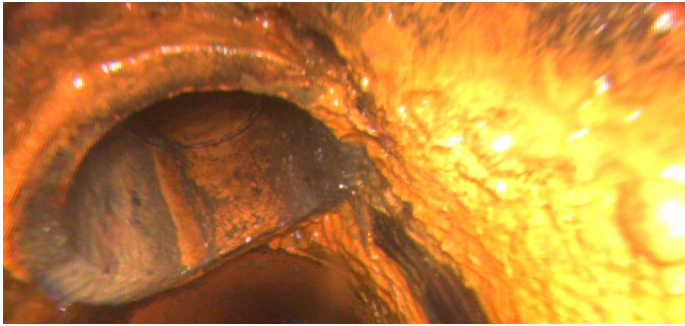
Code: **DAE**
Description: **Deposits Attached Encrustation**

Distance (ft): **73.0**
Structural Grade: **0**
O&M Grade: **2**
Clock Start/From: **7**
Clock To: **5**
1st Value:
2nd Value:
Value Percent: **5.000**
Continuous Index:
Within 8" of Joint: **NO**
Remarks:

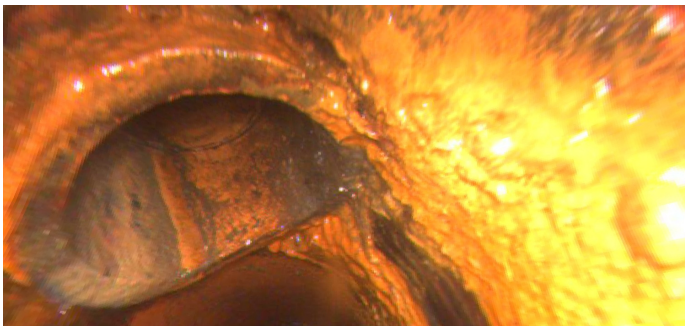
Code: **TBI**
Description: **Tap Break-in Intruding**

Distance (ft): **73.0**
Structural Grade: **0**
O&M Grade: **2**
Clock Start/From: **12**
Clock To:
1st Value: **4.000**
2nd Value: **1.000**
Value Percent:
Continuous Index:
Within 8" of Joint:
Remarks:

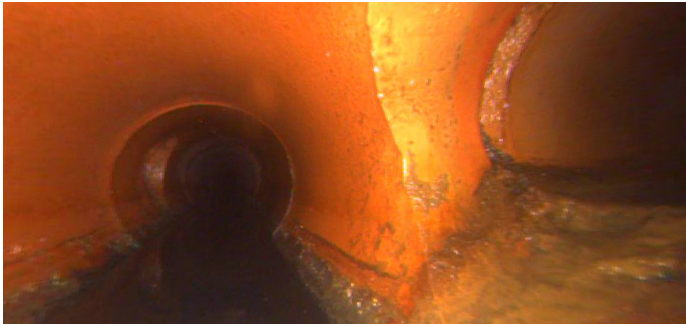
Code: **TF**
Description: **Tap Factory**

Distance (ft): **120.9**
Structural Grade: **0**
O&M Grade: **0**
Clock Start/From: **3**
Clock To:
1st Value: **4.000**
2nd Value:
Value Percent:
Continuous Index:
Within 8" of Joint:
Remarks:

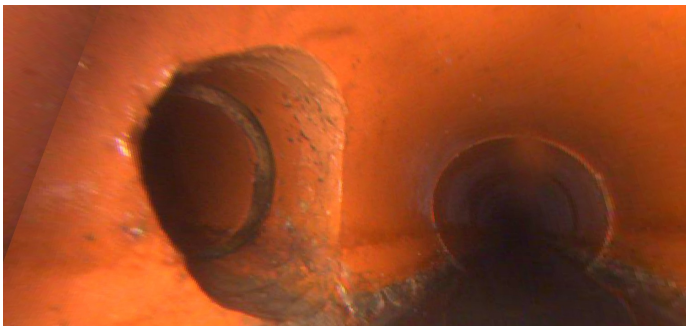
Code: **TF**
Description: **Tap Factory**

Distance (ft): **122.7**
Structural Grade: **0**
O&M Grade: **0**
Clock Start/From: **9**
Clock To:
1st Value: **4.000**
2nd Value:
Value Percent:
Continuous Index:
Within 8" of Joint:
Remarks:

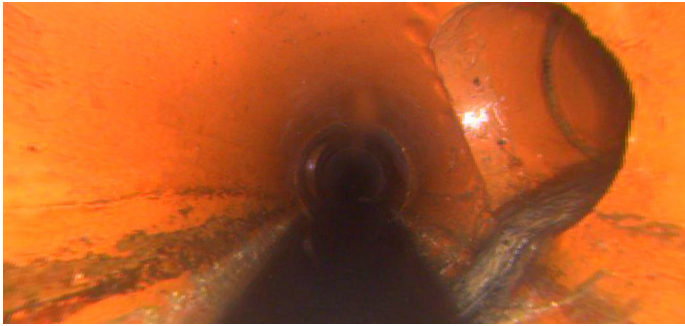
Code: **TF**
Description: **Tap Factory**

Distance (ft): **189.2**
Structural Grade: **0**
O&M Grade: **0**
Clock Start/From: **3**
Clock To:
1st Value: **4.000**
2nd Value:
Value Percent:
Continuous Index:
Within 8" of Joint:
Remarks:

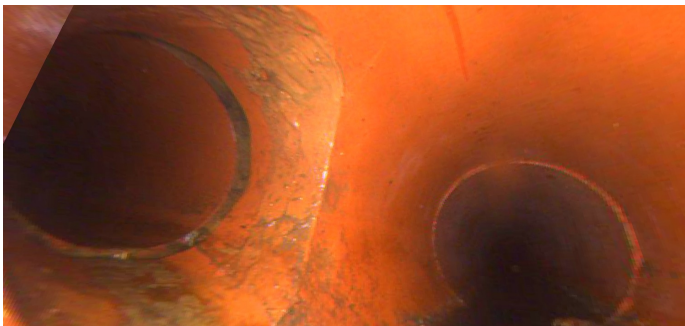
Code: **TF**
Description: **Tap Factory**

Distance (ft): **191.6**
Structural Grade: **0**
O&M Grade: **0**
Clock Start/From: **9**
Clock To:
1st Value: **4.000**
2nd Value:
Value Percent:
Continuous Index:
Within 8" of Joint:
Remarks:

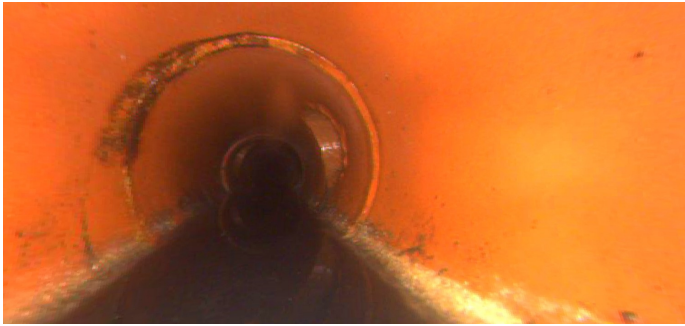
Code: **IS**
Description: **Infil Stain**

Distance (ft): **251.9**
Structural Grade: **0**
O&M Grade: **0**
Clock Start/From: **9**
Clock To: **12**
1st Value:
2nd Value:
Value Percent:
Continuous Index:
Within 8" of Joint: **YES**
Remarks:

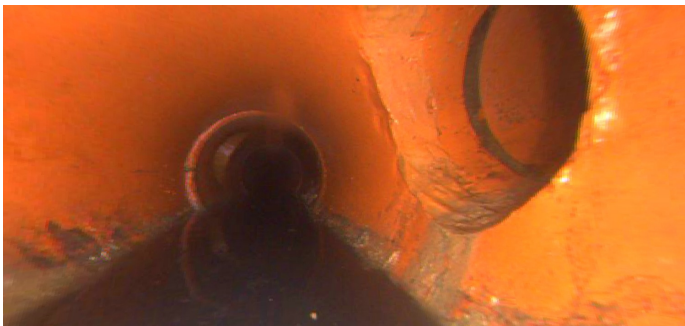
Code: **TF**
Description: **Tap Factory**

Distance (ft): **253.1**
Structural Grade: **0**
O&M Grade: **0**
Clock Start/From: **3**
Clock To:
1st Value: **4.000**
2nd Value:
Value Percent:
Continuous Index:
Within 8" of Joint:
Remarks:

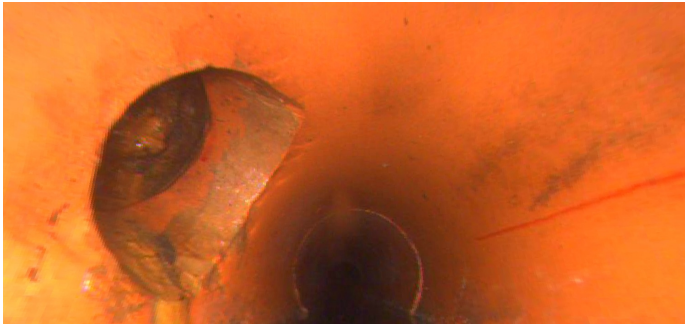
Code: **TFC**
Description: **Tap Factory Capped**

Distance (ft): **255.1**
Structural Grade: **0**
O&M Grade: **0**
Clock Start/From: **10**
Clock To:
1st Value: **4.000**
2nd Value:
Value Percent:
Continuous Index:
Within 8" of Joint:
Remarks:

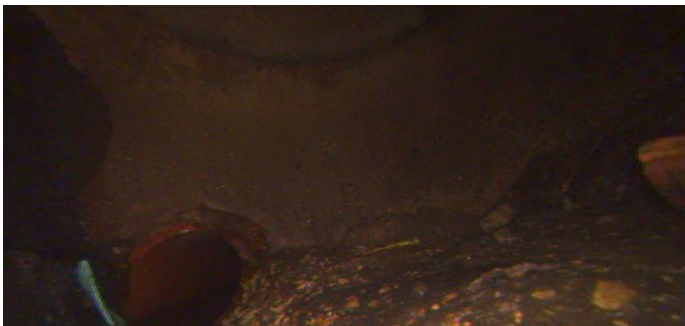
Code: **AMH**
Description: **Manhole**

Distance (ft): **306.3**
Structural Grade: **0**
O&M Grade: **0**
Clock Start/From:
Clock To:
1st Value:
2nd Value:
Value Percent:
Continuous Index:
Within 8" of Joint: **NO**
Remarks: **M-303-022**
