## Profile/Photo Observation Report

Street:	<b>Kenwood St</b>	Flow Control:	<b>Not Controlled</b>
City:	<b>Hobart, IN</b>	Year Renewed:	
Location:	<b>Light Highway</b>	Tape/Media #:	
Purpose:	<b>Routine Assessment</b>	Dia/Height:	<b>10"</b>
Use:	<b>Sanitary</b>	Material:	<b>VCP</b>
Drain Area:	<b>NA</b>	Lining:	
Category:	<b>NA</b>		
Comment:

Location Details:		Direction of Survey:	<b>Upstream</b>
US MH:	<b>M-303-022</b>	DS MH:	<b>M-303-023</b>
		Total Length Surveyed (ft):	<b>306.3</b>

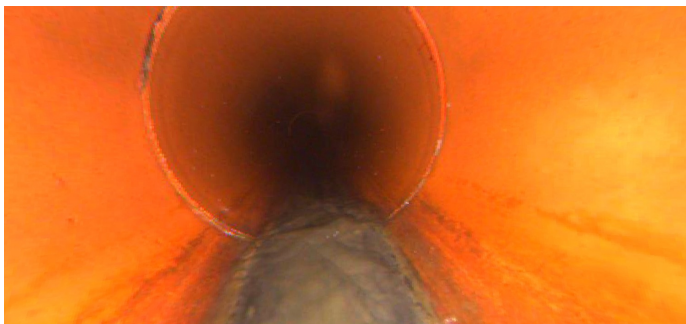
Code: **AMH**  
Description: **Manhole**

Distance (ft): **.0**  
Structural Grade: **0**  
O&M Grade: **0**  
Clock Start/From:  
Clock To:  
1st Value:  
2nd Value:  
Value Percent:  
Continuous Index:  
Within 8" of Joint: **NO**  
Remarks: **M-303-023**

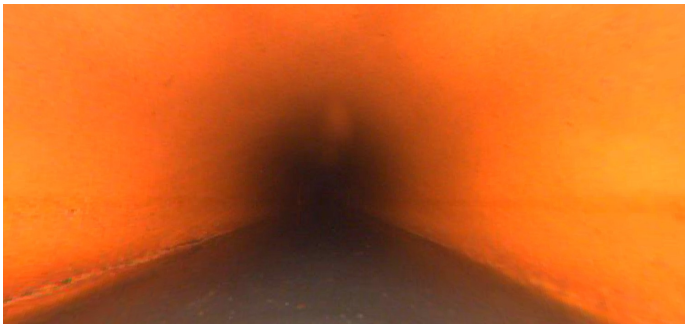
Code:	<b>MWLS</b>
Description:	<b>Water Level Sag</b>

Distance (ft):	<b>32.3</b>
Structural Grade:	<b>2</b>
O&M Grade:	<b>3</b>
Clock Start/From:	
Clock To:	
1st Value:	
2nd Value:	
Value Percent:	<b>10.000</b>
Continuous Index:	
Within 8" of Joint:	<b>NO</b>
Remarks:

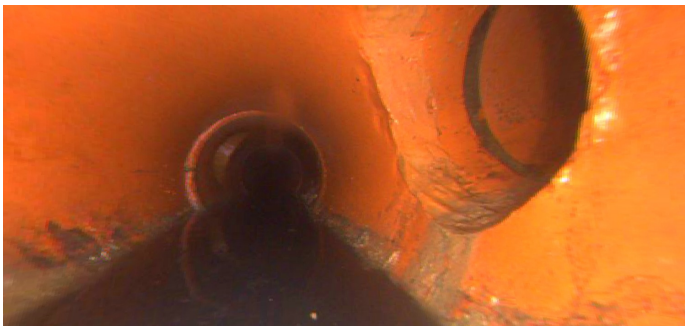
Code: **TF**  
Description: **Tap Factory**

Distance (ft): **253.1**  
Structural Grade: **0**  
O&M Grade: **0**  
Clock Start/From: **3**  
Clock To:  
1st Value: **4.000**  
2nd Value:  
Value Percent:  
Continuous Index:  
Within 8" of Joint:  
Remarks:

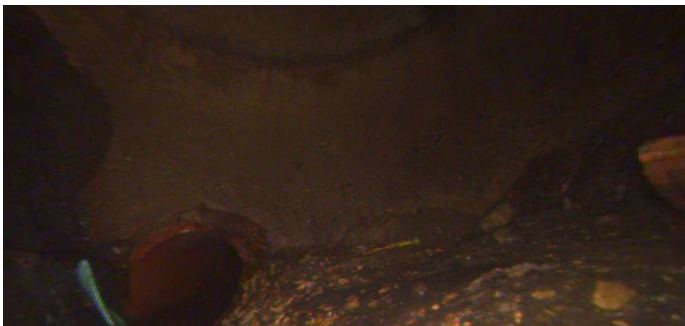
Code: **AMH**  
Description: **Manhole**

Distance (ft): **306.3**  
Structural Grade: **0**  
O&M Grade: **0**  
Clock Start/From:  
Clock To:  
1st Value:  
2nd Value:  
Value Percent:  
Continuous Index:  
Within 8" of Joint: **NO**  
Remarks: **M-303-022**
