Profile/Photo Observation Report

Date:	04/07/2018	Weather:		Coding:	PACP 6.0
Pipe Length (ft):		Owner:	City of Hobart	Pre Clean:	No Pre-Cleaning
P.O.#:	3-1	Surveyor:	M. Pielacha	PSR:	M-303-027-M-303-033
Customer:	City of Hobart	Clean Date:		Shape:	C

Street:	Ridgelawn Drive	Flow Control:	Not Controlled
City:	Hobart, IN	Year Renewed:	
Location:	Yard	Tape/Media #:	DEP 3
Purpose:	Reversal	Dia/Height:	18"
Use:	Sanitary	Material:	VCP
Drain Area:		Lining:	
Category:	NA		
Comment:			
Location Details:		Direction of Survey:	Upstream
US MH:	M-303-027	DS MH:	M-303-033
		Total Length Surveyed (ft):	197.0

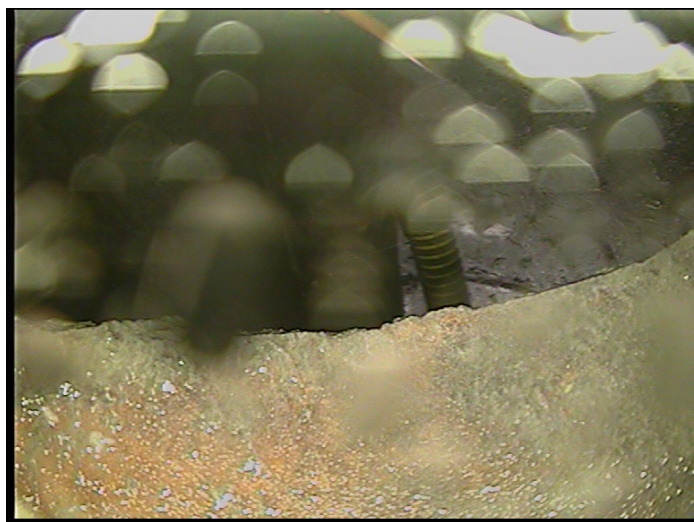
Code: **AMH**
 Description: **Manhole**

Distance (ft): **.0**
 Structural Grade: **0**
 O&M Grade: **0**
 Clock Start/From:
 Clock To:
 1st Value:
 2nd Value:
 Value Percent:
 Continuous Index:
 Within 8" of Joint: **NO**
 Remarks: **M-303-033**

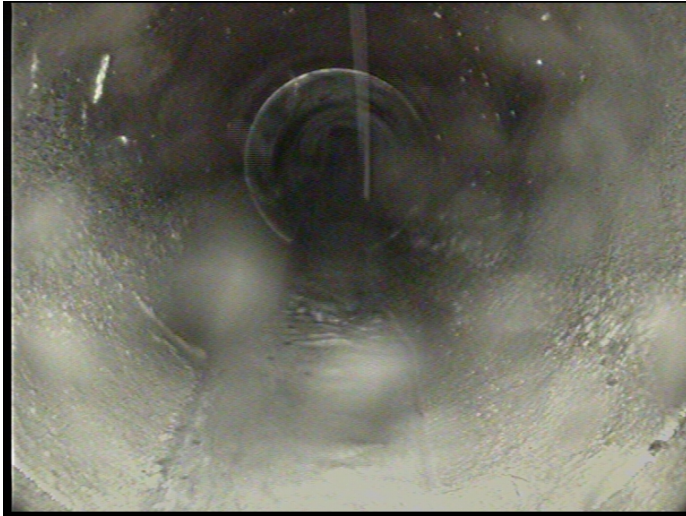
Code: **MWL**
Description: **Water Level**

Distance (ft): **.0**
Structural Grade: **0**
O&M Grade: **0**
Clock Start/From:
Clock To:
1st Value:
2nd Value:
Value Percent: **5.000**
Continuous Index:
Within 8" of Joint: **NO**
Remarks:

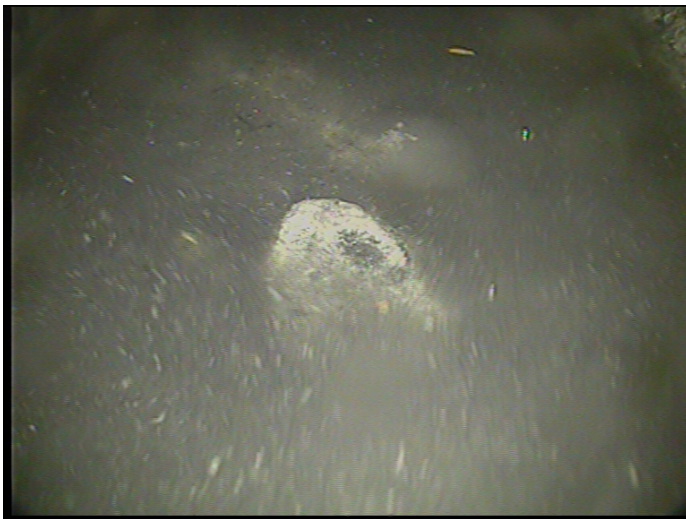
Code: **OBR**
Description: **Obstacle Rocks**

Distance (ft): **57.8**
Structural Grade: **0**
O&M Grade: **2**
Clock Start/From: **6**
Clock To:
1st Value:
2nd Value:
Value Percent: **10.000**
Continuous Index:
Within 8" of Joint: **NO**
Remarks:

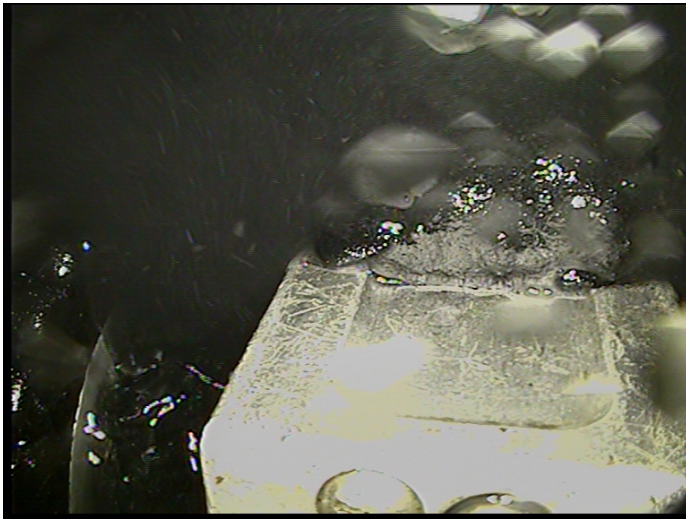
Code: **DSF**
Description: **Deposits Settled Fine**

Distance (ft): **194.0**
Structural Grade: **0**
O&M Grade: **3**
Clock Start/From: **5**
Clock To: **7**
1st Value:
2nd Value:
Value Percent: **15.000**
Continuous Index: **S01**
Within 8" of Joint: **YES**
Remarks:

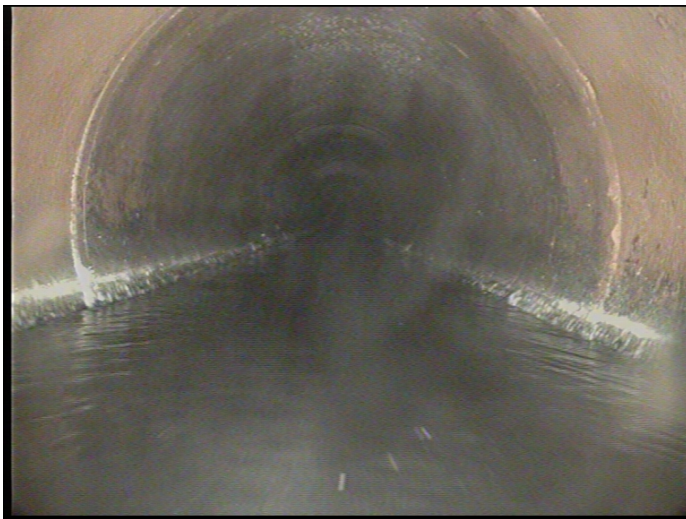
Code: **DSF**
Description: **Deposits Settled Fine**

Distance (ft): **197.0**
Structural Grade: **0**
O&M Grade: **3**
Clock Start/From: **5**
Clock To: **7**
1st Value:
2nd Value:
Value Percent: **15.000**
Continuous Index: **F01**
Within 8" of Joint: **NO**
Remarks:

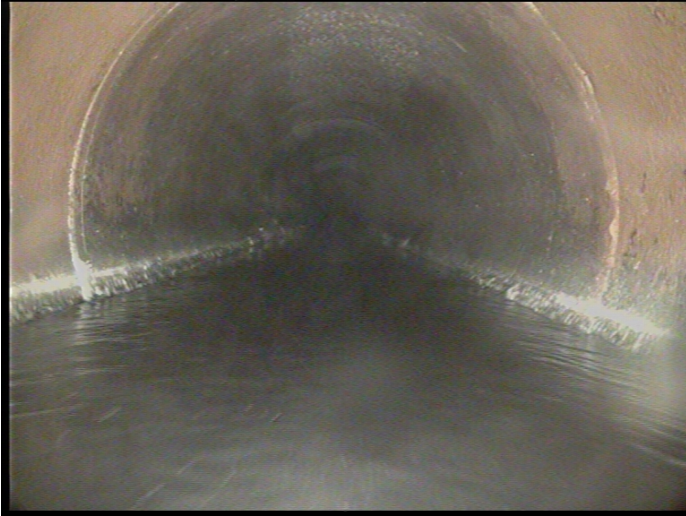
Code:	MSA
Description:	Abandoned Survey
Distance (ft):	197.0
Structural Grade:	0
O&M Grade:	0
Clock Start/From:	
Clock To:	
1st Value:	
2nd Value:	
Value Percent:	
Continuous Index:	
Within 8" of Joint:	NO
Remarks:	deep sediment
