Profile/Photo Observation Report

Date:	04/07/2018	Weather:		Coding:	PACP 6.0
Pipe Length (ft):		Owner:	City of Hobart	Pre Clean:	No Pre-Cleaning
P.O.#:	3-1	Surveyor:	M. Pielacha	PSR:	M-303-027-M-303-033
Customer:	City of Hobart	Clean Date:		Shape:	C

Street:	Ridgelawn Drive	Flow Control:	Not Controlled
City:	Hobart, IN	Year Renewed:	
Location:	Yard	Tape/Media #:	DEP 3
Purpose:	Reversal	Dia/Height:	18"
Use:	Sanitary	Material:	VCP
Drain Area:		Lining:

US MH: **M-303-027** DS MH: **M-303-033** Total Length Surveyed (ft): **197.0**

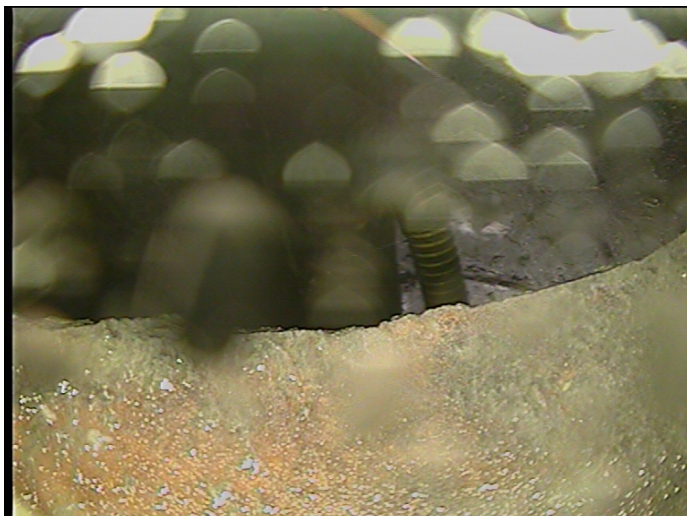
Code: **AMH**
 Description: **Manhole**

Distance (ft): **.0**
 Structural Grade: **0**
 O&M Grade: **0**
 Clock Start/From:
 Clock To:
 1st Value:
 2nd Value:
 Value Percent:
 Continuous Index:
 Within 8" of Joint: **NO**
 Remarks: **M-303-033**
