## Profile/Photo Observation Report

Street:	<b>38th. Ave.</b>	Flow Control:	<b>Not Controlled</b>
City:	<b>Hobart, IN</b>	Year Renewed:	
Location:	<b>Light Highway</b>	Tape/Media #:	
Purpose:	<b>Routine Assessment</b>	Dia/Height:	<b>10"</b>
Use:	<b>Sanitary</b>	Material:	<b>VCP</b>
Drain Area:	<b>NA</b>	Lining:	
Category:	<b>NA</b>		
Comment:

Location Details:		Direction of Survey:	<b>Upstream</b>
US MH:	<b>M-303-033</b>	DS MH:	<b>M-303-034</b>
		Total Length Surveyed (ft):	<b>193.5</b>

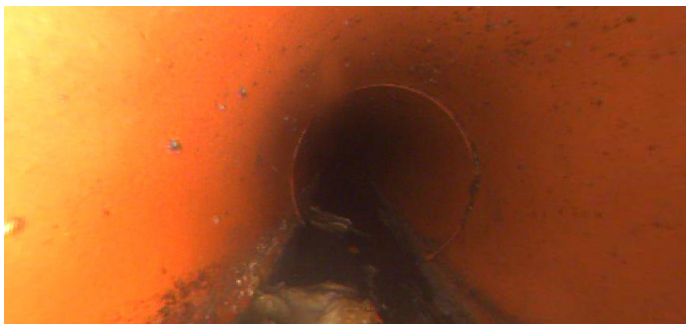
Code: **AMH**  
Description: **Manhole**

Distance (ft): **.0**  
Structural Grade: **0**  
O&M Grade: **0**  
Clock Start/From:  
Clock To:  
1st Value:  
2nd Value:  
Value Percent:  
Continuous Index:  
Within 8" of Joint: **NO**  
Remarks: **M-303-034**

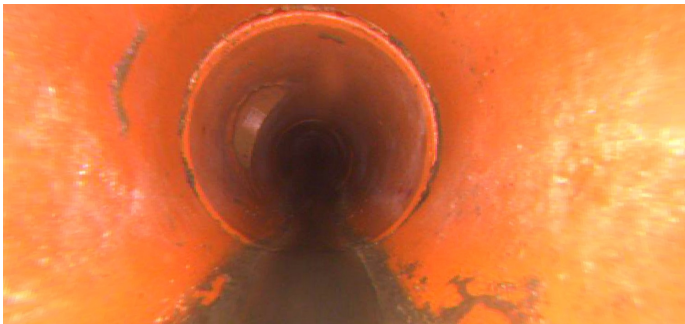
Code:	<b>TF</b>
Description:	<b>Tap Factory</b>

Distance (ft):	<b>31.6</b>
Structural Grade:	<b>0</b>
O&M Grade:	<b>0</b>
Clock Start/From:	<b>9</b>
Clock To:	
1st Value:	<b>4.000</b>
2nd Value:	
Value Percent:	
Continuous Index:	
Within 8" of Joint:	
Remarks:

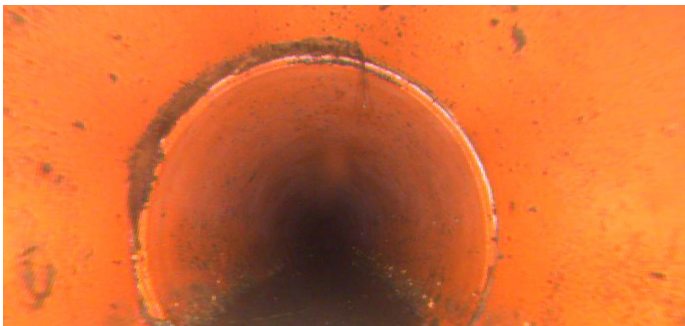
Code: **RFJ**  
Description: **Roots Fine Joint**

Distance (ft): **55.9**  
Structural Grade: **0**  
O&M Grade: **1**  
Clock Start/From: **9**  
Clock To: **12**  
1st Value:  
2nd Value:  
Value Percent:  
Continuous Index:  
Within 8" of Joint: **YES**  
Remarks:

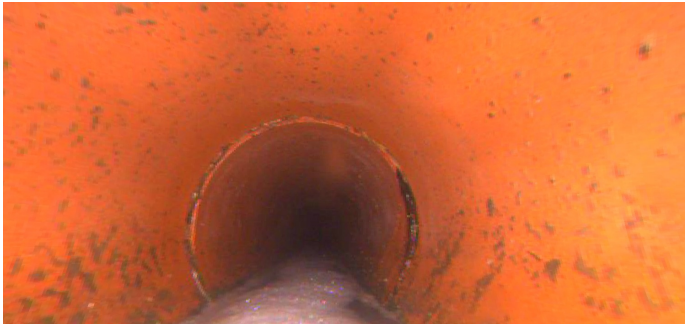
Code: **DAE**  
Description: **Deposits Attached Encrustation**

Distance (ft): **65.6**  
Structural Grade: **0**  
O&M Grade: **2**  
Clock Start/From: **8**  
Clock To: **4**  
1st Value:  
2nd Value:  
Value Percent: **10.000**  
Continuous Index:  
Within 8" of Joint: **YES**  
Remarks:

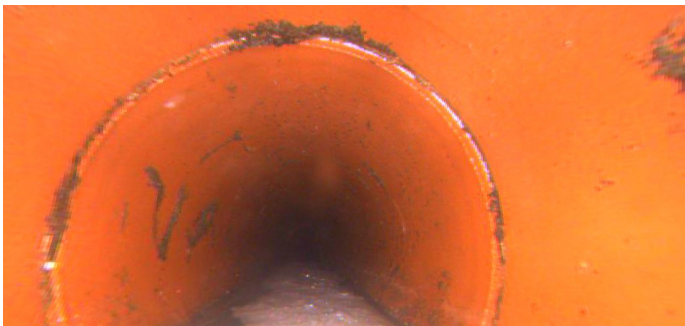
Code: **RFJ**  
Description: **Roots Fine Joint**

Distance (ft): **81.2**  
Structural Grade: **0**  
O&M Grade: **1**  
Clock Start/From: **8**  
Clock To: **3**  
1st Value:  
2nd Value:  
Value Percent:  
Continuous Index:  
Within 8" of Joint: **YES**  
Remarks:

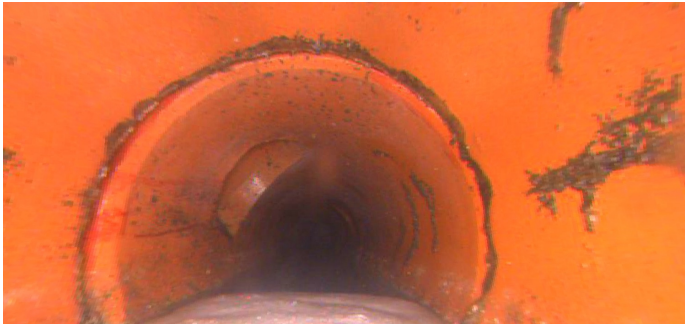
Code: **TF**  
Description: **Tap Factory**

Distance (ft): **86.1**  
Structural Grade: **0**  
O&M Grade: **0**  
Clock Start/From: **10**  
Clock To:  
1st Value: **4.000**  
2nd Value:  
Value Percent:  
Continuous Index:  
Within 8" of Joint:  
Remarks:

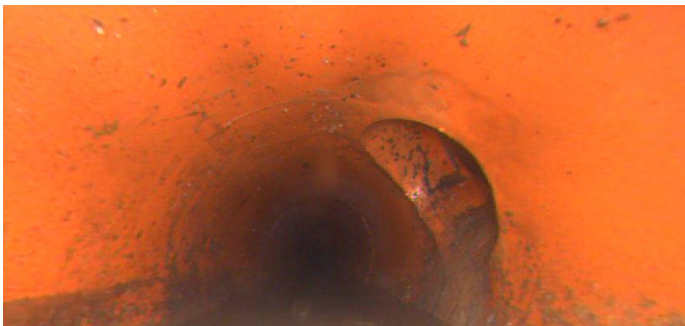
Code: **TF**  
Description: **Tap Factory**

Distance (ft): **88.6**  
Structural Grade: **0**  
O&M Grade: **0**  
Clock Start/From: **2**  
Clock To:  
1st Value: **4.000**  
2nd Value:  
Value Percent:  
Continuous Index:  
Within 8" of Joint:  
Remarks:

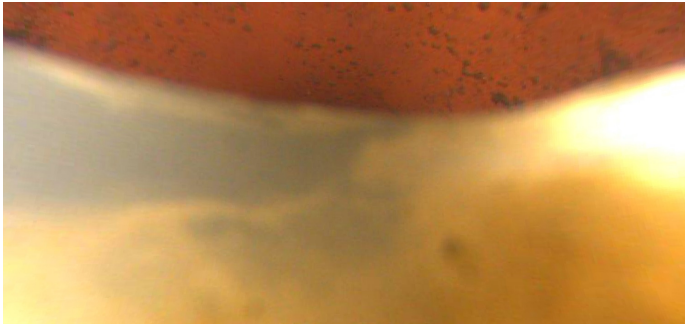
Code: **MWLS**  
Description: **Water Level Sag**

Distance (ft): **167.8**  
Structural Grade: **2**  
O&M Grade: **3**  
Clock Start/From:  
Clock To:  
1st Value:  
2nd Value:  
Value Percent: **20.000**  
Continuous Index: **S01**  
Within 8" of Joint: **NO**  
Remarks:
