Profile/Photo Observation Report

Street:	OFF W 38TH AVE	Flow Control:	Not Controlled
City:	Hobart, IN	Year Renewed:	
Location:	Light Highway	Tape/Media #:	
Purpose:	Routine Assessment	Dia/Height:	10"
Use:	Sanitary	Material:	VCP
Drain Area:	NA	Lining:	
Category:	NA		
Comment:

Location Details:		Direction of Survey:	Downstream
US MH:	M-303-035	DS MH:	M-303-036
		Total Length Surveyed (ft):	244.1

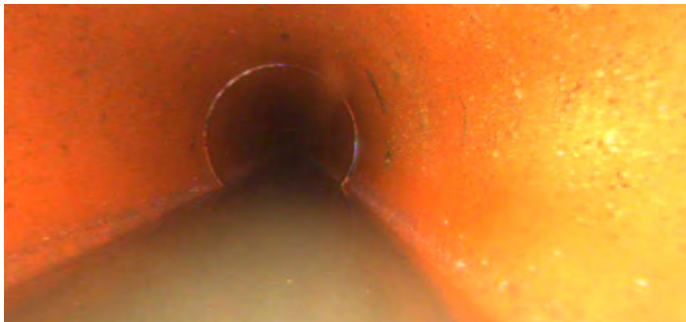
Code: **AMH**
Description: **Manhole**

Distance (ft): **.0**
Structural Grade: **0**
O&M Grade: **0**
Clock Start/From:
Clock To:
1st Value:
2nd Value:
Value Percent:
Continuous Index:
Within 8" of Joint: **NO**
Remarks: **M-303-035**

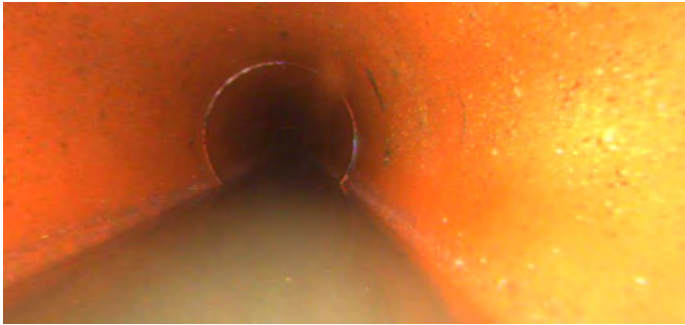
Code:	MWL
Description:	Water Level

Distance (ft):	.0
Structural Grade:	0
O&M Grade:	0
Clock Start/From:	
Clock To:	
1st Value:	
2nd Value:	
Value Percent:	5.000
Continuous Index:	
Within 8" of Joint:	NO
Remarks:

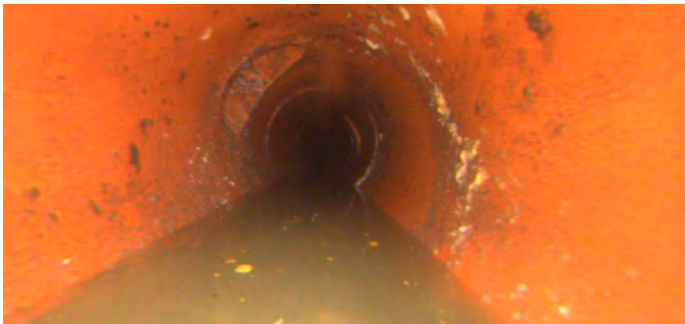
Code:	TF
Description:	Tap Factory

Distance (ft):	37.8
Structural Grade:	0
O&M Grade:	0
Clock Start/From:	10
Clock To:	
1st Value:	4.000
2nd Value:	
Value Percent:	
Continuous Index:	
Within 8" of Joint:	
Remarks:

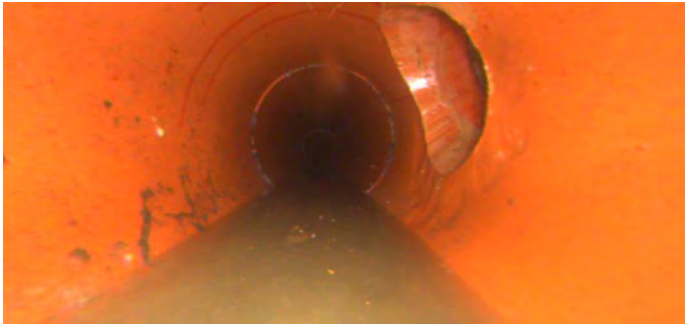
Code: **TF**
Description: **Tap Factory**

Distance (ft): **40.3**
Structural Grade: **0**
O&M Grade: **0**
Clock Start/From: **3**
Clock To:
1st Value: **4.000**
2nd Value:
Value Percent:
Continuous Index:
Within 8" of Joint:
Remarks:

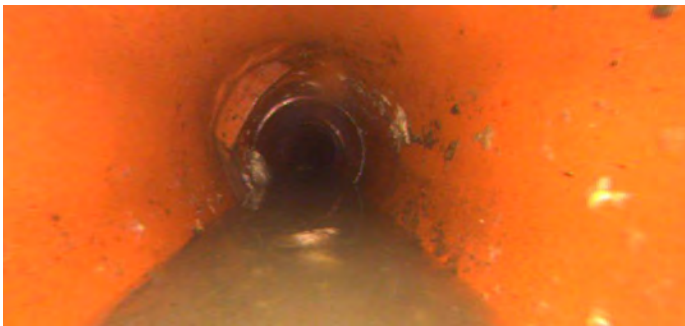
Code: **TF**
Description: **Tap Factory**

Distance (ft): **96.9**
Structural Grade: **0**
O&M Grade: **0**
Clock Start/From: **10**
Clock To:
1st Value: **4.000**
2nd Value:
Value Percent:
Continuous Index:
Within 8" of Joint:
Remarks:

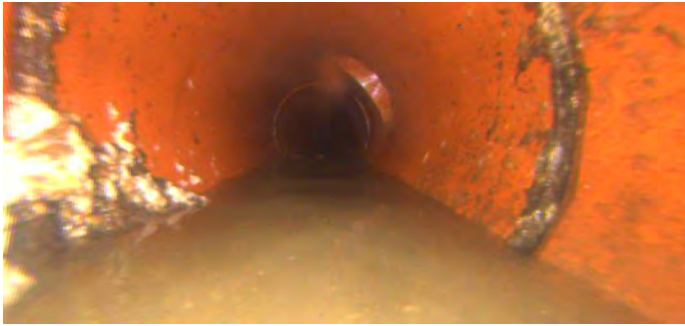
Code: **TF**
Description: **Tap Factory**

Distance (ft): **98.5**
Structural Grade: **0**
O&M Grade: **0**
Clock Start/From: **2**
Clock To:
1st Value: **4.000**
2nd Value:
Value Percent:
Continuous Index:
Within 8" of Joint:
Remarks:

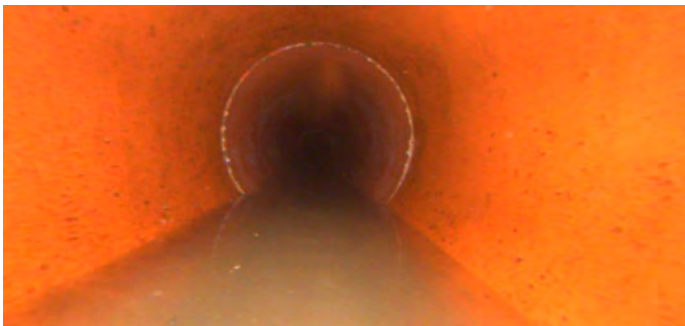
Code: **RFJ**
Description: **Roots Fine Joint**

Distance (ft): **119.8**
Structural Grade: **0**
O&M Grade: **1**
Clock Start/From: **8**
Clock To: **4**
1st Value:
2nd Value:
Value Percent:
Continuous Index: **S01**
Within 8" of Joint: **YES**
Remarks:

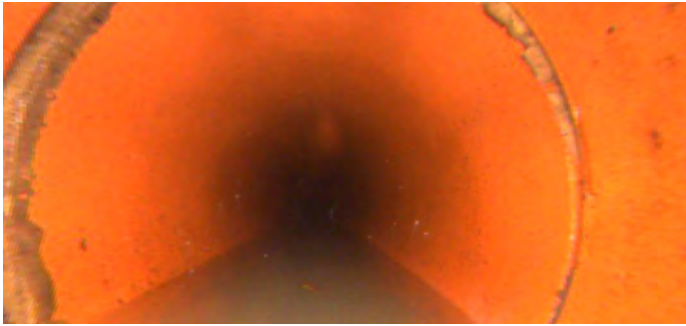
Code: **RFJ**
Description: **Roots Fine Joint**

Distance (ft): **135.6**
Structural Grade: **0**
O&M Grade: **1**
Clock Start/From: **8**
Clock To: **4**
1st Value:
2nd Value:
Value Percent:
Continuous Index: **F01**
Within 8" of Joint: **YES**
Remarks:

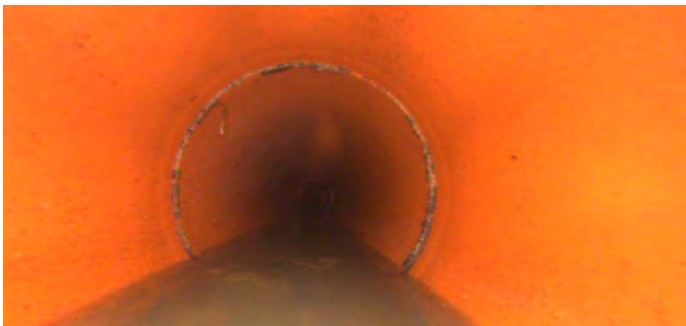
Code: **RFJ**
Description: **Roots Fine Joint**

Distance (ft): **150.2**
Structural Grade: **0**
O&M Grade: **1**
Clock Start/From: **7**
Clock To: **5**
1st Value:
2nd Value:
Value Percent:
Continuous Index:
Within 8" of Joint: **YES**
Remarks:

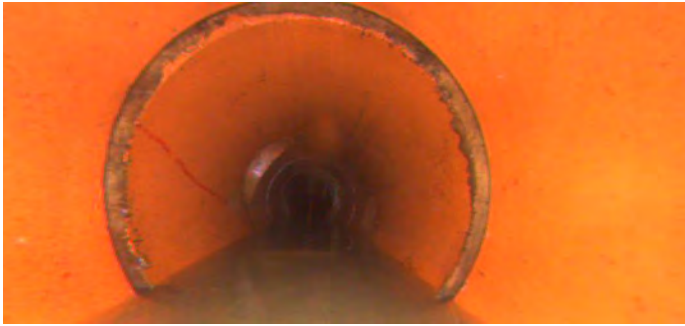
Code: **TF**
Description: **Tap Factory**

Distance (ft): **155.5**
Structural Grade: **0**
O&M Grade: **0**
Clock Start/From: **10**
Clock To:
1st Value: **4.000**
2nd Value:
Value Percent:
Continuous Index:
Within 8" of Joint:
Remarks:

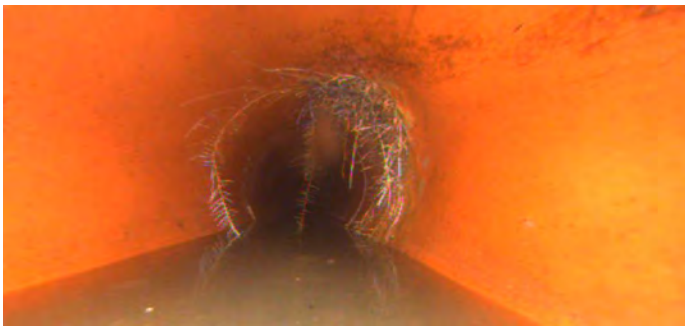
Code: **RMJ**
Description: **Roots Medium Joint**

Distance (ft): **158.2**
Structural Grade: **0**
O&M Grade: **3**
Clock Start/From: **8**
Clock To: **4**
1st Value:
2nd Value:
Value Percent: **20.000**
Continuous Index:
Within 8" of Joint: **YES**
Remarks:

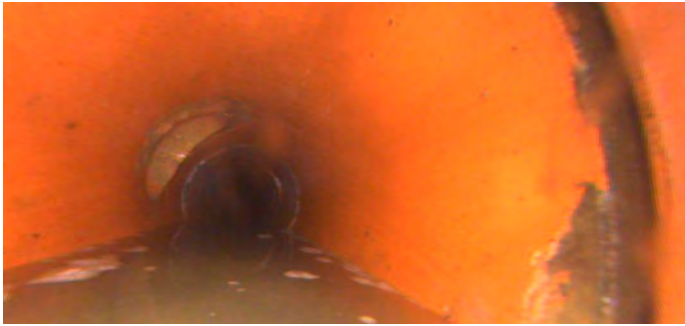
Code: **TF**
Description: **Tap Factory**

Distance (ft): **214.9**
Structural Grade: **0**
O&M Grade: **0**
Clock Start/From: **10**
Clock To:
1st Value: **4.000**
2nd Value:
Value Percent:
Continuous Index:
Within 8" of Joint:
Remarks:

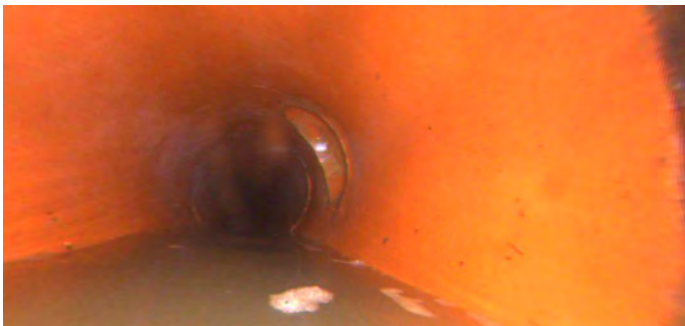
Code: **TF**
Description: **Tap Factory**

Distance (ft): **217.1**
Structural Grade: **0**
O&M Grade: **0**
Clock Start/From: **2**
Clock To:
1st Value: **4.000**
2nd Value:
Value Percent:
Continuous Index:
Within 8" of Joint:
Remarks:

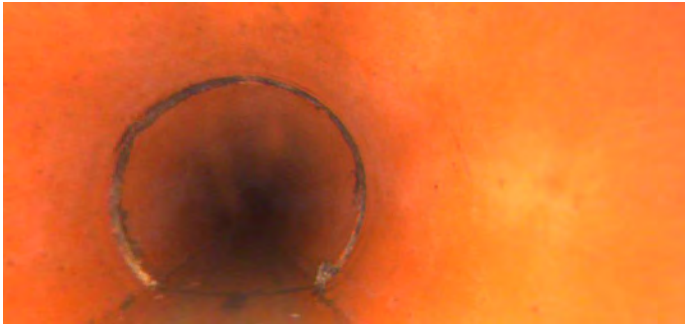
Code: **RFJ**
Description: **Roots Fine Joint**

Distance (ft): **228.1**
Structural Grade: **0**
O&M Grade: **1**
Clock Start/From: **7**
Clock To: **5**
1st Value:
2nd Value:
Value Percent:
Continuous Index:
Within 8" of Joint: **YES**
Remarks:

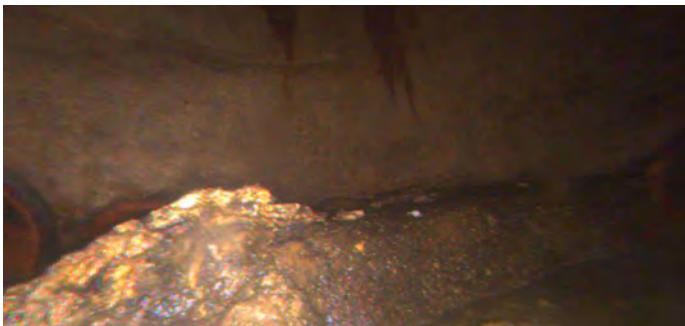
Code: **AMH**
Description: **Manhole**

Distance (ft): **244.1**
Structural Grade: **0**
O&M Grade: **0**
Clock Start/From:
Clock To:
1st Value:
2nd Value:
Value Percent:
Continuous Index:
Within 8" of Joint: **NO**
Remarks: **M-303-036**
