Profile/Photo Observation Report

Date:	03/28/2018	Weather:		Coding:	PACP 6.0
Pipe Length (ft):	124.2	Owner:	NA	Pre Clean:	Not Known
P.O.#:		Surveyor:	Selasie Honu	PSR:	P-303-037-036
Customer:		Clean Date:	01/01/1900	Shape:	C

Street:	OFF W 38TH AVE	Flow Control:	Not Controlled
City:	Hobart, IN	Year Renewed:	
Location:	Other	Tape/Media #:	
Purpose:	Not Known	Dia/Height:	8"
Use:	Sanitary	Material:	VCP
Drain Area:	NA	Lining:	
Category:	NA		
Comment:

Location Details:		Direction of Survey:	Upstream
US MH:	M-303-036	DS MH:	M-303-037
		Total Length Surveyed (ft):	123.6

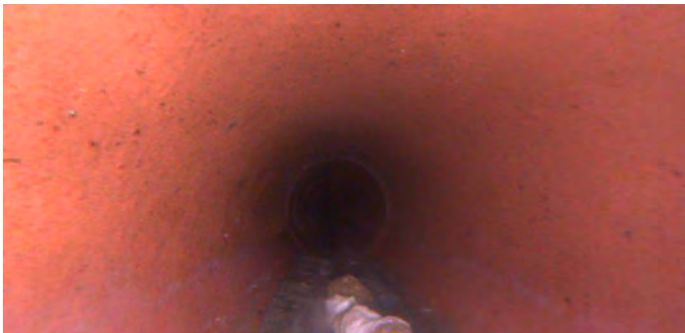
Code: **AMH**
Description: **Manhole**

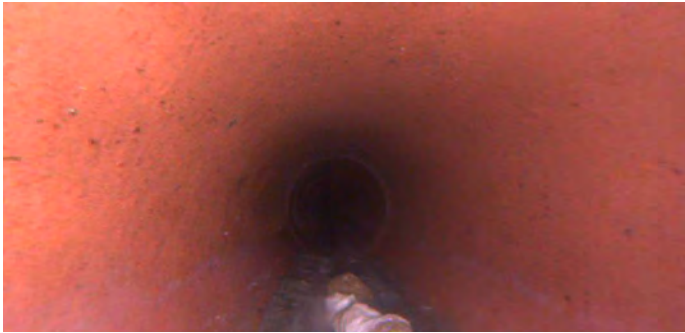
Code:	MWL
Description:	Water Level

Distance (ft):	.0
Structural Grade:	0
O&M Grade:	0
Clock Start/From:	
Clock To:	
1st Value:	
2nd Value:	
Value Percent:	5.000
Continuous Index:	
Within 8" of Joint:	NO
Remarks:

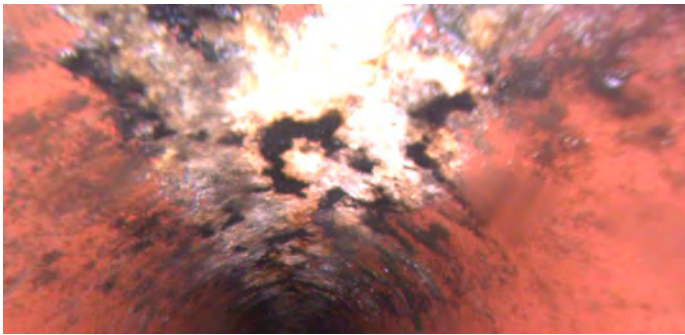
Code:	DAGS
Description:	Deposits Attached Grease

Distance (ft):	26.7
Structural Grade:	0
O&M Grade:	2
Clock Start/From:	11
Clock To:	1
1st Value:	
2nd Value:	
Value Percent:	5.000
Continuous Index:	S01
Within 8" of Joint:	NO
Remarks:

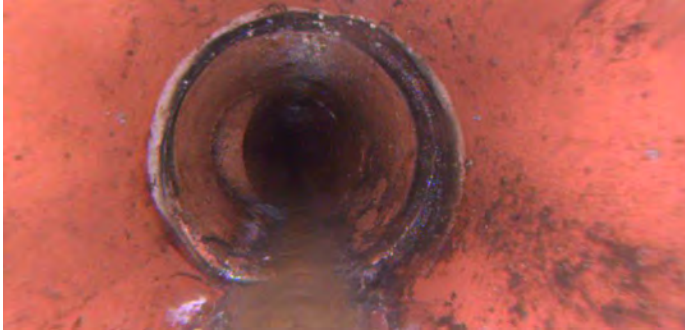
Code: **IW**
Description: **Infil Weeper**

Distance (ft): **42.4**
Structural Grade: **0**
O&M Grade: **2**
Clock Start/From: **8**
Clock To: **4**
1st Value:
2nd Value:
Value Percent:
Continuous Index:
Within 8" of Joint: **YES**
Remarks:

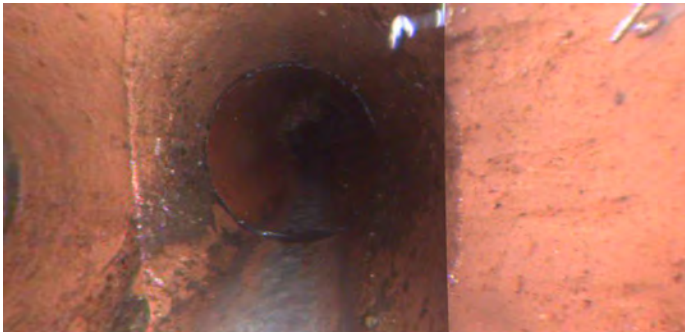
Code: **TFA**
Description: **Tap Factory Active**

Distance (ft): **44.0**
Structural Grade: **0**
O&M Grade: **0**
Clock Start/From: **9**
Clock To:
1st Value: **4.000**
2nd Value:
Value Percent:
Continuous Index:
Within 8" of Joint:
Remarks:

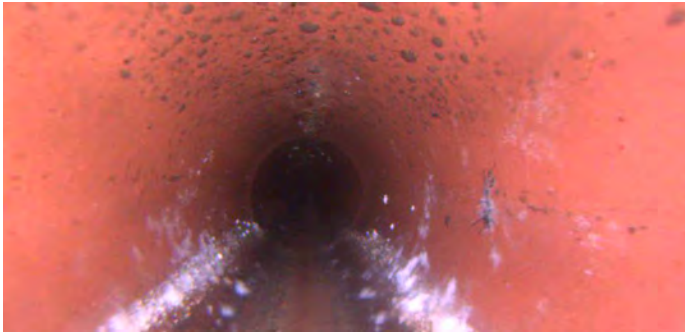
Code: **DAGS**
Description: **Deposits Attached Grease**

Distance (ft): **56.9**
Structural Grade: **0**
O&M Grade: **2**
Clock Start/From: **11**
Clock To: **1**
1st Value:
2nd Value:
Value Percent: **5.000**
Continuous Index: **F01**
Within 8" of Joint: **NO**
Remarks:

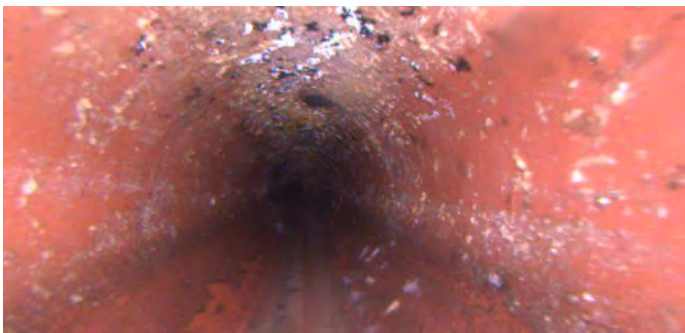
Code: **DAGS**
Description: **Deposits Attached Grease**

Distance (ft): **73.9**
Structural Grade: **0**
O&M Grade: **2**
Clock Start/From: **8**
Clock To: **4**
1st Value:
2nd Value:
Value Percent: **5.000**
Continuous Index: **S02**
Within 8" of Joint: **NO**
Remarks:

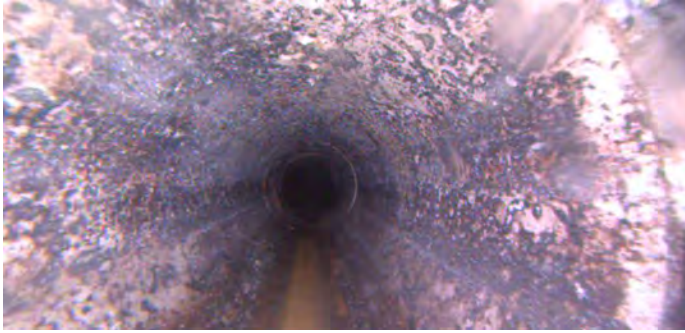
Code: **MMC**
Description: **Material Change**

Distance (ft): **81.9**
Structural Grade: **0**
O&M Grade: **0**
Clock Start/From:
Clock To:
1st Value:
2nd Value:
Value Percent:
Continuous Index:
Within 8" of Joint: **NO**
Remarks: **PVC**

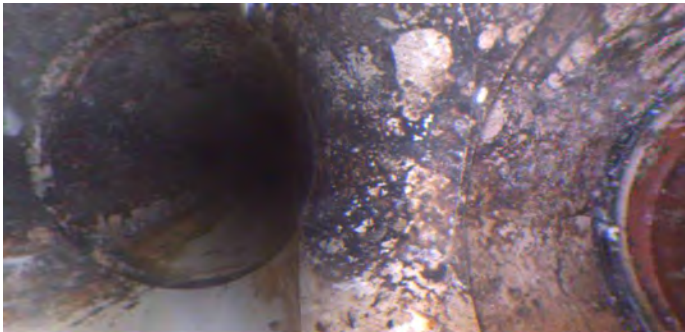
Code: **TF**
Description: **Tap Factory**

Distance (ft): **84.4**
Structural Grade: **0**
O&M Grade: **0**
Clock Start/From: **9**
Clock To:
1st Value: **4.000**
2nd Value:
Value Percent:
Continuous Index:
Within 8" of Joint:
Remarks:

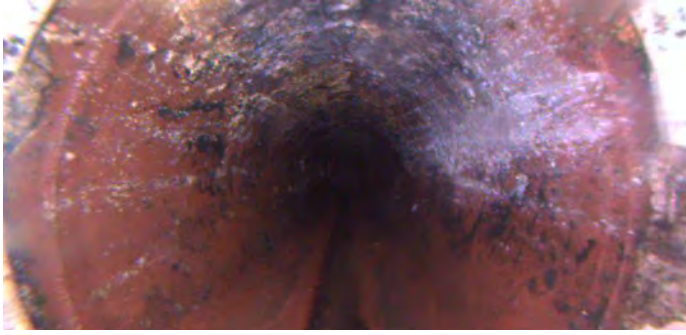
Code:	MMC
Description:	Material Change
Distance (ft):	84.8
Structural Grade:	0
O&M Grade:	0
Clock Start/From:	
Clock To:	
1st Value:	
2nd Value:	
Value Percent:	
Continuous Index:	
Within 8" of Joint:	NO
Remarks:	vcp

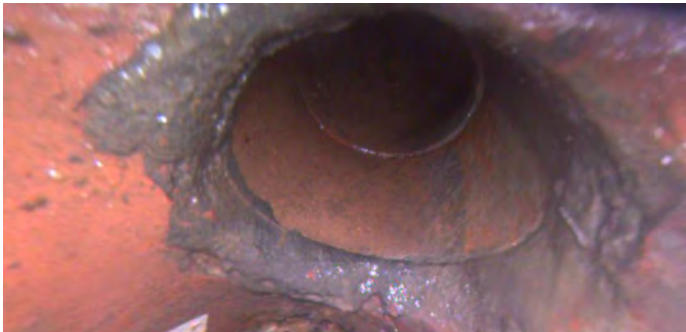
Code:	TBA
Description:	Tap Break-in Active
Distance (ft):	87.3
Structural Grade:	0
O&M Grade:	0
Clock Start/From:	12
Clock To:	
1st Value:	4.000
2nd Value:	
Value Percent:	
Continuous Index:	
Within 8" of Joint:	
Remarks:

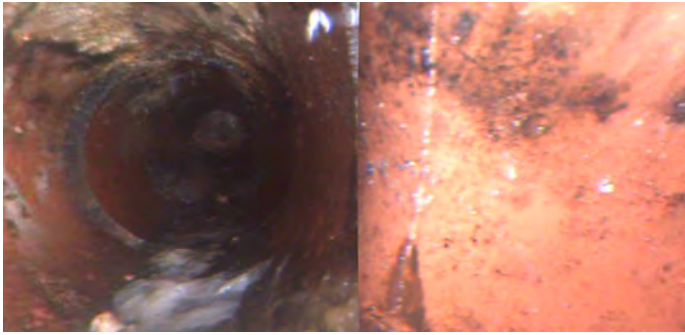
Code: **TFA**
Description: **Tap Factory Active**

Distance (ft): **90.5**
Structural Grade: **0**
O&M Grade: **0**
Clock Start/From: **9**
Clock To:
1st Value: **4.000**
2nd Value:
Value Percent:
Continuous Index:
Within 8" of Joint:
Remarks:

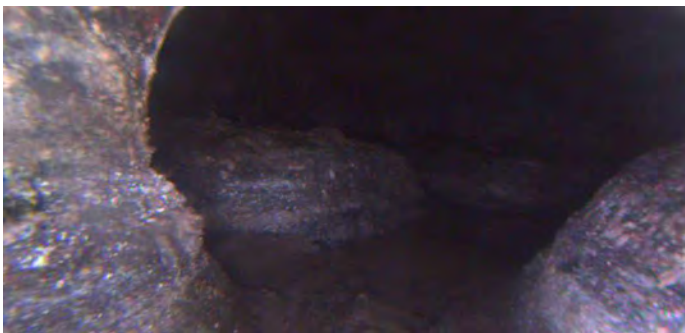
Code: **DAGS**
Description: **Deposits Attached Grease**

Distance (ft): **122.4**
Structural Grade: **0**
O&M Grade: **2**
Clock Start/From: **8**
Clock To: **4**
1st Value:
2nd Value:
Value Percent: **5.000**
Continuous Index: **F02**
Within 8" of Joint: **NO**
Remarks:

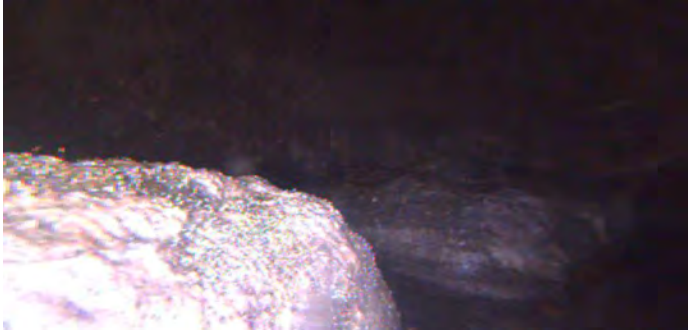
Code:	AMH
Description:	Manhole
Distance (ft):	123.6
Structural Grade:	0
O&M Grade:	0
Clock Start/From:	
Clock To:	
1st Value:	
2nd Value:	
Value Percent:	
Continuous Index:	
Within 8" of Joint:	NO
Remarks:	M-303-036
