## Profile/Photo Observation Report

Street:	<b>W 38TH AVE</b>	Flow Control:	<b>Not Controlled</b>
City:	<b>Hobart, IN</b>	Year Renewed:	
Location:	<b>Other</b>	Tape/Media #:	
Purpose:	<b>Not Known</b>	Dia/Height:	<b>8"</b>
Use:	<b>Sanitary</b>	Material:	<b>VCP</b>
Drain Area:	<b>NA</b>	Lining:	
Category:	<b>NA</b>		
Comment:

Location Details:		Direction of Survey:	<b>Upstream</b>
US MH:	<b>M-303-036</b>	DS MH:	<b>M-303-037</b>
		Total Length Surveyed (ft):	<b>123.6</b>

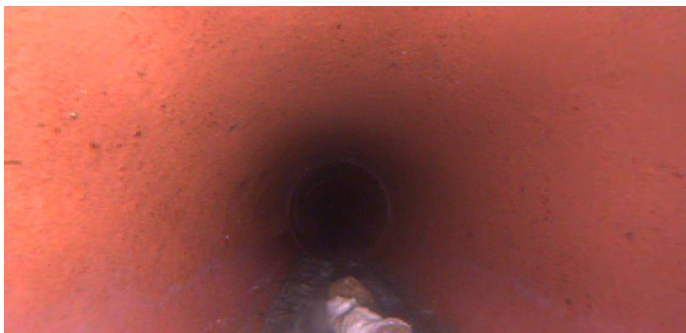
Code: **AMH**  
Description: **Manhole**

Distance (ft): **.0**  
Structural Grade: **0**  
O&M Grade: **0**  
Clock Start/From:  
Clock To:  
1st Value:  
2nd Value:  
Value Percent:  
Continuous Index:  
Within 8" of Joint: **NO**  
Remarks: **M-303-037**

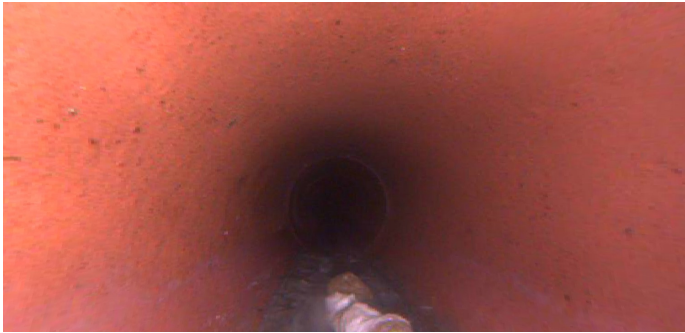
Code:	<b>MWL</b>
Description:	<b>Water Level</b>

Distance (ft):	<b>.0</b>
Structural Grade:	<b>0</b>
O&M Grade:	<b>0</b>
Clock Start/From:	
Clock To:	
1st Value:	
2nd Value:	
Value Percent:	<b>5.000</b>
Continuous Index:	
Within 8" of Joint:	<b>NO</b>
Remarks:

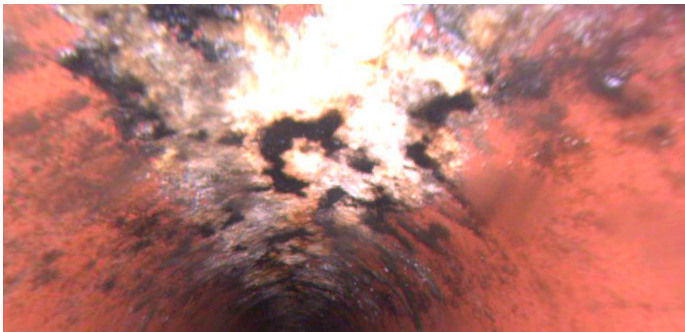
Code:	<b>DAGS</b>
Description:	<b>Deposits Attached Grease</b>

Distance (ft):	<b>26.7</b>
Structural Grade:	<b>0</b>
O&M Grade:	<b>2</b>
Clock Start/From:	<b>11</b>
Clock To:	<b>1</b>
1st Value:	
2nd Value:	
Value Percent:	<b>5.000</b>
Continuous Index:	<b>S01</b>
Within 8" of Joint:	<b>NO</b>
Remarks:

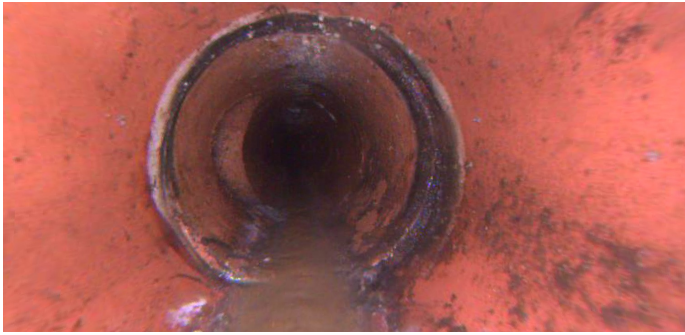
Code: **IW**  
Description: **Infil Weeper**

Distance (ft): **42.4**  
Structural Grade: **0**  
O&M Grade: **2**  
Clock Start/From: **8**  
Clock To: **4**  
1st Value:  
2nd Value:  
Value Percent:  
Continuous Index:  
Within 8" of Joint: **YES**  
Remarks:

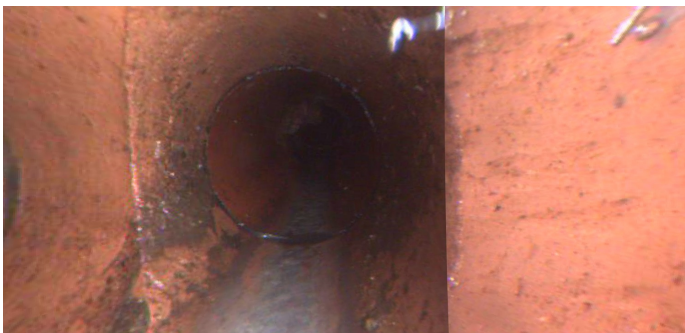
Code: **TFA**  
Description: **Tap Factory Active**

Distance (ft): **44.0**  
Structural Grade: **0**  
O&M Grade: **0**  
Clock Start/From: **9**  
Clock To:  
1st Value: **4.000**  
2nd Value:  
Value Percent:  
Continuous Index:  
Within 8" of Joint:  
Remarks:

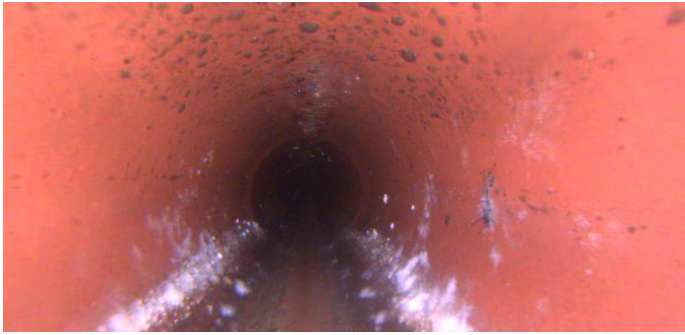
Code: **DAGS**  
Description: **Deposits Attached Grease**

Distance (ft): **56.9**  
Structural Grade: **0**  
O&M Grade: **2**  
Clock Start/From: **11**  
Clock To: **1**  
1st Value:  
2nd Value:  
Value Percent: **5.000**  
Continuous Index: **F01**  
Within 8" of Joint: **NO**  
Remarks:

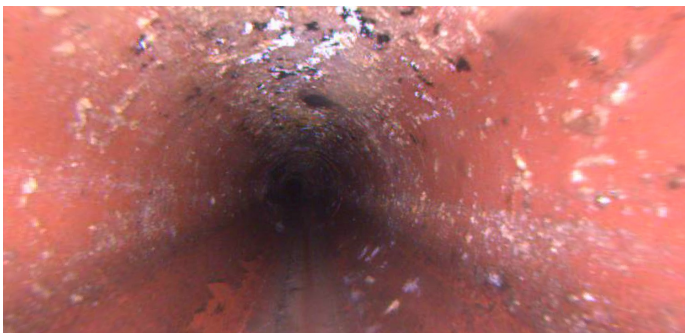
Code: **DAGS**  
Description: **Deposits Attached Grease**

Distance (ft): **73.9**  
Structural Grade: **0**  
O&M Grade: **2**  
Clock Start/From: **8**  
Clock To: **4**  
1st Value:  
2nd Value:  
Value Percent: **5.000**  
Continuous Index: **S02**  
Within 8" of Joint: **NO**  
Remarks:

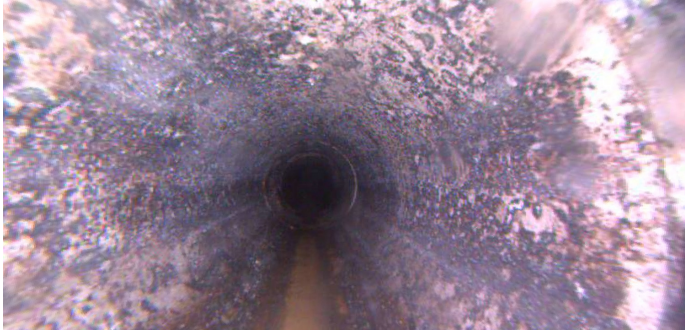
Code: **MMC**  
Description: **Material Change**

Distance (ft): **81.9**  
Structural Grade: **0**  
O&M Grade: **0**  
Clock Start/From:  
Clock To:  
1st Value:  
2nd Value:  
Value Percent:  
Continuous Index:  
Within 8" of Joint: **NO**  
Remarks: **PVC**

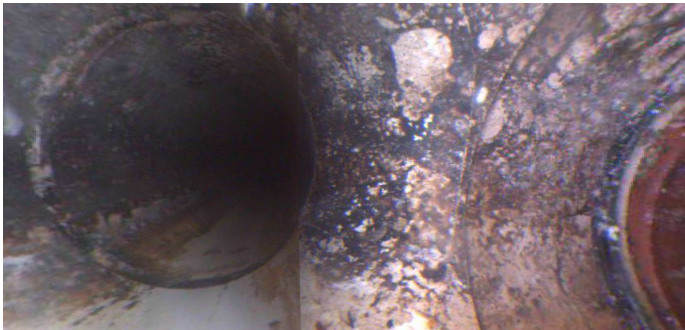
Code: **TF**  
Description: **Tap Factory**

Distance (ft): **84.4**  
Structural Grade: **0**  
O&M Grade: **0**  
Clock Start/From: **9**  
Clock To:  
1st Value: **4.000**  
2nd Value:  
Value Percent:  
Continuous Index:  
Within 8" of Joint:  
Remarks:

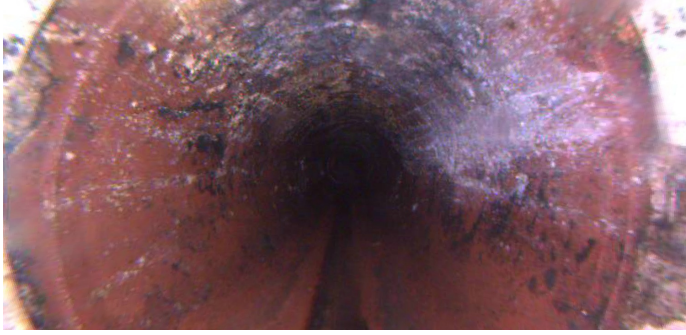
Code: **MMC**  
Description: **Material Change**

Distance (ft): **84.8**  
Structural Grade: **0**  
O&M Grade: **0**  
Clock Start/From:  
Clock To:  
1st Value:  
2nd Value:  
Value Percent:  
Continuous Index:  
Within 8" of Joint: **NO**  
Remarks: **vcp**

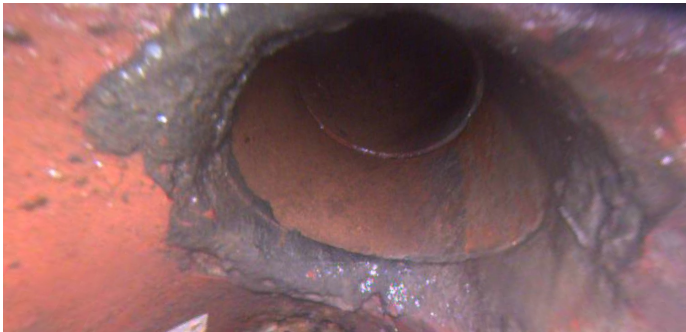
Code: **TBA**  
Description: **Tap Break-in Active**

Distance (ft): **87.3**  
Structural Grade: **0**  
O&M Grade: **0**  
Clock Start/From: **12**  
Clock To:  
1st Value: **4.000**  
2nd Value:  
Value Percent:  
Continuous Index:  
Within 8" of Joint:  
Remarks:

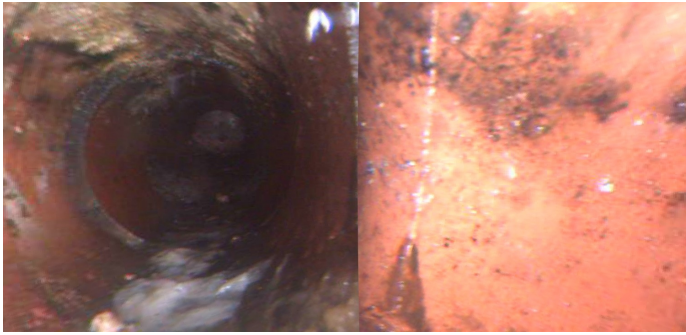
Code: **TFA**  
Description: **Tap Factory Active**

Distance (ft): **90.5**  
Structural Grade: **0**  
O&M Grade: **0**  
Clock Start/From: **9**  
Clock To:  
1st Value: **4.000**  
2nd Value:  
Value Percent:  
Continuous Index:  
Within 8" of Joint:  
Remarks:

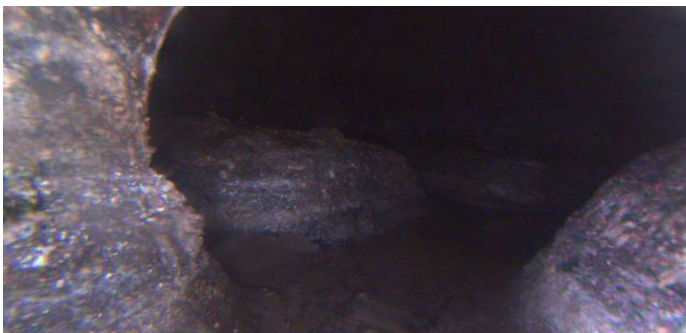
Code: **DAGS**  
Description: **Deposits Attached Grease**

Distance (ft): **122.4**  
Structural Grade: **0**  
O&M Grade: **2**  
Clock Start/From: **8**  
Clock To: **4**  
1st Value:  
2nd Value:  
Value Percent: **5.000**  
Continuous Index: **F02**  
Within 8" of Joint: **NO**  
Remarks:

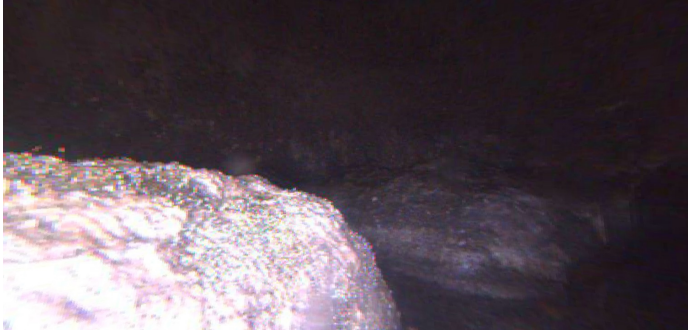
Code:	AMH
Description:	Manhole
Distance (ft):	123.6
Structural Grade:	0
O&M Grade:	0
Clock Start/From:	
Clock To:	
1st Value:	
2nd Value:	
Value Percent:	
Continuous Index:	
Within 8" of Joint:	NO
Remarks:	M-303-036
