Profile/Photo Observation Report

Street:	ROCHE ST & W 38TH AVE	Flow Control:	Not Controlled
City:	Hobart, IN	Year Renewed:	
Location:	Light Highway	Tape/Media #:	
Purpose:	Routine Assessment	Dia/Height:	10"
Use:	Sanitary	Material:	VCP
Drain Area:	NA	Lining:	
Category:	NA		
Comment:

Location Details:		Direction of Survey:	Upstream
US MH:	M-303-040	DS MH:	M-303-039
		Total Length Surveyed (ft):	196.8

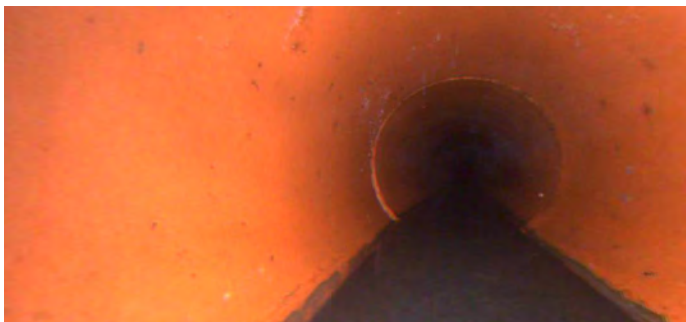
Code: **AMH**
Description: **Manhole**

Distance (ft): **.0**
Structural Grade: **0**
O&M Grade: **0**
Clock Start/From:
Clock To:
1st Value:
2nd Value:
Value Percent:
Continuous Index:
Within 8" of Joint: **NO**
Remarks: **M-303-039**

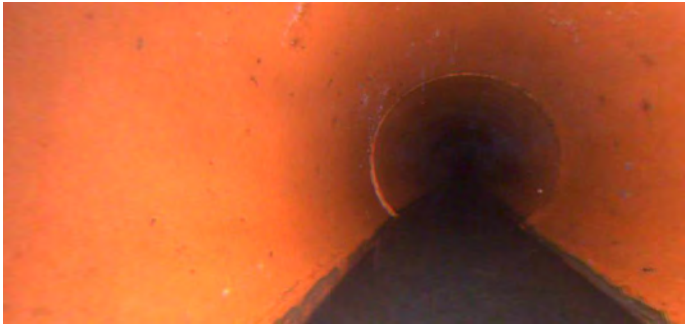
Code:	MWL
Description:	Water Level

Distance (ft):	.0
Structural Grade:	0
O&M Grade:	0
Clock Start/From:	
Clock To:	
1st Value:	
2nd Value:	
Value Percent:	5.000
Continuous Index:	
Within 8" of Joint:	NO
Remarks:

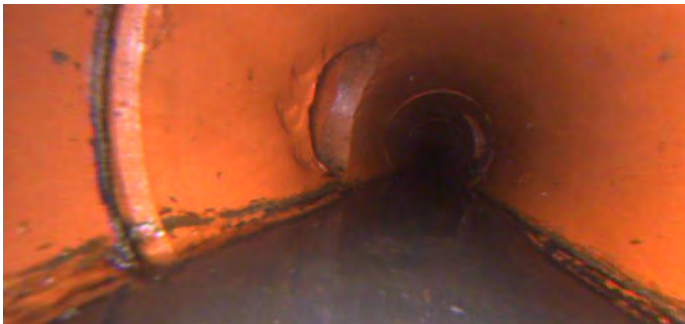
Code:	TF
Description:	Tap Factory

Distance (ft):	52.1
Structural Grade:	0
O&M Grade:	0
Clock Start/From:	9
Clock To:	
1st Value:	4.000
2nd Value:	
Value Percent:	
Continuous Index:	
Within 8" of Joint:	
Remarks:

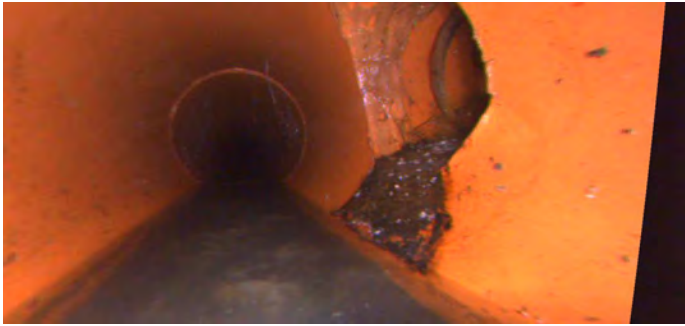
Code: **TF**
Description: **Tap Factory**

Distance (ft): **54.5**
Structural Grade: **0**
O&M Grade: **0**
Clock Start/From: **3**
Clock To:
1st Value: **4.000**
2nd Value:
Value Percent:
Continuous Index:
Within 8" of Joint:
Remarks:

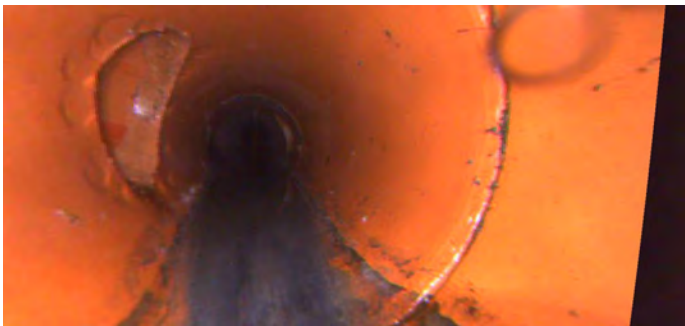
Code: **TF**
Description: **Tap Factory**

Distance (ft): **116.4**
Structural Grade: **0**
O&M Grade: **0**
Clock Start/From: **9**
Clock To:
1st Value: **4.000**
2nd Value:
Value Percent:
Continuous Index:
Within 8" of Joint:
Remarks:

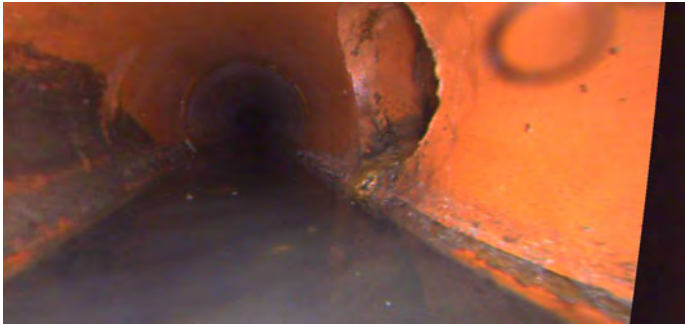
Code: **TF**
Description: **Tap Factory**

Distance (ft): **118.8**
Structural Grade: **0**
O&M Grade: **0**
Clock Start/From: **3**
Clock To:
1st Value: **4.000**
2nd Value:
Value Percent:
Continuous Index:
Within 8" of Joint:
Remarks:

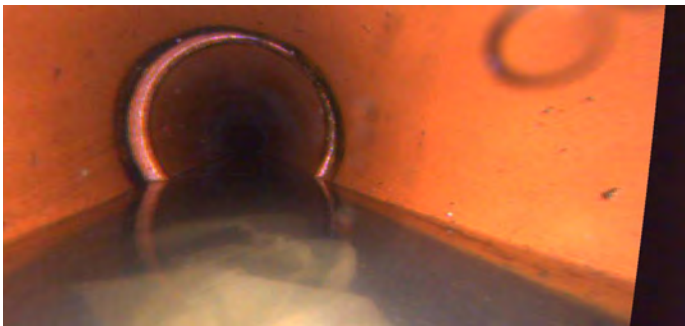
Code: **IS**
Description: **Infil Stain**

Distance (ft): **149.8**
Structural Grade: **0**
O&M Grade: **0**
Clock Start/From: **8**
Clock To: **4**
1st Value:
2nd Value:
Value Percent:
Continuous Index:
Within 8" of Joint: **YES**
Remarks:

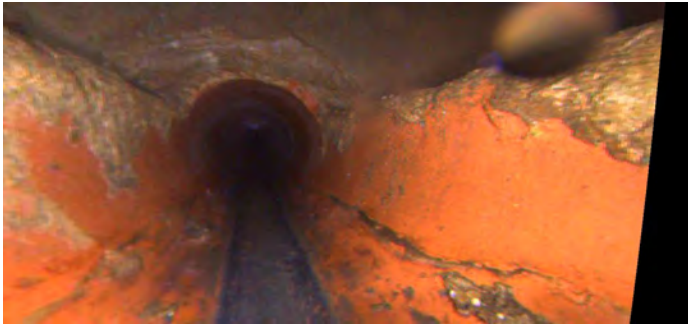
Code:	AMH
Description:	Manhole
Distance (ft):	196.8
Structural Grade:	0
O&M Grade:	0
Clock Start/From:	
Clock To:	
1st Value:	
2nd Value:	
Value Percent:	
Continuous Index:	
Within 8" of Joint:	NO
Remarks:	M-303-040
