## Profile/Photo Observation Report

Street:	<b>Roche St.</b>	Flow Control:	<b>Not Controlled</b>
City:	<b>Hobart, IN</b>	Year Renewed:	
Location:	<b>Light Highway</b>	Tape/Media #:	
Purpose:	<b>Routine Assessment</b>	Dia/Height:	<b>10"</b>
Use:	<b>Sanitary</b>	Material:	<b>VCP</b>
Drain Area:	<b>NA</b>	Lining:	
Category:	<b>NA</b>		
Comment:

Location Details:		Direction of Survey:	<b>Upstream</b>
US MH:	<b>M-303-040</b>	DS MH:	<b>M-303-039</b>
		Total Length Surveyed (ft):	<b>196.8</b>

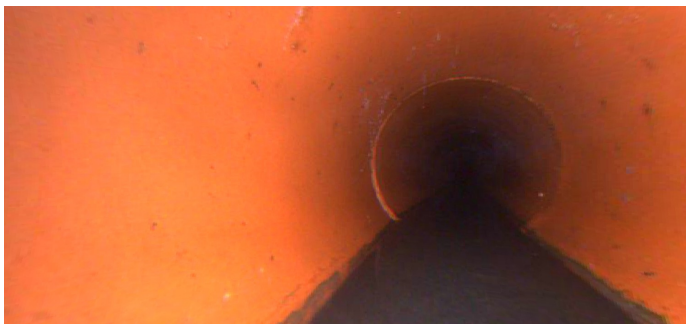
Code: **AMH**  
Description: **Manhole**

Distance (ft): **.0**  
Structural Grade: **0**  
O&M Grade: **0**  
Clock Start/From:  
Clock To:  
1st Value:  
2nd Value:  
Value Percent:  
Continuous Index:  
Within 8" of Joint: **NO**  
Remarks: **M-303-039**

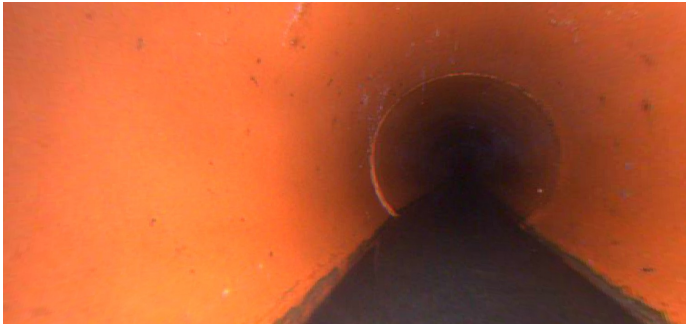
Code:	<b>MWL</b>
Description:	<b>Water Level</b>

Distance (ft):	<b>.0</b>
Structural Grade:	<b>0</b>
O&M Grade:	<b>0</b>
Clock Start/From:	
Clock To:	
1st Value:	
2nd Value:	
Value Percent:	<b>5.000</b>
Continuous Index:	
Within 8" of Joint:	<b>NO</b>
Remarks:

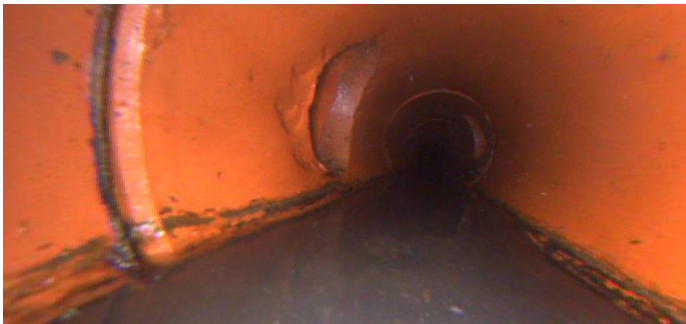
Code:	<b>TF</b>
Description:	<b>Tap Factory</b>

Distance (ft):	<b>52.1</b>
Structural Grade:	<b>0</b>
O&M Grade:	<b>0</b>
Clock Start/From:	<b>9</b>
Clock To:	
1st Value:	<b>4.000</b>
2nd Value:	
Value Percent:	
Continuous Index:	
Within 8" of Joint:	
Remarks:

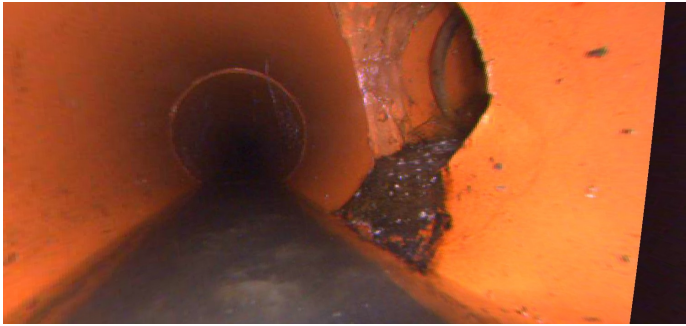
Code: **TF**  
Description: **Tap Factory**

Distance (ft): **54.5**  
Structural Grade: **0**  
O&M Grade: **0**  
Clock Start/From: **3**  
Clock To:  
1st Value: **4.000**  
2nd Value:  
Value Percent:  
Continuous Index:  
Within 8" of Joint:  
Remarks:

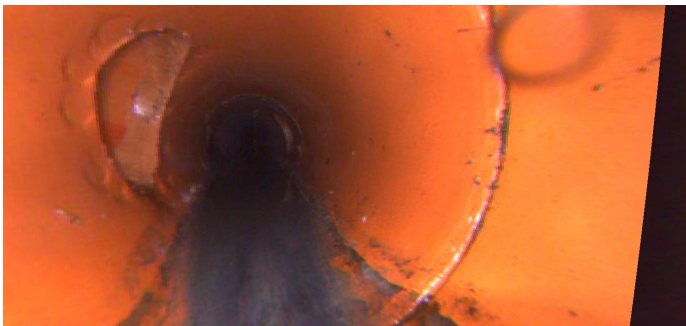
Code: **TF**  
Description: **Tap Factory**

Distance (ft): **116.4**  
Structural Grade: **0**  
O&M Grade: **0**  
Clock Start/From: **9**  
Clock To:  
1st Value: **4.000**  
2nd Value:  
Value Percent:  
Continuous Index:  
Within 8" of Joint:  
Remarks:

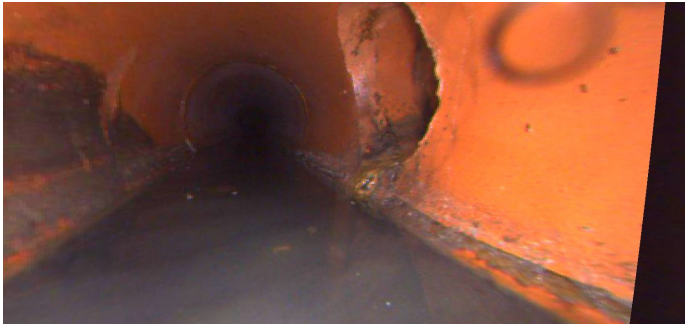
Code: **TF**  
Description: **Tap Factory**

Distance (ft): **118.8**  
Structural Grade: **0**  
O&M Grade: **0**  
Clock Start/From: **3**  
Clock To:  
1st Value: **4.000**  
2nd Value:  
Value Percent:  
Continuous Index:  
Within 8" of Joint:  
Remarks:

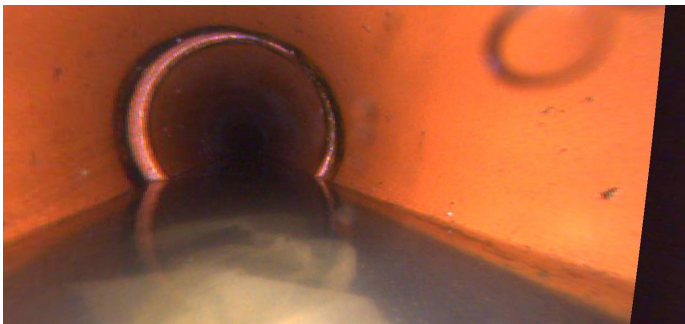
Code: **IS**  
Description: **Infil Stain**

Distance (ft): **149.8**  
Structural Grade: **0**  
O&M Grade: **0**  
Clock Start/From: **8**  
Clock To: **4**  
1st Value:  
2nd Value:  
Value Percent:  
Continuous Index:  
Within 8" of Joint: **YES**  
Remarks:

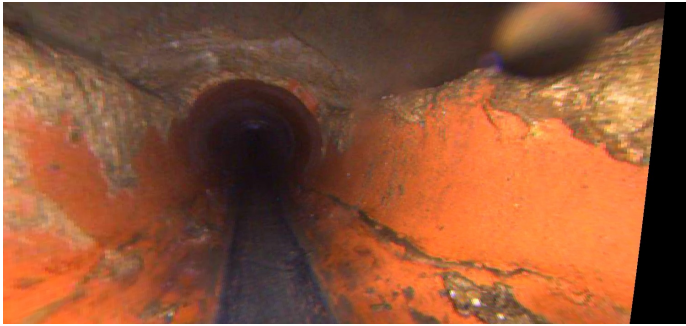
Code:	<b>AMH</b>
Description:	<b>Manhole</b>
Distance (ft):	<b>196.8</b>
Structural Grade:	<b>0</b>
O&M Grade:	<b>0</b>
Clock Start/From:	
Clock To:	
1st Value:	
2nd Value:	
Value Percent:	
Continuous Index:	
Within 8" of Joint:	<b>NO</b>
Remarks:	<b>M-303-040</b>
