Profile/Photo Observation Report

Date:	03/29/2018	Weather:		Coding:	PACP 6.0
Pipe Length (ft):	202.2	Owner:	NA	Pre Clean:	Not Known
P.O.#:		Surveyor:	Jen Costello	PSR:	P-303-040-041
Customer:		Clean Date:	01/01/1900	Shape:	C

Street:	ROCHE ST	Flow Control:	Not Controlled
City:	Hobart, IN	Year Renewed:	
Location:	Other	Tape/Media #:	
Purpose:	Not Known	Dia/Height:	10"
Use:	Sanitary	Material:	VCP
Drain Area:	NA	Lining:	
Category:	NA		
Comment:

Location Details:		Direction of Survey:	Downstream
US MH:	M-303-041	DS MH:	M-303-040
		Total Length Surveyed (ft):	199.6

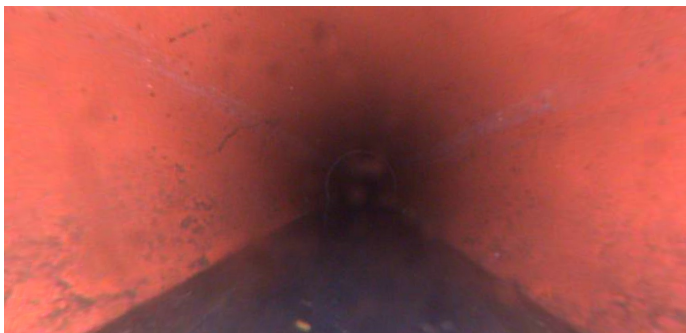
Code: **AMH**
Description: **Manhole**

Distance (ft): **.0**
Structural Grade: **0**
O&M Grade: **0**
Clock Start/From:
Clock To:
1st Value:
2nd Value:
Value Percent:
Continuous Index:
Within 8" of Joint: **NO**
Remarks: **M-303-041**

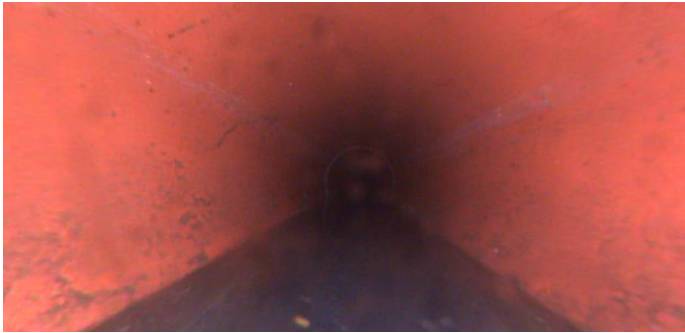
Code:	MWL
Description:	Water Level

Distance (ft):	.0
Structural Grade:	0
O&M Grade:	0
Clock Start/From:	
Clock To:	
1st Value:	
2nd Value:	
Value Percent:	10.000
Continuous Index:	
Within 8" of Joint:	NO
Remarks:

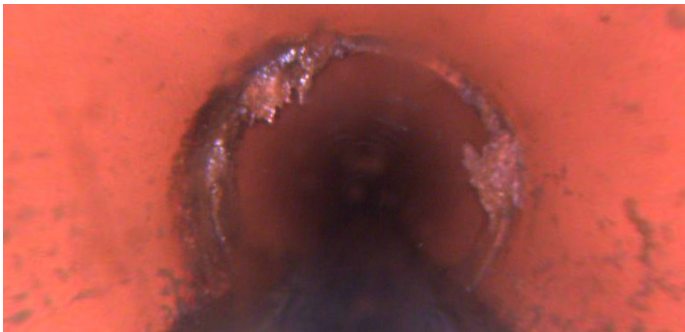
Code:	DAE
Description:	Deposits Attached Encrustation

Distance (ft):	29.1
Structural Grade:	0
O&M Grade:	2
Clock Start/From:	8
Clock To:	4
1st Value:	
2nd Value:	
Value Percent:	5.000
Continuous Index:	
Within 8" of Joint:	YES
Remarks:

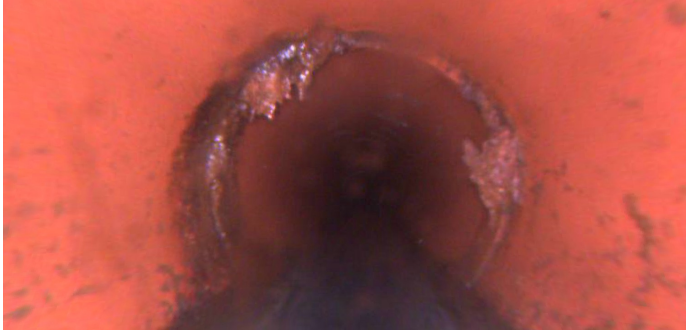
Code: ID
Description: Infil Dripper

Distance (ft): 29.1
Structural Grade: 0
O&M Grade: 3
Clock Start/From: 10
Clock To: 2
1st Value:
2nd Value:
Value Percent:
Continuous Index:
Within 8" of Joint: YES
Remarks:

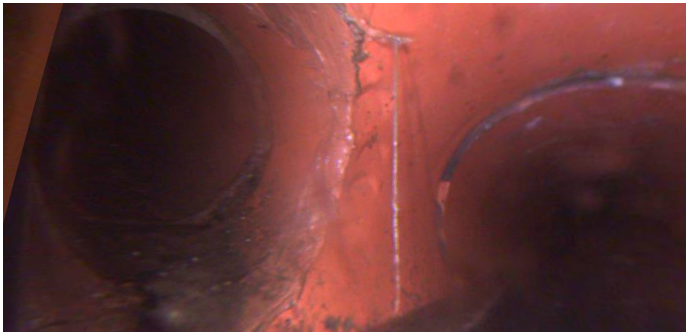
Code: TF
Description: Tap Factory

Distance (ft): 61.6
Structural Grade: 0
O&M Grade: 0
Clock Start/From: 9
Clock To:
1st Value: 4.000
2nd Value:
Value Percent:
Continuous Index:
Within 8" of Joint:
Remarks:

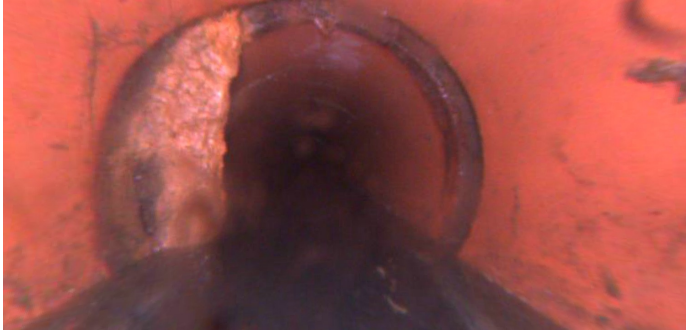
Code: **DAE**
Description: **Deposits Attached Encrustation**

Distance (ft): **72.0**
Structural Grade: **0**
O&M Grade: **2**
Clock Start/From: **7**
Clock To: **11**
1st Value:
2nd Value:
Value Percent: **10.000**
Continuous Index:
Within 8" of Joint: **YES**
Remarks:

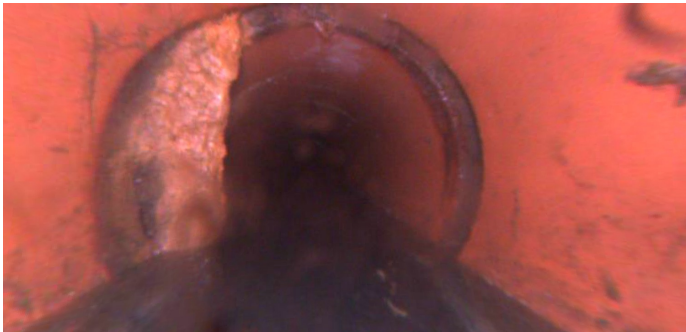
Code: **IW**
Description: **Infil Weeper**

Distance (ft): **72.0**
Structural Grade: **0**
O&M Grade: **2**
Clock Start/From: **8**
Clock To: **4**
1st Value:
2nd Value:
Value Percent:
Continuous Index:
Within 8" of Joint: **YES**
Remarks:

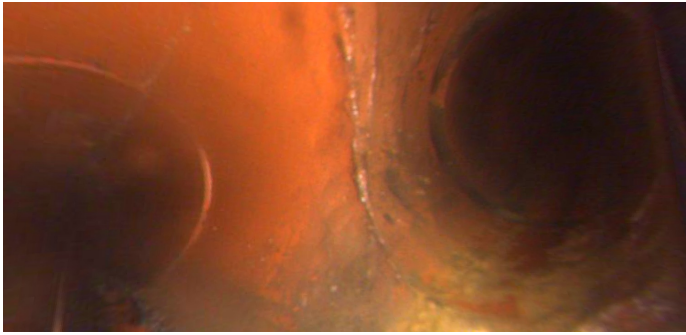
Code: **TF**
Description: **Tap Factory**

Distance (ft): **119.2**
Structural Grade: **0**
O&M Grade: **0**
Clock Start/From: **9**
Clock To:
1st Value: **4.000**
2nd Value:
Value Percent:
Continuous Index:
Within 8" of Joint:
Remarks:

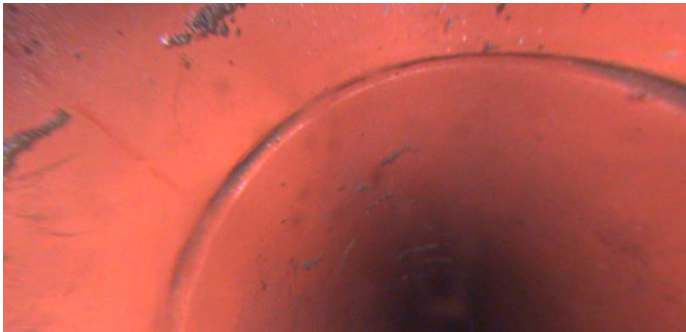
Code: **CL**
Description: **Crack Longitudinal**

Distance (ft): **144.8**
Structural Grade: **2**
O&M Grade: **0**
Clock Start/From: **10**
Clock To:
1st Value:
2nd Value:
Value Percent:
Continuous Index:
Within 8" of Joint: **YES**
Remarks:

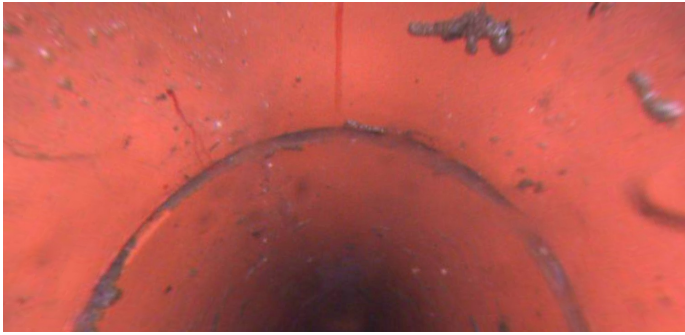
Code: **CM**
Description: **Crack Multiple**

Distance (ft): **164.9**
Structural Grade: **3**
O&M Grade: **0**
Clock Start/From: **11**
Clock To: **12**
1st Value:
2nd Value:
Value Percent:
Continuous Index:
Within 8" of Joint: **YES**
Remarks:

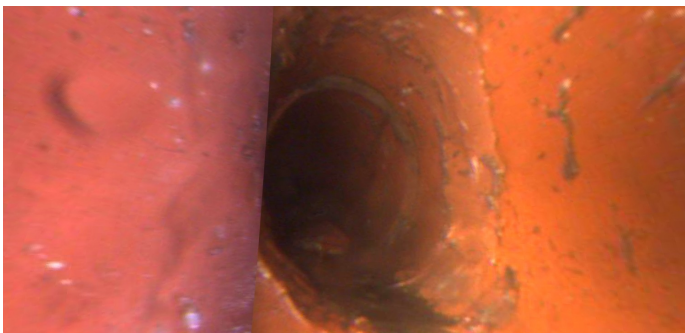
Code: **TF**
Description: **Tap Factory**

Distance (ft): **182.0**
Structural Grade: **0**
O&M Grade: **0**
Clock Start/From: **3**
Clock To:
1st Value: **4.000**
2nd Value:
Value Percent:
Continuous Index:
Within 8" of Joint:
Remarks:

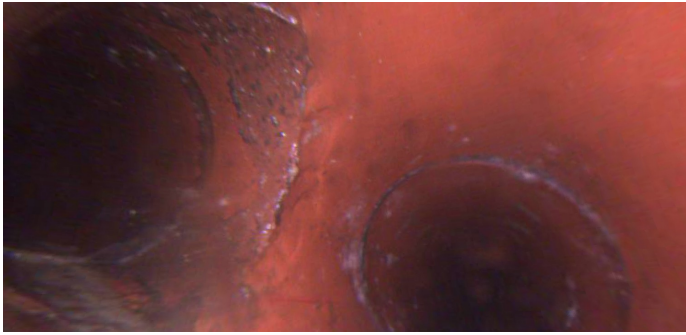
Code: **TF**
Description: **Tap Factory**

Distance (ft): **183.5**
Structural Grade: **0**
O&M Grade: **0**
Clock Start/From: **9**
Clock To:
1st Value: **4.000**
2nd Value:
Value Percent:
Continuous Index:
Within 8" of Joint:
Remarks:

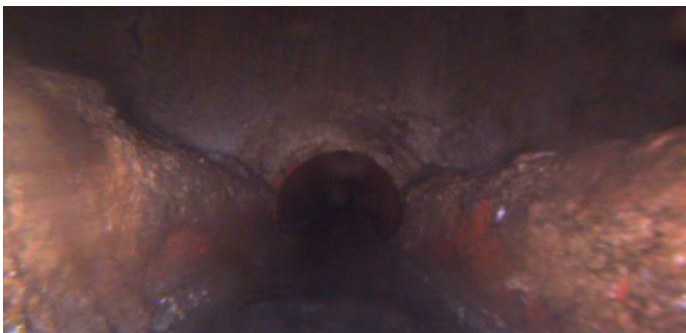
Code: **AMH**
Description: **Manhole**

Distance (ft): **199.6**
Structural Grade: **0**
O&M Grade: **0**
Clock Start/From:
Clock To:
1st Value:
2nd Value:
Value Percent:
Continuous Index:
Within 8" of Joint: **NO**
Remarks: **M-303-040**
