Profile/Photo Observation Report

Date:	03/29/2018	Weather:		Coding:	PACP 6.0
Pipe Length (ft):	121.3	Owner:	NA	Pre Clean:	Not Known
P.O.#:		Surveyor:	Jen Costello	PSR:	P-303-042-041
Customer:		Clean Date:	01/01/1900	Shape:	C

Street:	ROCHE ST	Flow Control:	Not Controlled
City:	Hobart, IN	Year Renewed:	
Location:	Other	Tape/Media #:	
Purpose:	Not Known	Dia/Height:	12"
Use:	Sanitary	Material:	VCP
Drain Area:	NA	Lining:	
Category:	NA		
Comment:

Location Details:		Direction of Survey:	Downstream
US MH:	M-303-041	DS MH:	M-303-042
		Total Length Surveyed (ft):	53.5

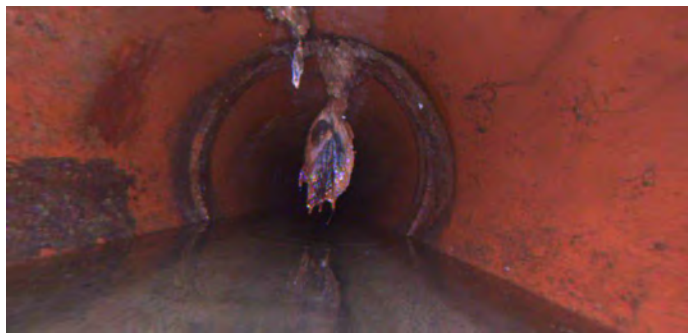
Code: **AMH**
 Description: **Manhole**
 Distance (ft): **.0**
 Structural Grade: **0**
 O&M Grade: **0**
 Clock Start/From:
 Clock To:
 1st Value:
 2nd Value:
 Value Percent:
 Continuous Index:
 Within 8" of Joint: **NO**
 Remarks: **M-303-041**

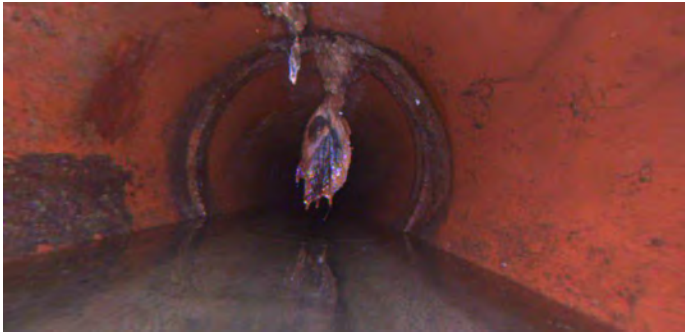
Code:	MWL
Description:	Water Level

Distance (ft):	.0
Structural Grade:	0
O&M Grade:	0
Clock Start/From:	
Clock To:	
1st Value:	
2nd Value:	
Value Percent:	30.000
Continuous Index:	
Within 8" of Joint:	NO
Remarks:

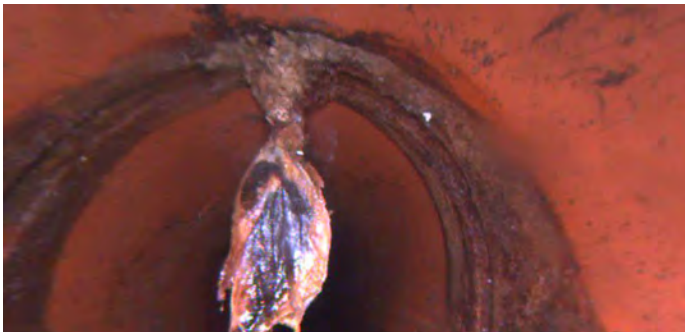
Code:	DAE
Description:	Deposits Attached Encrustation

Distance (ft):	1.3
Structural Grade:	0
O&M Grade:	2
Clock Start/From:	8
Clock To:	4
1st Value:	
2nd Value:	
Value Percent:	5.000
Continuous Index:	
Within 8" of Joint:	YES
Remarks:

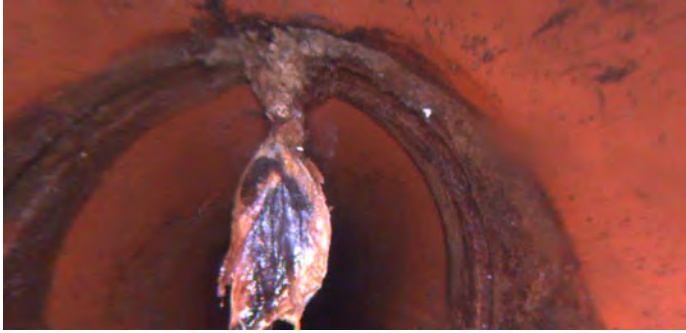
Code: **DAR**
Description: **Deposits Attached Ragging**

Distance (ft): **1.3**
Structural Grade: **0**
O&M Grade: **2**
Clock Start/From: **12**
Clock To:
1st Value:
2nd Value:
Value Percent: **10.000**
Continuous Index:
Within 8" of Joint: **YES**
Remarks:

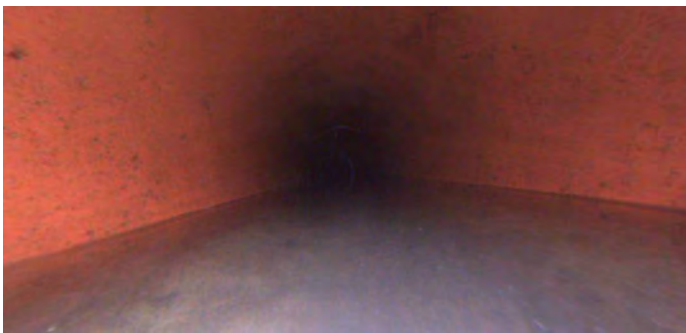
Code: **MSA**
Description: **Abandoned Survey**

Distance (ft): **53.5**
Structural Grade: **0**
O&M Grade: **0**
Clock Start/From:
Clock To:
1st Value:
2nd Value:
Value Percent:
Continuous Index:
Within 8" of Joint: **NO**
Remarks: **DEBRIS UNDER WATER**
