Profile/Photo Observation Report

Date:	09/26/2018	Weather:		Coding:	PACP 6.0
Pipe Length (ft):	243.9	Owner:	NA	Pre Clean:	Not Known
P.O.#:		Surveyor:	Justin Gonzales	PSR:	P-303-045.1-045
Customer:		Clean Date:	01/01/1900	Shape:	C

Street:	Brown St.	Flow Control:	Not Controlled
City:	Hobart, IN	Year Renewed:	
Location:	Light Highway	Tape/Media #:	
Purpose:	Routine Assessment	Dia/Height:	8"
Use:	Sanitary	Material:	VCP
Drain Area:	NA	Lining:	
Category:	NA		
Comment:

Location Details:		Direction of Survey:	Downstream
US MH:	M-303-045	DS MH:	M-303-045.1
		Total Length Surveyed (ft):	282.6

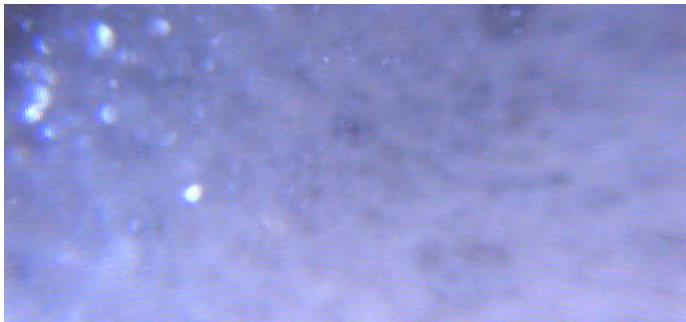
Code: **AMH**
Description: **Manhole**

Distance (ft): **.0**
Structural Grade: **0**
O&M Grade: **0**
Clock Start/From:
Clock To:
1st Value:
2nd Value:
Value Percent:
Continuous Index:
Within 8" of Joint: **NO**
Remarks: **M-303-045**

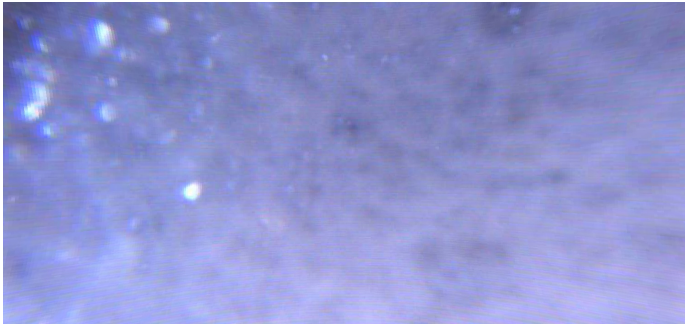
Code:	MWL
Description:	Water Level

Distance (ft):	.0
Structural Grade:	0
O&M Grade:	0
Clock Start/From:	
Clock To:	
1st Value:	
2nd Value:	
Value Percent:	10.000
Continuous Index:	
Within 8" of Joint:	NO
Remarks:	SOAP SUDS

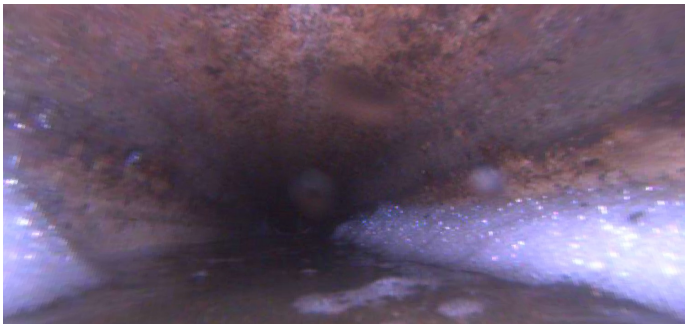
Code:	MGO
Description:	General Observation

Distance (ft):	5.1
Structural Grade:	0
O&M Grade:	0
Clock Start/From:	
Clock To:	
1st Value:	
2nd Value:	
Value Percent:	
Continuous Index:	
Within 8" of Joint:	NO
Remarks:	SOAP SUDS

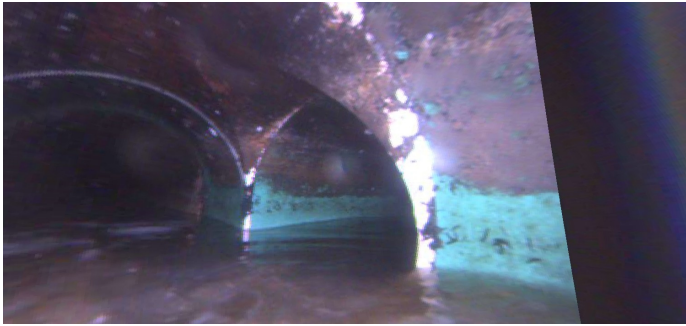
Code: **TFA**
Description: **Tap Factory Active**

Distance (ft): **13.6**
Structural Grade: **0**
O&M Grade: **0**
Clock Start/From: **9**
Clock To:
1st Value: **6.000**
2nd Value:
Value Percent:
Continuous Index:
Within 8" of Joint:
Remarks:

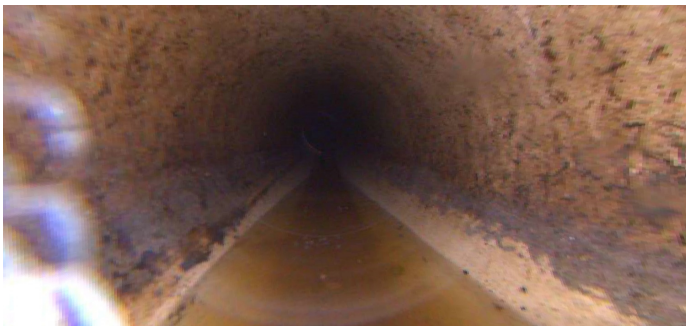
Code: **MGO**
Description: **General Observation**

Distance (ft): **20.9**
Structural Grade: **0**
O&M Grade: **0**
Clock Start/From:
Clock To:
1st Value:
2nd Value:
Value Percent:
Continuous Index:
Within 8" of Joint: **NO**
Remarks: **BACK TO FROM CAMERA**

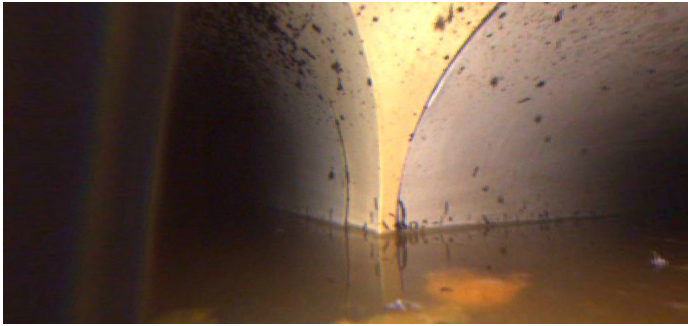
Code: **TFA**
Description: **Tap Factory Active**

Distance (ft): **76.3**
Structural Grade: **0**
O&M Grade: **0**
Clock Start/From: **9**
Clock To:
1st Value: **6.000**
2nd Value:
Value Percent:
Continuous Index:
Within 8" of Joint:
Remarks:

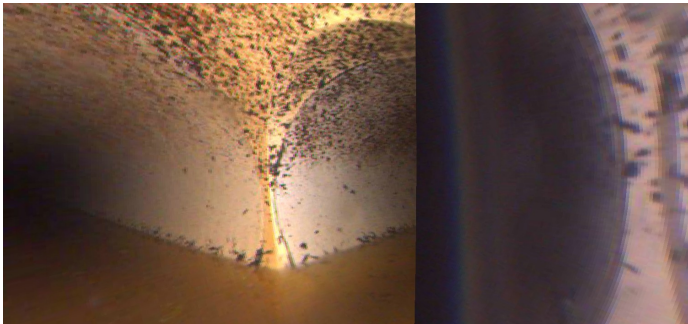
Code: **TFA**
Description: **Tap Factory Active**

Distance (ft): **84.1**
Structural Grade: **0**
O&M Grade: **0**
Clock Start/From: **3**
Clock To:
1st Value: **6.000**
2nd Value:
Value Percent:
Continuous Index:
Within 8" of Joint:
Remarks:

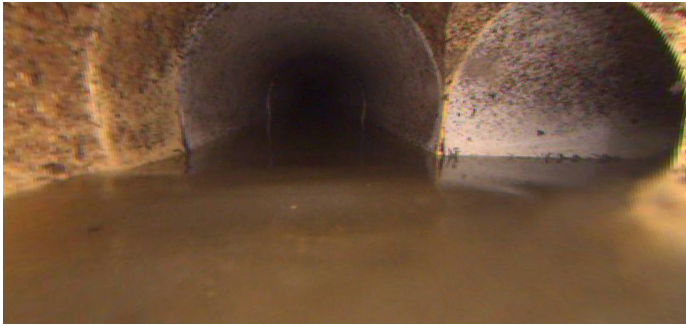
Code: **TFA**
Description: **Tap Factory Active**

Distance (ft): **161.5**
Structural Grade: **0**
O&M Grade: **0**
Clock Start/From: **3**
Clock To:
1st Value: **4.000**
2nd Value:
Value Percent:
Continuous Index:
Within 8" of Joint:
Remarks:

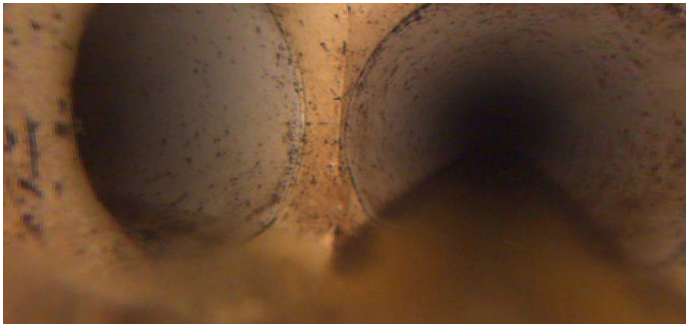
Code: **TF**
Description: **Tap Factory**

Distance (ft): **174.8**
Structural Grade: **0**
O&M Grade: **0**
Clock Start/From: **9**
Clock To:
1st Value: **4.000**
2nd Value:
Value Percent:
Continuous Index:
Within 8" of Joint:
Remarks:

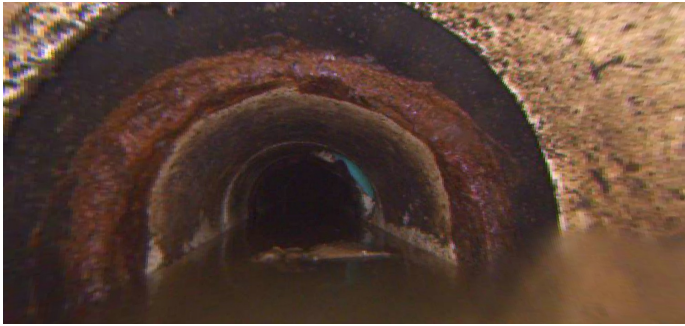
Code: **JSL**
Description: **Joint Separated Large**

Distance (ft): **184.2**
Structural Grade: **2**
O&M Grade: **0**
Clock Start/From:
Clock To:
1st Value:
2nd Value:
Value Percent:
Continuous Index:
Within 8" of Joint: **NO**
Remarks:

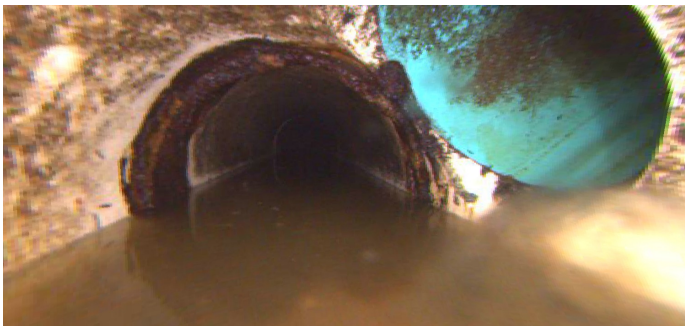
Code: **TF**
Description: **Tap Factory**

Distance (ft): **185.2**
Structural Grade: **0**
O&M Grade: **0**
Clock Start/From: **2**
Clock To:
1st Value: **6.000**
2nd Value:
Value Percent:
Continuous Index:
Within 8" of Joint:
Remarks:

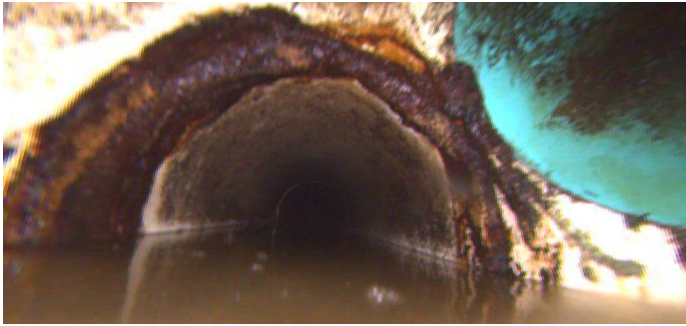
Code: **DAE**
Description: **Deposits Attached Encrustation**

Distance (ft): **185.4**
Structural Grade: **0**
O&M Grade: **2**
Clock Start/From: **7**
Clock To: **5**
1st Value:
2nd Value:
Value Percent: **5.000**
Continuous Index:
Within 8" of Joint: **YES**
Remarks:

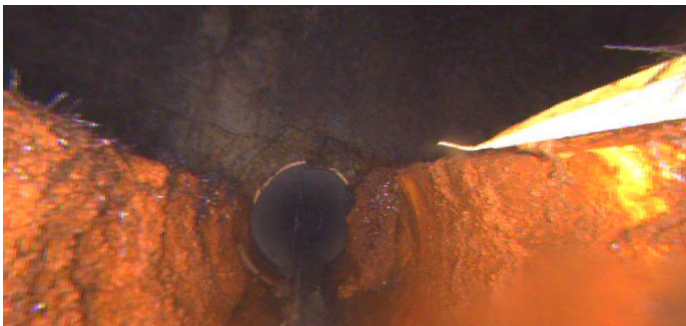
Code: **AMH**
Description: **Manhole**

Distance (ft): **282.6**
Structural Grade: **0**
O&M Grade: **0**
Clock Start/From:
Clock To:
1st Value:
2nd Value:
Value Percent:
Continuous Index:
Within 8" of Joint: **NO**
Remarks: **M-303-045.1**
