Profile/Photo Observation Report

Date:	09/26/2018	Weather:		Coding:	PACP 6.0
Pipe Length (ft):	329.7	Owner:	NA	Pre Clean:	Not Known
P.O.#:		Surveyor:	Justin Gonzales	PSR:	P-303-045.2-045.1
Customer:		Clean Date:	01/01/1900	Shape:	C

Street:	BROWN ST	Flow Control:	Not Controlled
City:	Hobart, IN	Year Renewed:	
Location:	Light Highway	Tape/Media #:	
Purpose:	Routine Assessment	Dia/Height:	10"
Use:	Sanitary	Material:	VCP
Drain Area:	NA	Lining:	
Category:	NA		
Comment:			
Location Details:		Direction of Survey:	Upstream
US MH:	M-303-045.1	DS MH:	M-303-045.2
		Total Length Surveyed (ft):	269.5

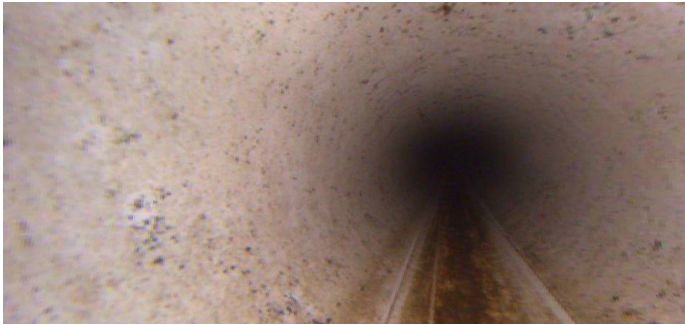
Code:	MWL
Description:	Water Level

Distance (ft):	.0
Structural Grade:	0
O&M Grade:	0
Clock Start/From:	
Clock To:	
1st Value:	
2nd Value:	
Value Percent:	5.000
Continuous Index:	
Within 8" of Joint:	NO
Remarks:

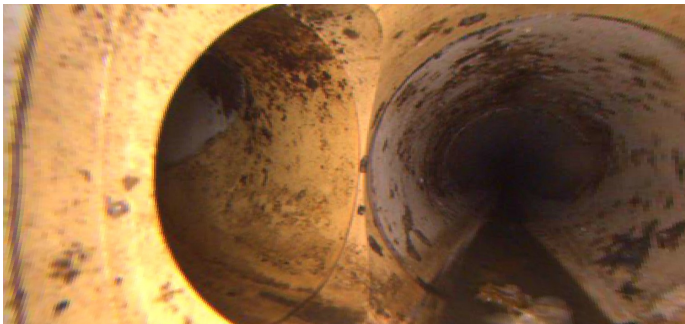
Code:	TF
Description:	Tap Factory

Distance (ft):	96.3
Structural Grade:	0
O&M Grade:	0
Clock Start/From:	9
Clock To:	
1st Value:	6.000
2nd Value:	
Value Percent:	
Continuous Index:	
Within 8" of Joint:	
Remarks:

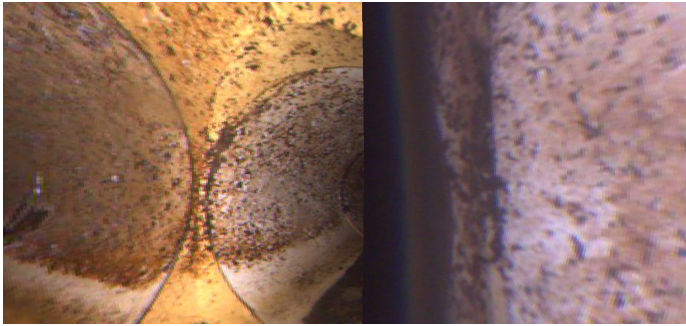
Code: **TF**
Description: **Tap Factory**

Distance (ft): **110.7**
Structural Grade: **0**
O&M Grade: **0**
Clock Start/From: **3**
Clock To:
1st Value: **6.000**
2nd Value:
Value Percent:
Continuous Index:
Within 8" of Joint:
Remarks:

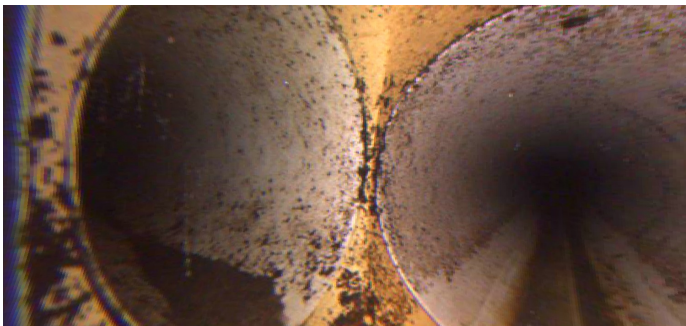
Code: **TF**
Description: **Tap Factory**

Distance (ft): **177.6**
Structural Grade: **0**
O&M Grade: **0**
Clock Start/From: **9**
Clock To:
1st Value: **6.000**
2nd Value:
Value Percent:
Continuous Index:
Within 8" of Joint:
Remarks:

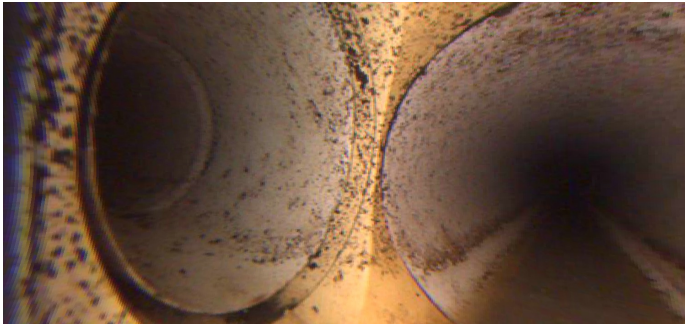
Code: **TF**
Description: **Tap Factory**

Distance (ft): **223.1**
Structural Grade: **0**
O&M Grade: **0**
Clock Start/From: **9**
Clock To:
1st Value: **6.000**
2nd Value:
Value Percent:
Continuous Index:
Within 8" of Joint:
Remarks:

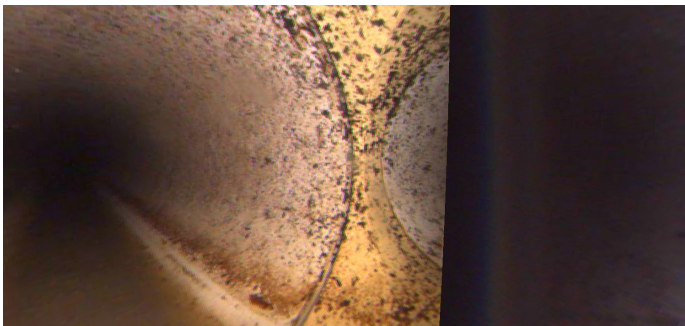
Code: **TF**
Description: **Tap Factory**

Distance (ft): **229.1**
Structural Grade: **0**
O&M Grade: **0**
Clock Start/From: **3**
Clock To:
1st Value: **4.000**
2nd Value:
Value Percent:
Continuous Index:
Within 8" of Joint:
Remarks:

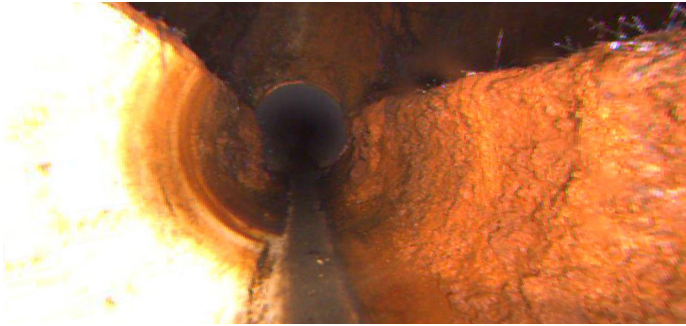
Code: **AMH**
Description: **Manhole**

Distance (ft): **269.5**
Structural Grade: **0**
O&M Grade: **0**
Clock Start/From:
Clock To:
1st Value:
2nd Value:
Value Percent:
Continuous Index:
Within 8" of Joint: **NO**
Remarks: **M-303-045.1**
