## Profile/Photo Observation Report

Street:	<b>ALLEY BETWEEN W 37TH AVE &amp; W 3</b>	Flow Control:	<b>Not Controlled</b>
City:	<b>Hobart, IN</b>	Year Renewed:	
Location:	<b>Other</b>	Tape/Media #:	
Purpose:	<b>Not Known</b>	Dia/Height:	<b>10"</b>
Use:	<b>Sanitary</b>	Material:	<b>VCP</b>
Drain Area:	<b>NA</b>	Lining:	
Category:	<b>NA</b>		
Comment:

Location Details:		Direction of Survey:	<b>Downstream</b>
US MH:	<b>M-303-049</b>	DS MH:	<b>M-303-048</b>
		Total Length Surveyed (ft):	<b>223.9</b>

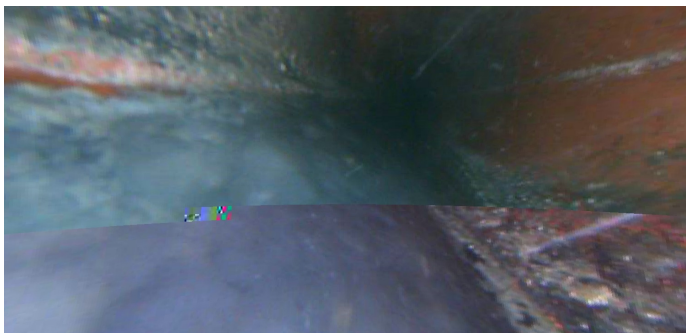
Code: **AMH**  
Description: **Manhole**

Distance (ft): **.0**  
Structural Grade: **0**  
O&M Grade: **0**  
Clock Start/From:  
Clock To:  
1st Value:  
2nd Value:  
Value Percent:  
Continuous Index:  
Within 8" of Joint: **NO**  
Remarks: **M-303-049**

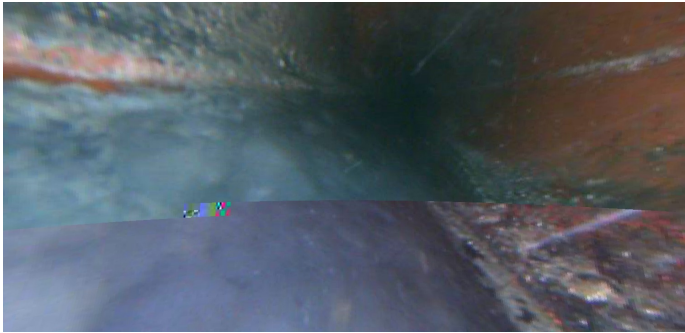
Code:	<b>MWL</b>
Description:	<b>Water Level</b>

Distance (ft):	<b>.0</b>
Structural Grade:	<b>0</b>
O&M Grade:	<b>0</b>
Clock Start/From:	
Clock To:	
1st Value:	
2nd Value:	
Value Percent:	<b>5.000</b>
Continuous Index:	
Within 8" of Joint:	<b>NO</b>
Remarks:

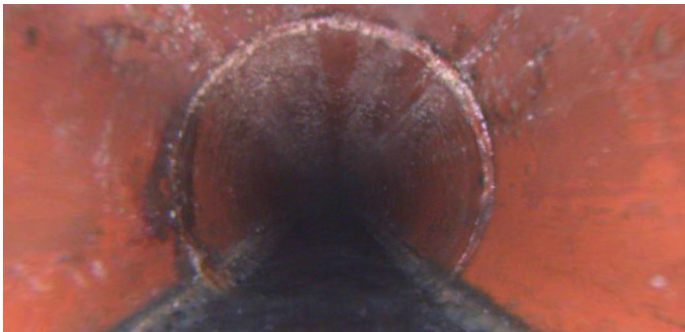
Code:	<b>IW</b>
Description:	<b>Infil Weeper</b>

Distance (ft):	<b>23.6</b>
Structural Grade:	<b>0</b>
O&M Grade:	<b>2</b>
Clock Start/From:	<b>8</b>
Clock To:	<b>4</b>
1st Value:	
2nd Value:	
Value Percent:	
Continuous Index:	
Within 8" of Joint:	<b>YES</b>
Remarks:

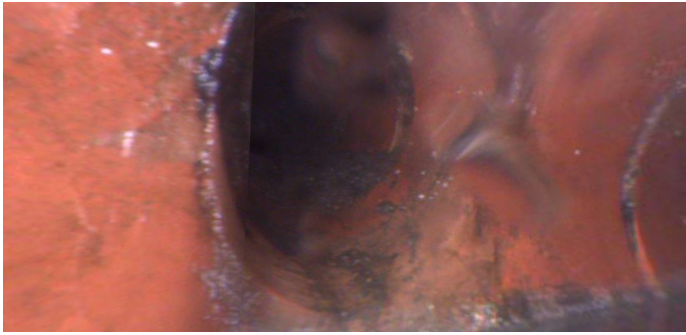
Code: **TFA**  
Description: **Tap Factory Active**

Distance (ft): **99.8**  
Structural Grade: **0**  
O&M Grade: **0**  
Clock Start/From: **3**  
Clock To:  
1st Value: **4.000**  
2nd Value:  
Value Percent:  
Continuous Index:  
Within 8" of Joint:  
Remarks:

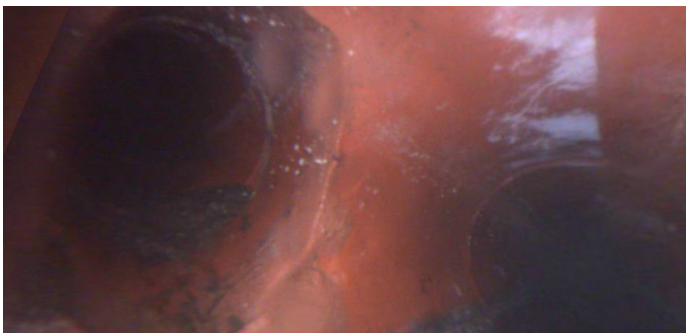
Code: **TF**  
Description: **Tap Factory**

Distance (ft): **101.4**  
Structural Grade: **0**  
O&M Grade: **0**  
Clock Start/From: **9**  
Clock To:  
1st Value: **4.000**  
2nd Value:  
Value Percent:  
Continuous Index:  
Within 8" of Joint:  
Remarks:

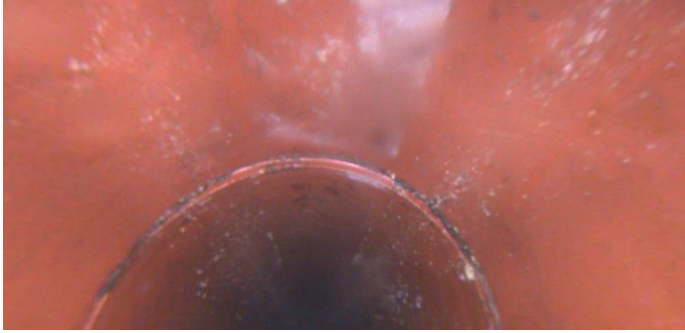
Code: **CL**  
Description: **Crack Longitudinal**

Distance (ft): **102.3**  
Structural Grade: **2**  
O&M Grade: **0**  
Clock Start/From: **12**  
Clock To:  
1st Value:  
2nd Value:  
Value Percent:  
Continuous Index:  
Within 8" of Joint: **YES**  
Remarks:

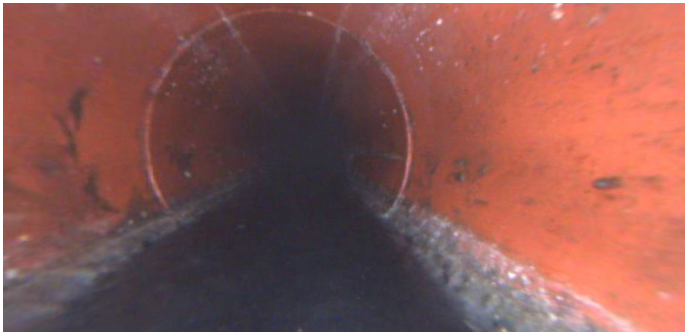
Code: **DAGS**  
Description: **Deposits Attached Grease**

Distance (ft): **107.1**  
Structural Grade: **0**  
O&M Grade: **2**  
Clock Start/From: **8**  
Clock To: **4**  
1st Value:  
2nd Value:  
Value Percent: **5.000**  
Continuous Index: **S01**  
Within 8" of Joint: **NO**  
Remarks:

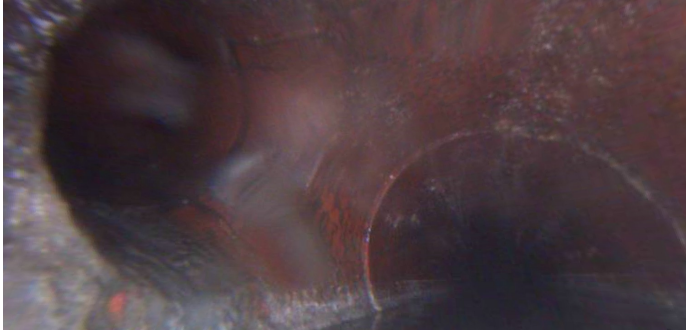
Code: **TF**  
Description: **Tap Factory**

Distance (ft): **174.2**  
Structural Grade: **0**  
O&M Grade: **0**  
Clock Start/From: **3**  
Clock To:  
1st Value: **4.000**  
2nd Value:  
Value Percent:  
Continuous Index:  
Within 8" of Joint:  
Remarks:

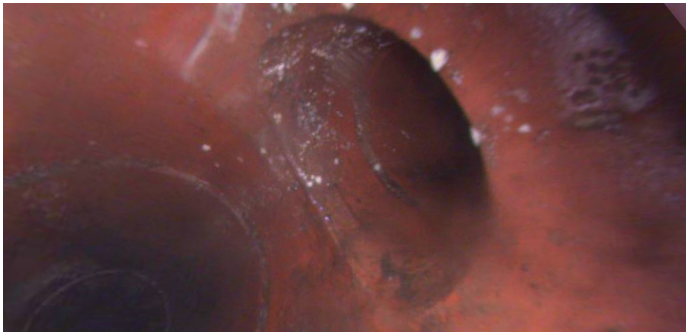
Code: **TF**  
Description: **Tap Factory**

Distance (ft): **176.2**  
Structural Grade: **0**  
O&M Grade: **0**  
Clock Start/From: **10**  
Clock To:  
1st Value: **4.000**  
2nd Value:  
Value Percent:  
Continuous Index:  
Within 8" of Joint:  
Remarks:

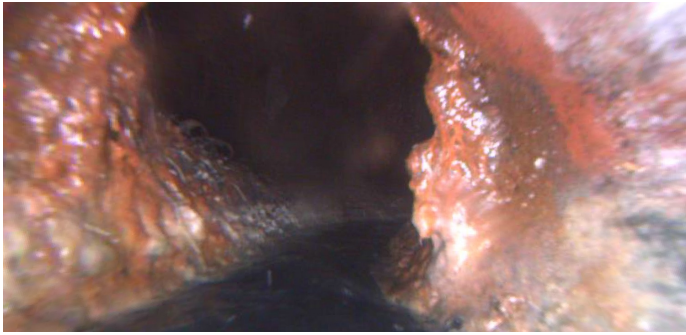
Code: **DAGS**  
Description: **Deposits Attached Grease**

Distance (ft): **221.6**  
Structural Grade: **0**  
O&M Grade: **2**  
Clock Start/From: **8**  
Clock To: **4**  
1st Value:  
2nd Value:  
Value Percent: **5.000**  
Continuous Index: **F01**  
Within 8" of Joint: **NO**  
Remarks:

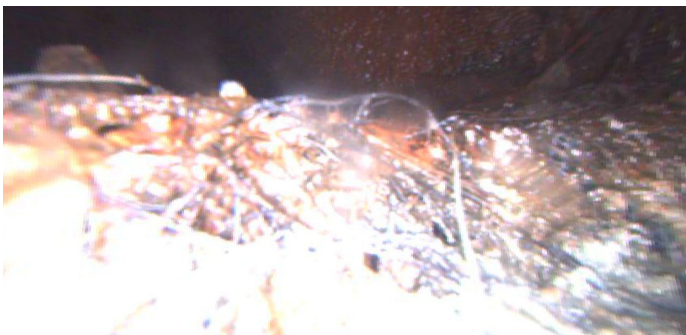
Code: **AMH**  
Description: **Manhole**

Distance (ft): **223.9**  
Structural Grade: **0**  
O&M Grade: **0**  
Clock Start/From:  
Clock To:  
1st Value:  
2nd Value:  
Value Percent:  
Continuous Index:  
Within 8" of Joint: **NO**  
Remarks: **M-303-048**
