Profile/Photo Observation Report

Street:	ALLEY BETWEEN W 37TH AVE & W 3	Flow Control:	Not Controlled
City:	Hobart, IN	Year Renewed:	
Location:	Light Highway	Tape/Media #:	
Purpose:	Routine Assessment	Dia/Height:	10"
Use:	Sanitary	Material:	VCP
Drain Area:	NA	Lining:	
Category:	NA		
Comment:

Location Details:		Direction of Survey:	Upstream
US MH:	M-303-050	DS MH:	M-303-049
		Total Length Surveyed (ft):	7.5

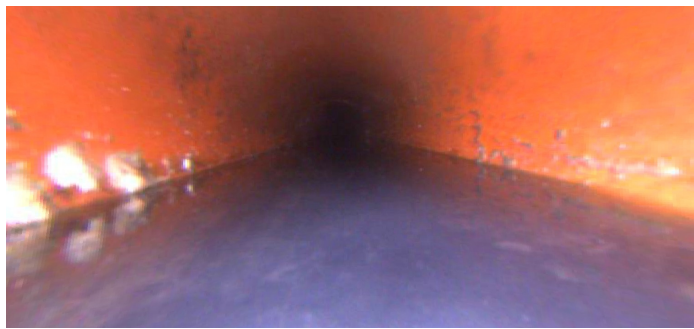
Code: **AMH**
Description: **Manhole**

Distance (ft): **.0**
Structural Grade: **0**
O&M Grade: **0**
Clock Start/From:
Clock To:
1st Value:
2nd Value:
Value Percent:
Continuous Index:
Within 8" of Joint: **NO**
Remarks: **M-303-049**

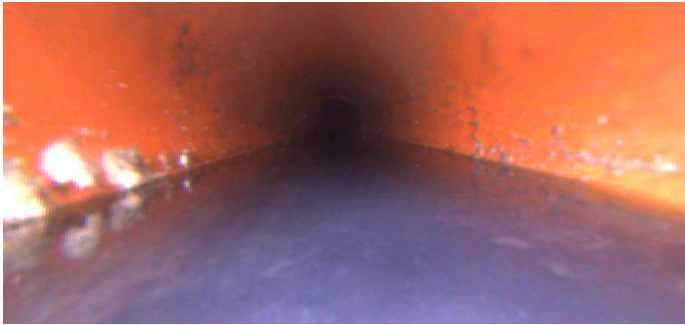
Code:	MWL
Description:	Water Level

Distance (ft):	.0
Structural Grade:	0
O&M Grade:	0
Clock Start/From:	
Clock To:	
1st Value:	
2nd Value:	
Value Percent:	5.000
Continuous Index:	
Within 8" of Joint:	NO
Remarks:

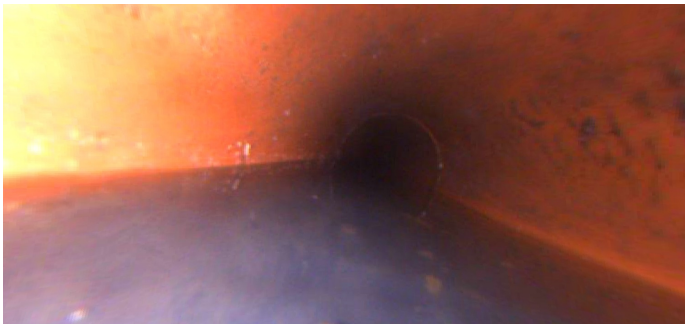
Code:	MSA
Description:	Abandoned Survey

Distance (ft):	7.5
Structural Grade:	0
O&M Grade:	0
Clock Start/From:	
Clock To:	
1st Value:	
2nd Value:	
Value Percent:	
Continuous Index:	
Within 8" of Joint:	NO
Remarks:	cAMERA STOPPPED
