Profile/Photo Observation Report

Date:	03/27/2018	Weather:		Coding:	PACP 6.0
Pipe Length (ft):	372.6	Owner:	NA	Pre Clean:	Not Known
P.O.#:		Surveyor:	JUSTIN GONZALES	PSR:	P-303-053-052
Customer:		Clean Date:	01/01/1900	Shape:	C

Street:	ALLEY BETWEEN N LIVERPOOL RD &	Flow Control:	Not Controlled
City:	Hobart, IN	Year Renewed:	
Location:	Other	Tape/Media #:	
Purpose:	Not Known	Dia/Height:	10"
Use:	Sanitary	Material:	VCP
Drain Area:	NA	Lining:	
Category:	NA		
Comment:

Location Details:		Direction of Survey:	Downstream
US MH:	M-303-052	DS MH:	M-303-053
		Total Length Surveyed (ft):	368.1

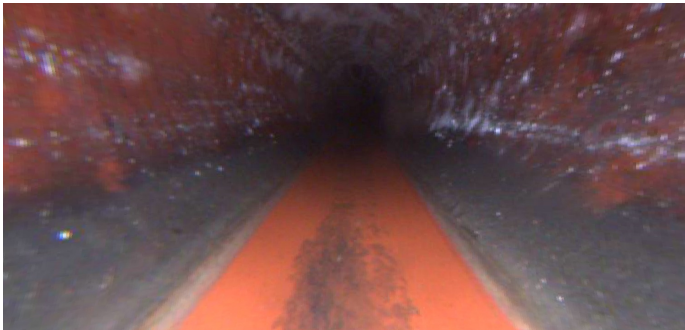
Code: **MWL**
Description: **Water Level**

Distance (ft): **.0**
Structural Grade: **0**
O&M Grade: **0**
Clock Start/From:
Clock To:
1st Value:
2nd Value:
Value Percent: **5.000**
Continuous Index:
Within 8" of Joint: **NO**
Remarks:

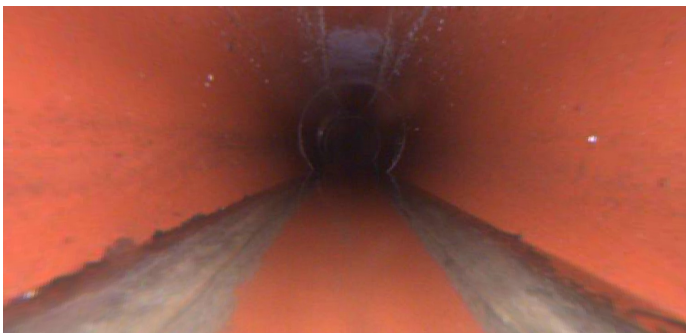
Code: **MGO**
Description: **General Observation**

Distance (ft): **64.3**
Structural Grade: **0**
O&M Grade: **0**
Clock Start/From:
Clock To:
1st Value:
2nd Value:
Value Percent:
Continuous Index:
Within 8" of Joint: **NO**
Remarks: **FRONT CAMERA FUNCTIONAL**

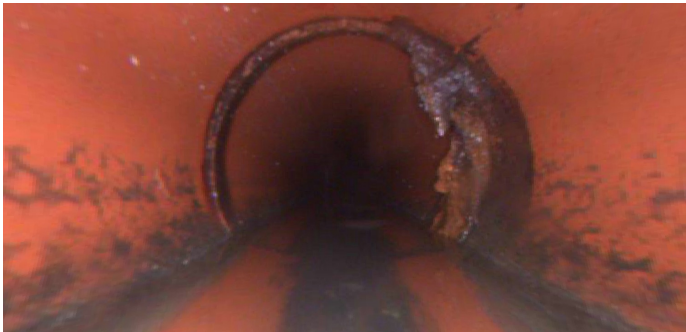
Code: **IS**
Description: **Infil Stain**

Distance (ft): **97.6**
Structural Grade: **0**
O&M Grade: **0**
Clock Start/From: **7**
Clock To: **1**
1st Value:
2nd Value:
Value Percent:
Continuous Index:
Within 8" of Joint: **YES**
Remarks:

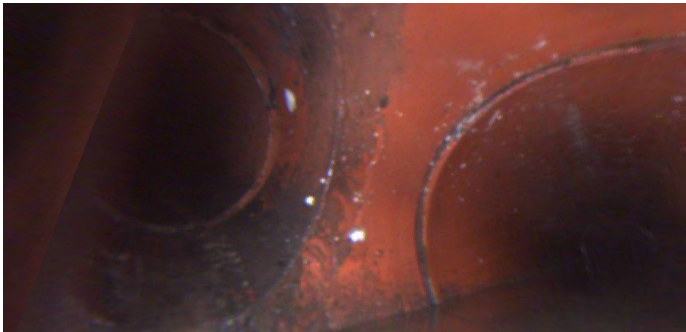
Code: **TF**
Description: **Tap Factory**

Distance (ft): **109.9**
Structural Grade: **0**
O&M Grade: **0**
Clock Start/From: **9**
Clock To:
1st Value: **4.000**
2nd Value:
Value Percent:
Continuous Index:
Within 8" of Joint:
Remarks:

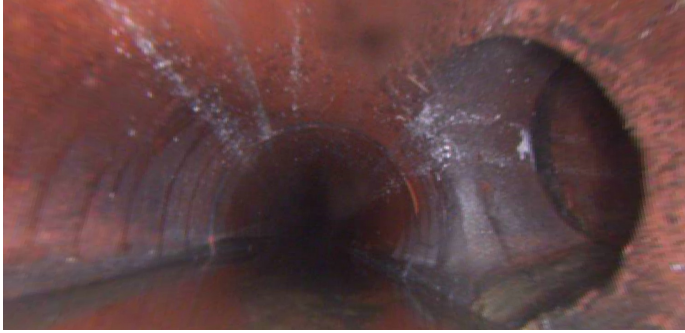
Code: **TF**
Description: **Tap Factory**

Distance (ft): **116.6**
Structural Grade: **0**
O&M Grade: **0**
Clock Start/From: **3**
Clock To:
1st Value: **4.000**
2nd Value:
Value Percent:
Continuous Index:
Within 8" of Joint:
Remarks:

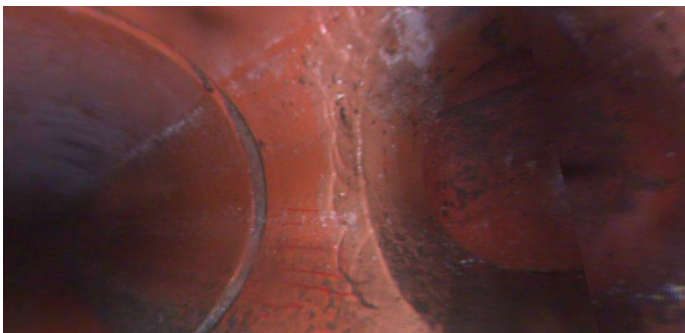
Code: **TFC**
Description: **Tap Factory Capped**

Distance (ft): **159.6**
Structural Grade: **0**
O&M Grade: **0**
Clock Start/From: **3**
Clock To:
1st Value: **4.000**
2nd Value:
Value Percent:
Continuous Index:
Within 8" of Joint:
Remarks:

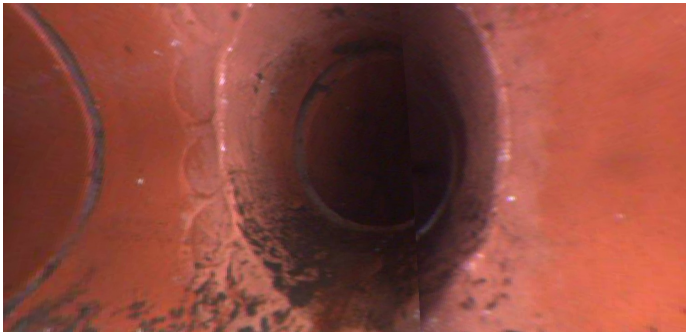
Code: **TF**
Description: **Tap Factory**

Distance (ft): **198.4**
Structural Grade: **0**
O&M Grade: **0**
Clock Start/From: **3**
Clock To:
1st Value: **4.000**
2nd Value:
Value Percent:
Continuous Index:
Within 8" of Joint:
Remarks:

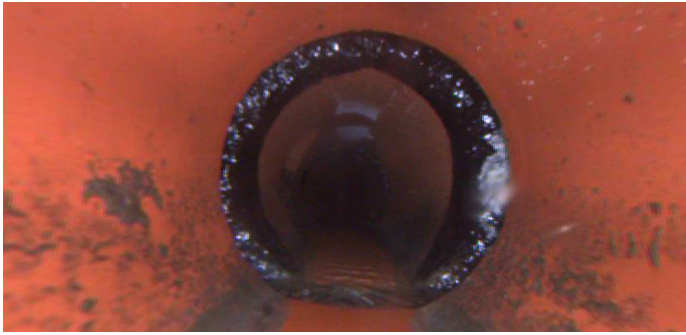
Code: **IW**
Description: **Infil Weeper**

Distance (ft): **233.3**
Structural Grade: **0**
O&M Grade: **2**
Clock Start/From: **7**
Clock To: **5**
1st Value:
2nd Value:
Value Percent:
Continuous Index:
Within 8" of Joint: **YES**
Remarks:

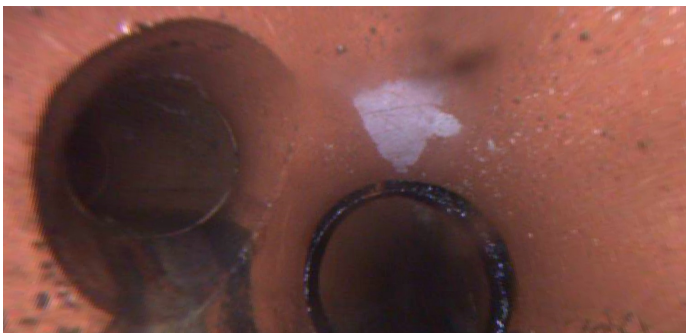
Code: **TF**
Description: **Tap Factory**

Distance (ft): **234.8**
Structural Grade: **0**
O&M Grade: **0**
Clock Start/From: **9**
Clock To:
1st Value: **4.000**
2nd Value:
Value Percent:
Continuous Index:
Within 8" of Joint:
Remarks:

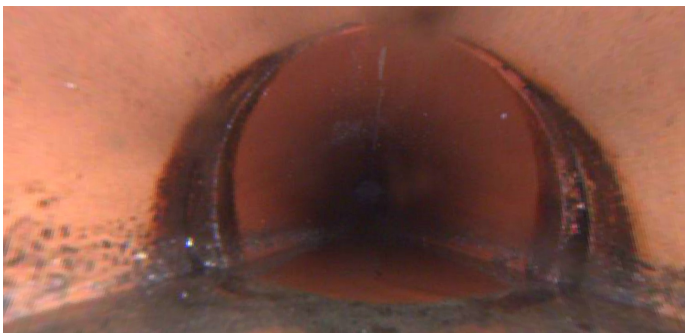
Code: **IW**
Description: **Infil Weeper**

Distance (ft): **240.4**
Structural Grade: **0**
O&M Grade: **2**
Clock Start/From: **7**
Clock To: **5**
1st Value:
2nd Value:
Value Percent:
Continuous Index:
Within 8" of Joint: **YES**
Remarks:

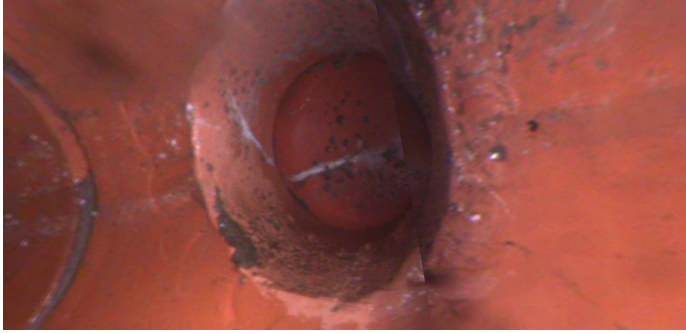
Code: **TFC**
Description: **Tap Factory Capped**

Distance (ft): **272.2**
Structural Grade: **0**
O&M Grade: **0**
Clock Start/From: **2**
Clock To:
1st Value: **4.000**
2nd Value:
Value Percent:
Continuous Index:
Within 8" of Joint:
Remarks:

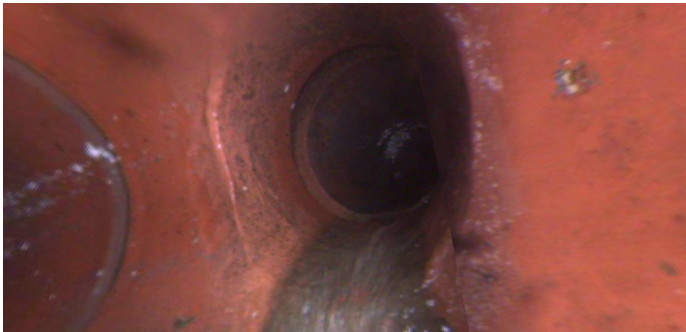
Code: **TF**
Description: **Tap Factory**

Distance (ft): **304.2**
Structural Grade: **0**
O&M Grade: **0**
Clock Start/From: **2**
Clock To:
1st Value: **4.000**
2nd Value:
Value Percent:
Continuous Index:
Within 8" of Joint:
Remarks:

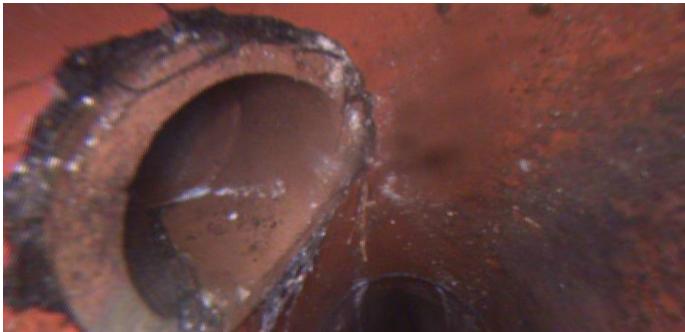
Code: **TBD**
Description: **Tap Break-in Defective**

Distance (ft): **308.7**
Structural Grade: **0**
O&M Grade: **3**
Clock Start/From: **10**
Clock To:
1st Value: **4.000**
2nd Value:
Value Percent:
Continuous Index:
Within 8" of Joint:
Remarks: **ROOTS SURROUNDING OUTSIDE OF TAP BREAK-IN**

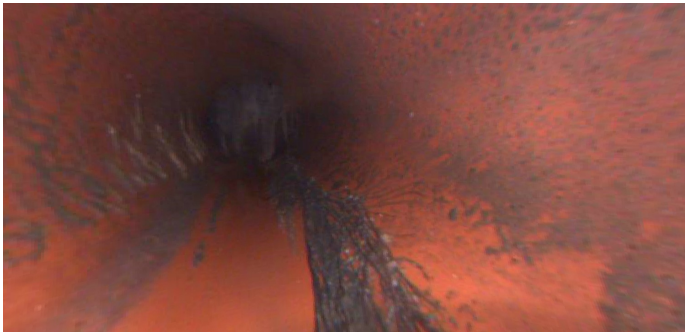
Code: **RFB**
Description: **Roots Fine Barrel**

Distance (ft): **364.3**
Structural Grade: **0**
O&M Grade: **2**
Clock Start/From: **5**
Clock To:
1st Value:
2nd Value:
Value Percent:
Continuous Index:
Within 8" of Joint: **NO**
Remarks:

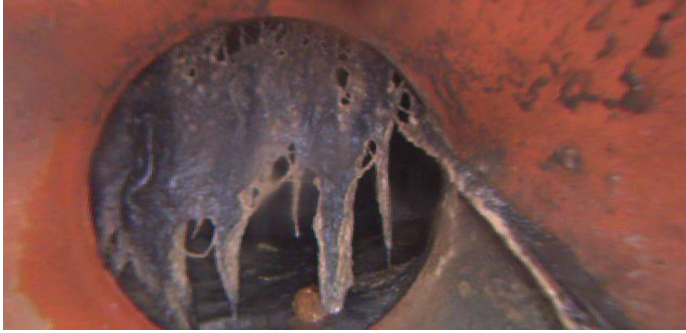
Code: **RMJ**
Description: **Roots Medium Joint**

Distance (ft): **366.4**
Structural Grade: **0**
O&M Grade: **3**
Clock Start/From: **7**
Clock To: **3**
1st Value:
2nd Value:
Value Percent: **50.000**
Continuous Index:
Within 8" of Joint: **YES**
Remarks:

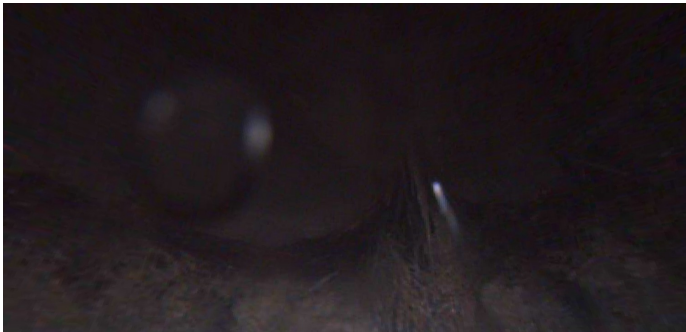
Code: **AMH**
Description: **Manhole**

Distance (ft): **368.1**
Structural Grade: **0**
O&M Grade: **0**
Clock Start/From:
Clock To:
1st Value:
2nd Value:
Value Percent:
Continuous Index:
Within 8" of Joint: **NO**
Remarks: **M-303-053**

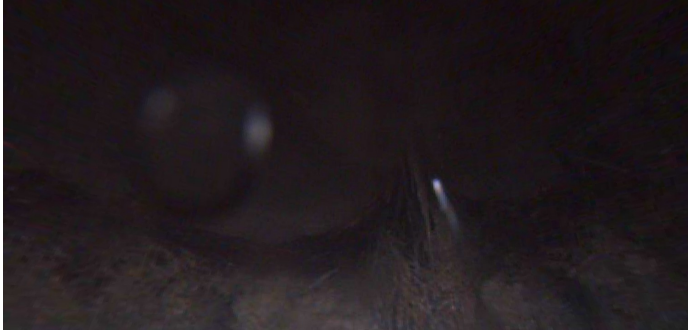
Code:	DAGS
Description:	Deposits Attached Grease
Distance (ft):	368.1
Structural Grade:	0
O&M Grade:	2
Clock Start/From:	7
Clock To:	5
1st Value:	
2nd Value:	
Value Percent:	5.000
Continuous Index:	F01
Within 8" of Joint:	YES
Remarks:	WANDER
