Profile/Photo Observation Report

Date:	04/04/2018	Weather:		Coding:	PACP 6.0
Pipe Length (ft):	204.2	Owner:	NA	Pre Clean:	Not Known
P.O.#:		Surveyor:	Jen Costello	PSR:	P-303-058-059
Customer:		Clean Date:	01/01/1900	Shape:	C

Street:	w hansen blvd	Flow Control:	Not Controlled
City:	Hobart, IN	Year Renewed:	
Location:	Other	Tape/Media #:	
Purpose:	Not Known	Dia/Height:	10"
Use:	Sanitary	Material:	PVC
Drain Area:	NA	Lining:	
Category:	NA		
Comment:

Location Details:		Direction of Survey:	Downstream
US MH:	M-303-059	DS MH:	M-303-058
		Total Length Surveyed (ft):	200.6

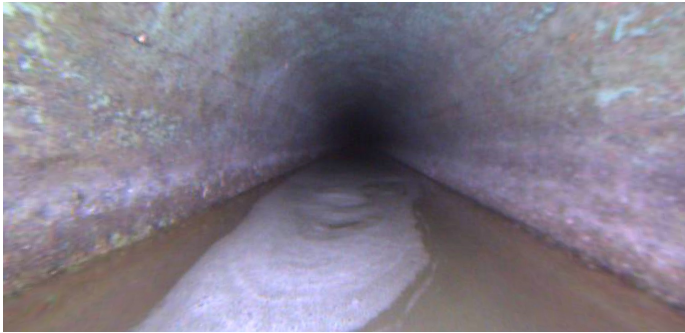
Code:	MWL
Description:	Water Level

Distance (ft):	.0
Structural Grade:	0
O&M Grade:	0
Clock Start/From:	
Clock To:	
1st Value:	
2nd Value:	
Value Percent:	30.000
Continuous Index:	
Within 8" of Joint:	NO
Remarks:

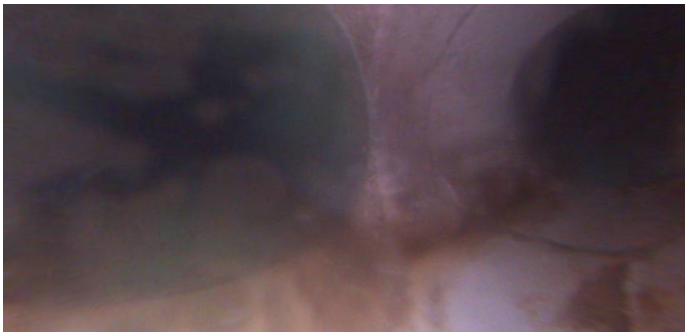
Code:	TFA
Description:	Tap Factory Active

Distance (ft):	75.9
Structural Grade:	0
O&M Grade:	0
Clock Start/From:	3
Clock To:	
1st Value:	4.000
2nd Value:	
Value Percent:	
Continuous Index:	
Within 8" of Joint:	
Remarks:

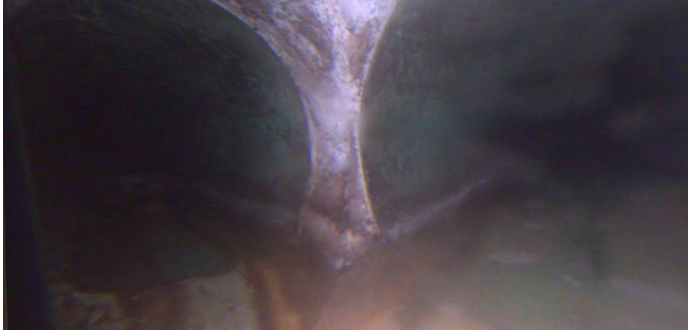
Code: **TFA**
Description: **Tap Factory Active**

Distance (ft): **89.2**
Structural Grade: **0**
O&M Grade: **0**
Clock Start/From: **9**
Clock To:
1st Value: **4.000**
2nd Value:
Value Percent:
Continuous Index:
Within 8" of Joint:
Remarks:

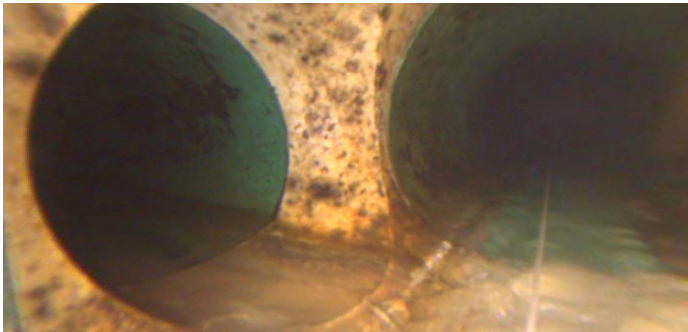
Code: **TFA**
Description: **Tap Factory Active**

Distance (ft): **152.7**
Structural Grade: **0**
O&M Grade: **0**
Clock Start/From: **3**
Clock To:
1st Value: **4.000**
2nd Value:
Value Percent:
Continuous Index:
Within 8" of Joint:
Remarks:

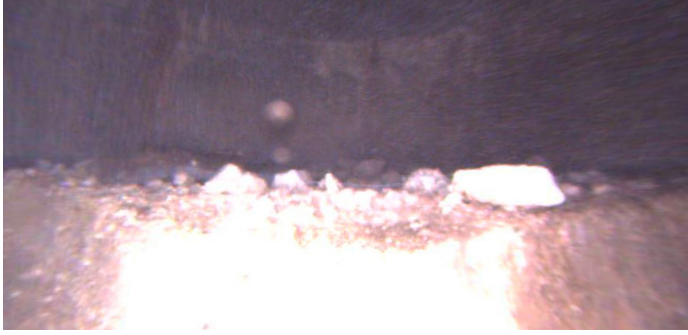
Code:	AMH
Description:	Manhole
Distance (ft):	200.6
Structural Grade:	0
O&M Grade:	0
Clock Start/From:	
Clock To:	
1st Value:	
2nd Value:	
Value Percent:	
Continuous Index:	
Within 8" of Joint:	NO
Remarks:	M-303-058
