## Profile/Photo Observation Report

Street:	<b>W HANSEN BLVD</b>	Flow Control:	<b>Not Controlled</b>
City:	<b>Hobart, IN</b>	Year Renewed:	
Location:	<b>Other</b>	Tape/Media #:	
Purpose:	<b>Not Known</b>	Dia/Height:	<b>10"</b>
Use:	<b>Sanitary</b>	Material:	<b>PVC</b>
Drain Area:	<b>NA</b>	Lining:	
Category:	<b>NA</b>		
Comment:

Location Details:		Direction of Survey:	<b>Upstream</b>
US MH:	<b>M-303-060</b>	DS MH:	<b>M-303-061</b>
		Total Length Surveyed (ft):	<b>277.8</b>

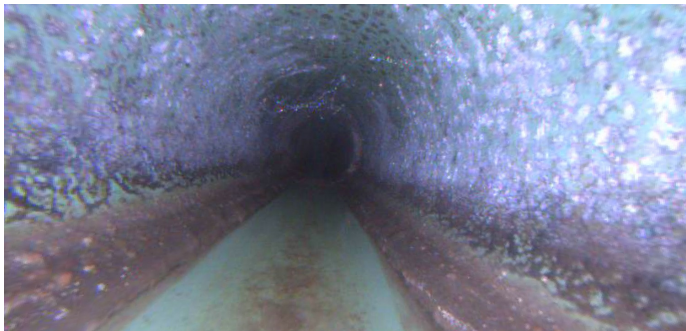
Code: **AMH**  
Description: **Manhole**

Distance (ft): **.0**  
Structural Grade: **0**  
O&M Grade: **0**  
Clock Start/From:  
Clock To:  
1st Value:  
2nd Value:  
Value Percent:  
Continuous Index:  
Within 8" of Joint: **NO**  
Remarks: **M-303-061**

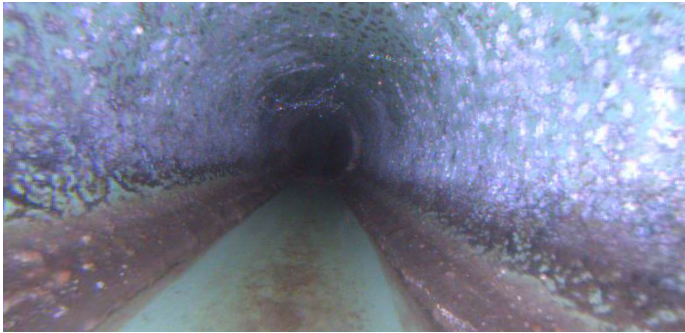
Code:	<b>MWL</b>
Description:	<b>Water Level</b>

Distance (ft):	<b>.0</b>
Structural Grade:	<b>0</b>
O&M Grade:	<b>0</b>
Clock Start/From:	
Clock To:	
1st Value:	
2nd Value:	
Value Percent:	<b>5.000</b>
Continuous Index:	
Within 8" of Joint:	<b>NO</b>
Remarks:

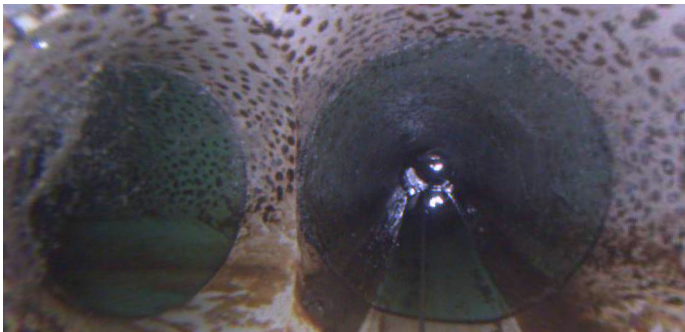
Code:	<b>TF</b>
Description:	<b>Tap Factory</b>

Distance (ft):	<b>3.7</b>
Structural Grade:	<b>0</b>
O&M Grade:	<b>0</b>
Clock Start/From:	<b>3</b>
Clock To:	
1st Value:	<b>4.000</b>
2nd Value:	
Value Percent:	
Continuous Index:	
Within 8" of Joint:	
Remarks:

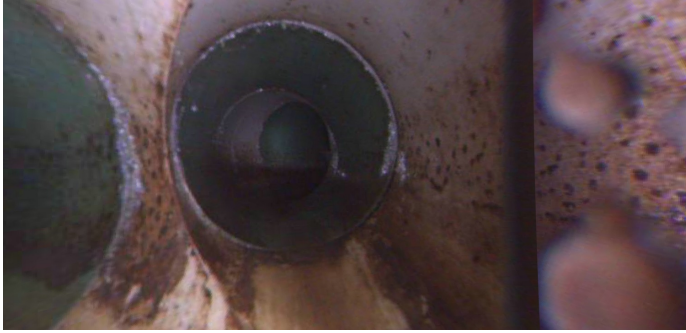
Code: **TF**  
Description: **Tap Factory**

Distance (ft): **34.6**  
Structural Grade: **0**  
O&M Grade: **0**  
Clock Start/From: **9**  
Clock To:  
1st Value: **4.000**  
2nd Value:  
Value Percent:  
Continuous Index:  
Within 8" of Joint:  
Remarks:

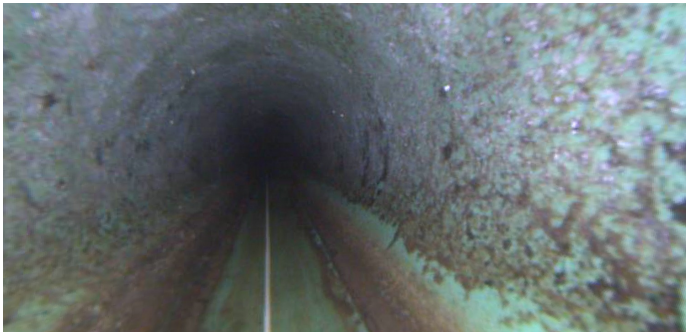
Code: **MGO**  
Description: **General Observation**

Distance (ft): **92.8**  
Structural Grade: **0**  
O&M Grade: **0**  
Clock Start/From:  
Clock To:  
1st Value:  
2nd Value:  
Value Percent:  
Continuous Index:  
Within 8" of Joint: **NO**  
Remarks: **REAR CAMERA**

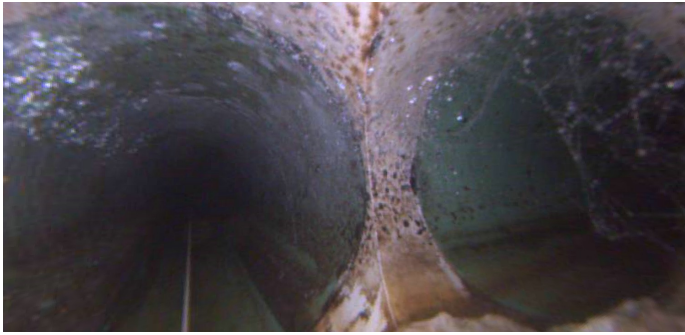
Code: **TFA**  
Description: **Tap Factory Active**

Distance (ft): **95.0**  
Structural Grade: **0**  
O&M Grade: **0**  
Clock Start/From: **9**  
Clock To:  
1st Value: **4.000**  
2nd Value:  
Value Percent:  
Continuous Index:  
Within 8" of Joint:  
Remarks:

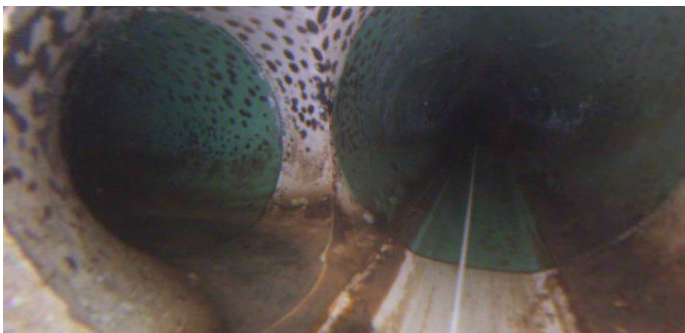
Code: **TFA**  
Description: **Tap Factory Active**

Distance (ft): **98.6**  
Structural Grade: **0**  
O&M Grade: **0**  
Clock Start/From: **3**  
Clock To:  
1st Value: **4.000**  
2nd Value:  
Value Percent:  
Continuous Index:  
Within 8" of Joint:  
Remarks:

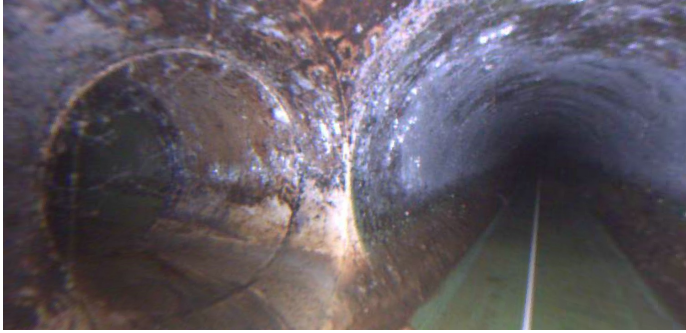
Code: **TFA**  
Description: **Tap Factory Active**

Distance (ft): **162.2**  
Structural Grade: **0**  
O&M Grade: **0**  
Clock Start/From: **3**  
Clock To:  
1st Value: **4.000**  
2nd Value:  
Value Percent:  
Continuous Index:  
Within 8" of Joint:  
Remarks:

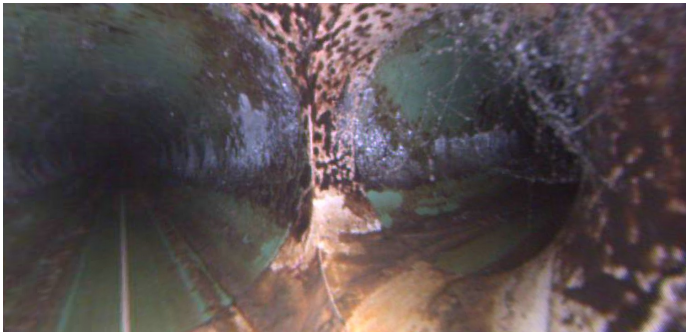
Code: **TFA**  
Description: **Tap Factory Active**

Distance (ft): **175.3**  
Structural Grade: **0**  
O&M Grade: **0**  
Clock Start/From: **9**  
Clock To:  
1st Value: **4.000**  
2nd Value:  
Value Percent:  
Continuous Index:  
Within 8" of Joint:  
Remarks:

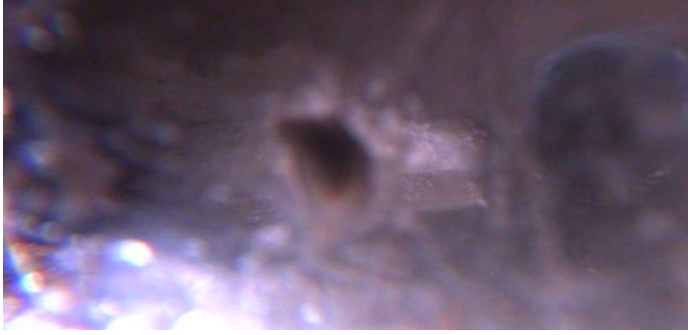
Code:	AMH
Description:	Manhole
Distance (ft):	277.8
Structural Grade:	0
O&M Grade:	0
Clock Start/From:	
Clock To:	
1st Value:	
2nd Value:	
Value Percent:	
Continuous Index:	
Within 8" of Joint:	NO
Remarks:	M-303-060
