Profile/Photo Observation Report

Street:	W HANSEN BLVD	Flow Control:	Not Controlled
City:	Hobart, IN	Year Renewed:	
Location:	Other	Tape/Media #:	
Purpose:	Not Known	Dia/Height:	10"
Use:	Sanitary	Material:	PVC
Drain Area:	NA	Lining:	
Category:	NA		
Comment:

Location Details:		Direction of Survey:	Downstream
US MH:	M-303-061	DS MH:	M-303-062
		Total Length Surveyed (ft):	278.4

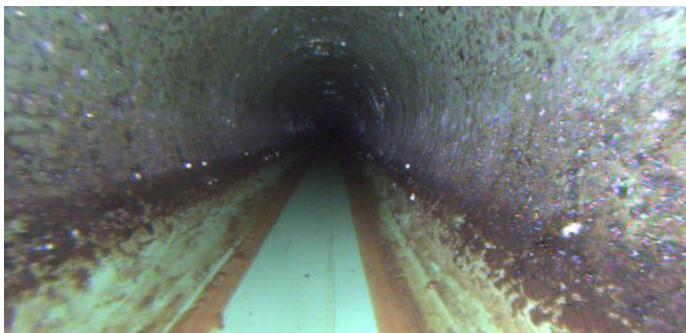
Code: **AMH**
Description: **Manhole**

Distance (ft): **.0**
Structural Grade: **0**
O&M Grade: **0**
Clock Start/From:
Clock To:
1st Value:
2nd Value:
Value Percent:
Continuous Index:
Within 8" of Joint: **NO**
Remarks: **M-303-061**

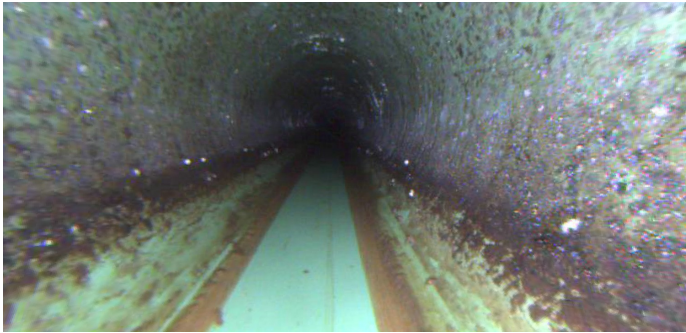
Code:	MWL
Description:	Water Level

Distance (ft):	.0
Structural Grade:	0
O&M Grade:	0
Clock Start/From:	
Clock To:	
1st Value:	
2nd Value:	
Value Percent:	5.000
Continuous Index:	
Within 8" of Joint:	NO
Remarks:

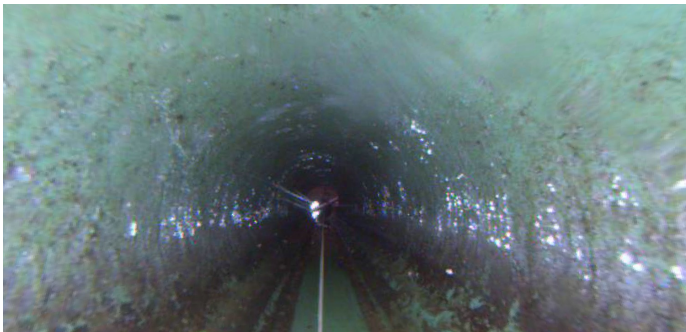
Code:	MGO
Description:	General Observation

Distance (ft):	6.0
Structural Grade:	0
O&M Grade:	0
Clock Start/From:	
Clock To:	
1st Value:	
2nd Value:	
Value Percent:	
Continuous Index:	
Within 8" of Joint:	NO
Remarks:	rear camera

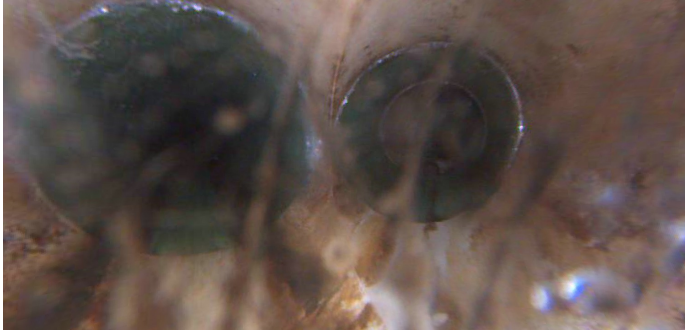
Code: **TF**
Description: **Tap Factory**

Distance (ft): **100.7**
Structural Grade: **0**
O&M Grade: **0**
Clock Start/From: **3**
Clock To:
1st Value: **4.000**
2nd Value:
Value Percent:
Continuous Index:
Within 8" of Joint:
Remarks:

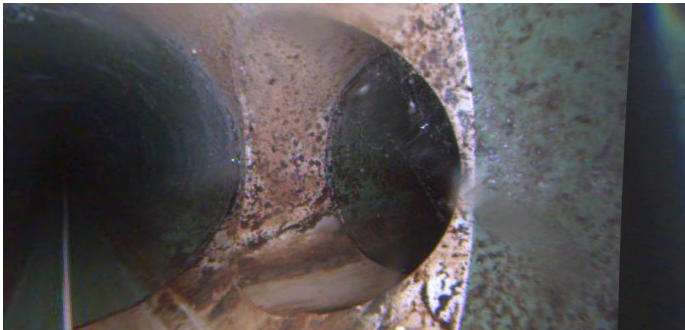
Code: **TF**
Description: **Tap Factory**

Distance (ft): **114.7**
Structural Grade: **0**
O&M Grade: **0**
Clock Start/From: **9**
Clock To:
1st Value: **4.000**
2nd Value:
Value Percent:
Continuous Index:
Within 8" of Joint:
Remarks:

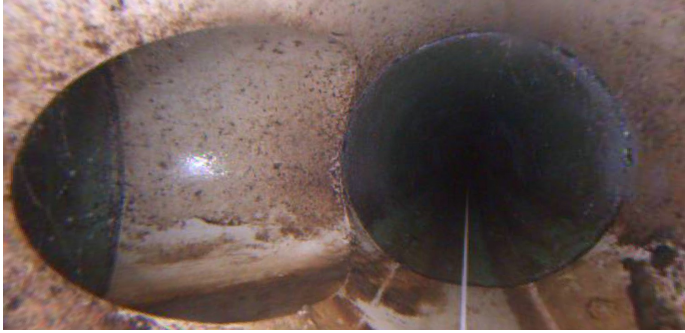
Code: **TFA**
Description: **Tap Factory Active**

Distance (ft): **165.5**
Structural Grade: **0**
O&M Grade: **0**
Clock Start/From: **3**
Clock To:
1st Value: **4.000**
2nd Value:
Value Percent:
Continuous Index:
Within 8" of Joint:
Remarks:

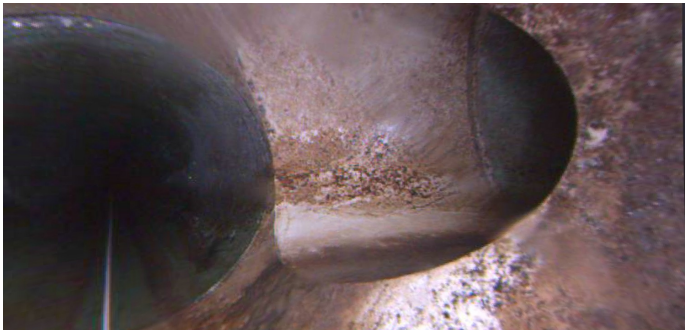
Code: **TFA**
Description: **Tap Factory Active**

Distance (ft): **178.7**
Structural Grade: **0**
O&M Grade: **0**
Clock Start/From: **9**
Clock To:
1st Value: **4.000**
2nd Value:
Value Percent:
Continuous Index:
Within 8" of Joint:
Remarks:

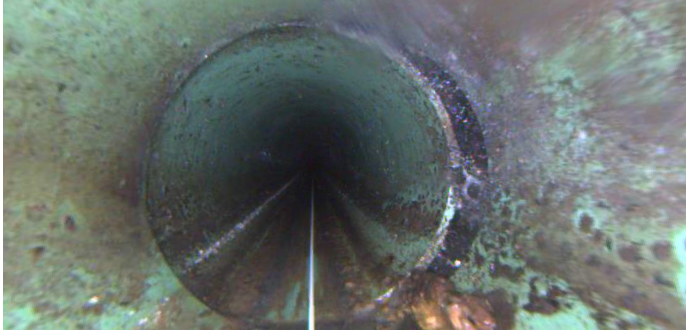
Code: **JOM**
Description: **Joint Offset Medium**

Distance (ft): **228.3**
Structural Grade: **1**
O&M Grade: **0**
Clock Start/From:
Clock To:
1st Value:
2nd Value:
Value Percent:
Continuous Index:
Within 8" of Joint: **NO**
Remarks:

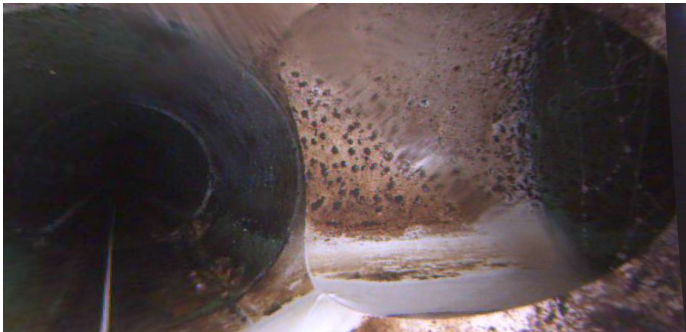
Code: **TFA**
Description: **Tap Factory Active**

Distance (ft): **229.3**
Structural Grade: **0**
O&M Grade: **0**
Clock Start/From: **9**
Clock To:
1st Value: **4.000**
2nd Value:
Value Percent:
Continuous Index:
Within 8" of Joint:
Remarks:

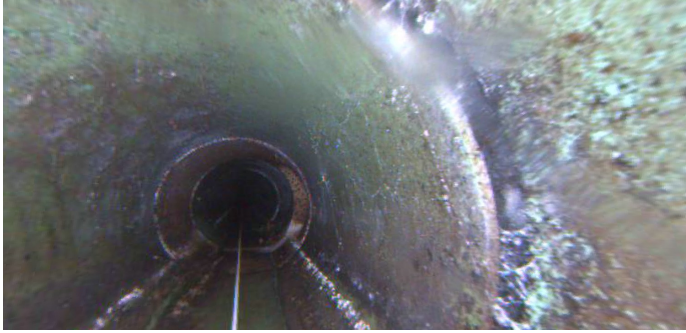
Code: **JOM**
Description: **Joint Offset Medium**

Distance (ft): **230.9**
Structural Grade: **1**
O&M Grade: **0**
Clock Start/From:
Clock To:
1st Value:
2nd Value:
Value Percent:
Continuous Index:
Within 8" of Joint: **NO**
Remarks:

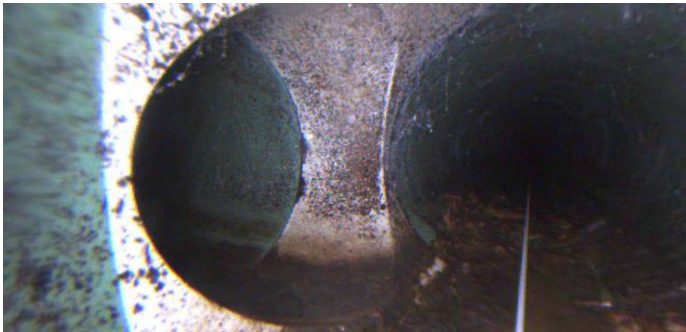
Code: **TFA**
Description: **Tap Factory Active**

Distance (ft): **242.0**
Structural Grade: **0**
O&M Grade: **0**
Clock Start/From: **3**
Clock To:
1st Value: **4.000**
2nd Value:
Value Percent:
Continuous Index:
Within 8" of Joint:
Remarks:

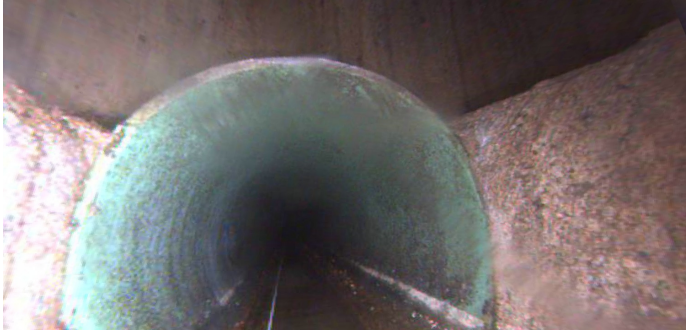
Code:	AMH
Description:	Manhole
Distance (ft):	277.8
Structural Grade:	0
O&M Grade:	0
Clock Start/From:	
Clock To:	
1st Value:	
2nd Value:	
Value Percent:	
Continuous Index:	
Within 8" of Joint:	NO
Remarks:	M-303-062
