Profile/Photo Observation Report

Street:	W HANSEN BLVD & S HANSEN BLVD	Flow Control:	Not Controlled
City:	Hobart, IN	Year Renewed:	
Location:	Other	Tape/Media #:	
Purpose:	Not Known	Dia/Height:	10"
Use:	Sanitary	Material:	PVC
Drain Area:	NA	Lining:	
Category:	NA		
Comment:

Location Details:		Direction of Survey:	Upstream
US MH:	M-303-063	DS MH:	M-303-059
		Total Length Surveyed (ft):	66.9

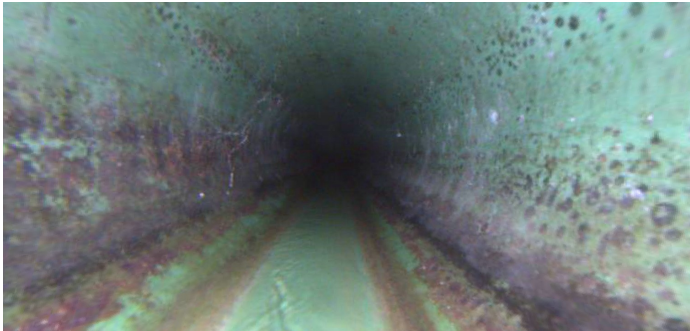
Code: AMH

Description: Manhole

Distance (ft): .0

Structural Grade: 0

O&M Grade: 0

Remarks: M-303-059

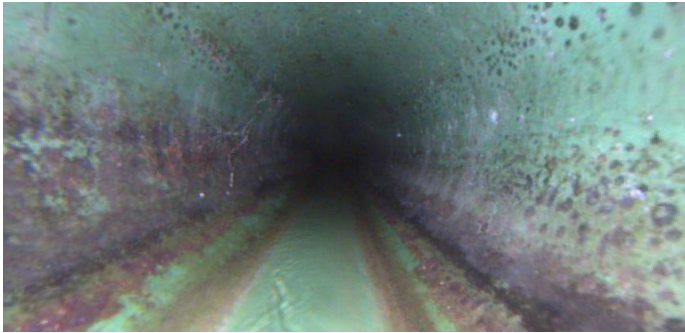
Code:	MWL
Description:	Water Level

Distance (ft):	.0
Structural Grade:	0
O&M Grade:	0
Clock Start/From:	
Clock To:	
1st Value:	
2nd Value:	
Value Percent:	5.000
Continuous Index:	
Within 8" of Joint:	NO
Remarks:

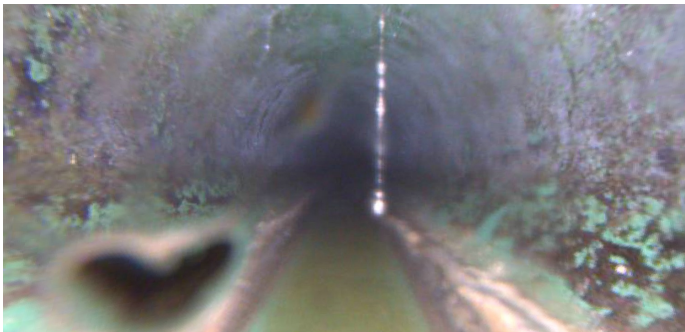
Code:	MSA
Description:	Abandoned Survey

Distance (ft):	66.9
Structural Grade:	0
O&M Grade:	0
Clock Start/From:	
Clock To:	
1st Value:	
2nd Value:	
Value Percent:	
Continuous Index:	
Within 8" of Joint:	NO
Remarks:	unknown
