Profile/Photo Observation Report

Location Details:		Direction of Survey:	Downstream
US MH:	M-303-063	DS MH:	M-303-059
		Total Length Surveyed (ft):	223.3

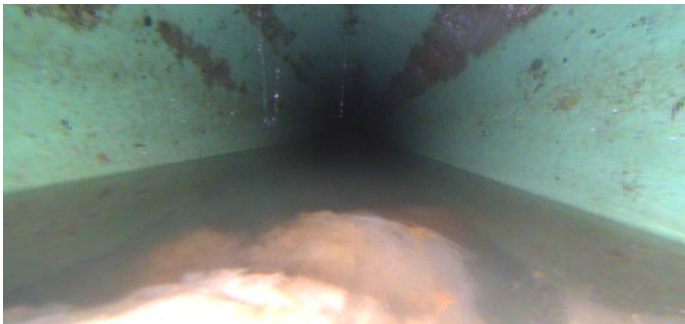
Code: **AMH**
Description: **Manhole**

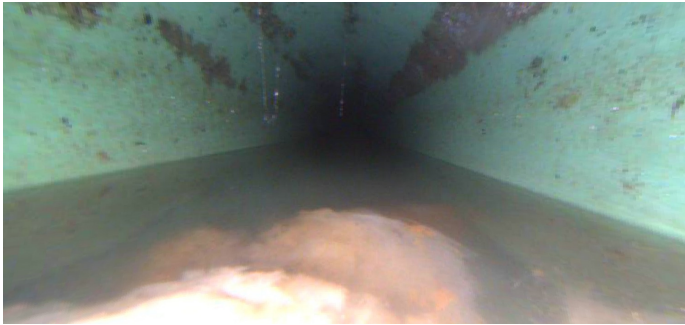
Code:	MWL
Description:	Water Level

Distance (ft):	.0
Structural Grade:	0
O&M Grade:	0
Clock Start/From:	
Clock To:	
1st Value:	
2nd Value:	
Value Percent:	15.000
Continuous Index:	
Within 8" of Joint:	NO
Remarks:

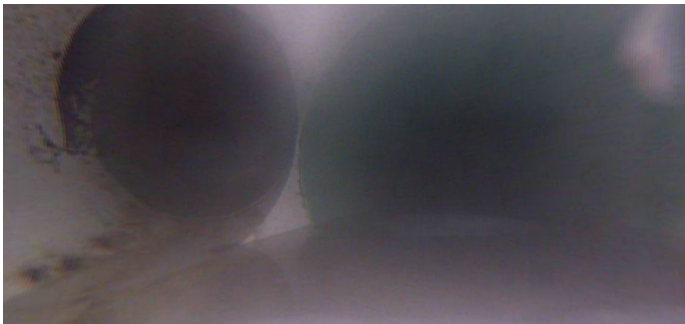
Code:	TF
Description:	Tap Factory

Distance (ft):	49.7
Structural Grade:	0
O&M Grade:	0
Clock Start/From:	9
Clock To:	
1st Value:	6.000
2nd Value:	
Value Percent:	
Continuous Index:	
Within 8" of Joint:	
Remarks:

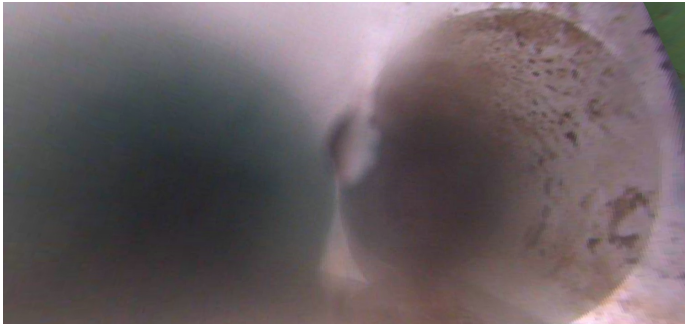
Code: **TF**
Description: **Tap Factory**

Distance (ft): **75.7**
Structural Grade: **0**
O&M Grade: **0**
Clock Start/From: **3**
Clock To:
1st Value: **6.000**
2nd Value:
Value Percent:
Continuous Index:
Within 8" of Joint:
Remarks:

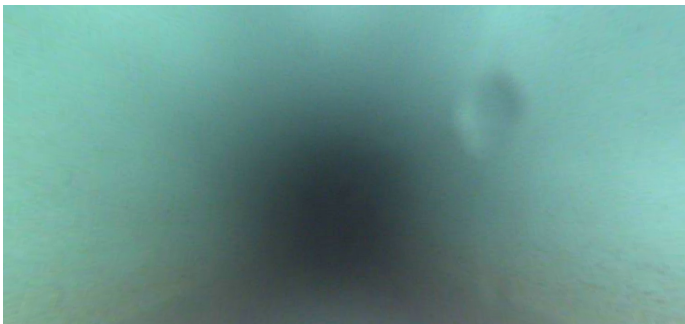
Code: **MGO**
Description: **General Observation**

Distance (ft): **77.3**
Structural Grade: **0**
O&M Grade: **0**
Clock Start/From:
Clock To:
1st Value:
2nd Value:
Value Percent:
Continuous Index:
Within 8" of Joint: **NO**
Remarks: **LIGHT FOG/STEAM**

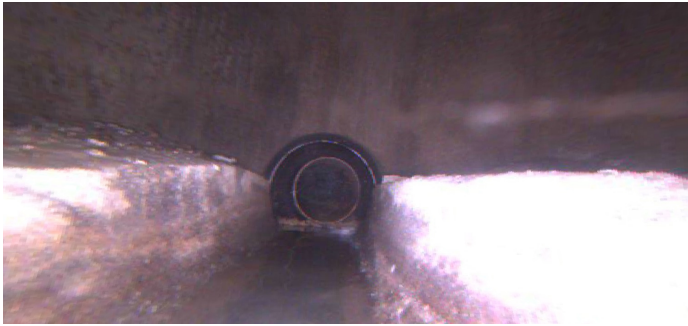
Code:	AMH
Description:	Manhole
Distance (ft):	223.3
Structural Grade:	0
O&M Grade:	0
Clock Start/From:	
Clock To:	
1st Value:	
2nd Value:	
Value Percent:	
Continuous Index:	
Within 8" of Joint:	NO
Remarks:	M-303-059
