## Profile/Photo Observation Report

Street:	<b>E HANSEN BLVD &amp; S HANSEN BLVD</b>	Flow Control:	<b>Not Controlled</b>
City:	<b>Hobart, IN</b>	Year Renewed:	
Location:	<b>Other</b>	Tape/Media #:	
Purpose:	<b>Not Known</b>	Dia/Height:	<b>10"</b>
Use:	<b>Sanitary</b>	Material:	<b>PVC</b>
Drain Area:	<b>NA</b>	Lining:	
Category:	<b>NA</b>		
Comment:

Location Details:		Direction of Survey:	<b>Downstream</b>
US MH:	<b>M-303-065</b>	DS MH:	<b>M-303-064</b>
		Total Length Surveyed (ft):	<b>267.5</b>

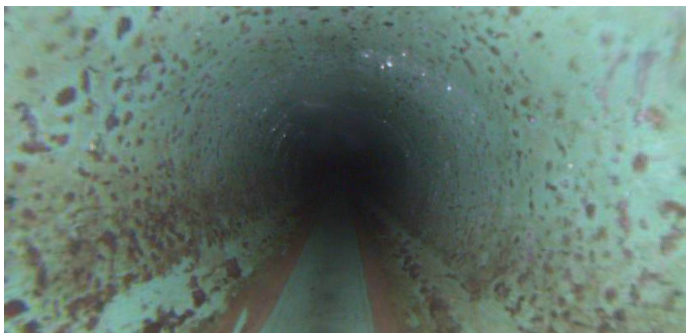
Code: **AMH**  
Description: **Manhole**

Distance (ft): **.0**  
Structural Grade: **0**  
O&M Grade: **0**  
Clock Start/From:  
Clock To:  
1st Value:  
2nd Value:  
Value Percent:  
Continuous Index:  
Within 8" of Joint: **NO**  
Remarks: **M-303-065**

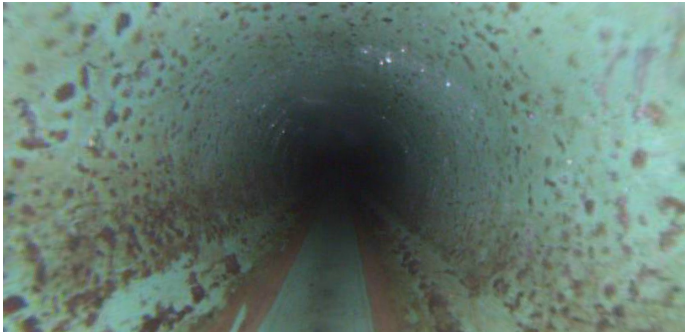
Code:	<b>MWL</b>
Description:	<b>Water Level</b>

Distance (ft):	<b>.0</b>
Structural Grade:	<b>0</b>
O&M Grade:	<b>0</b>
Clock Start/From:	
Clock To:	
1st Value:	
2nd Value:	
Value Percent:	<b>5.000</b>
Continuous Index:	
Within 8" of Joint:	<b>NO</b>
Remarks:

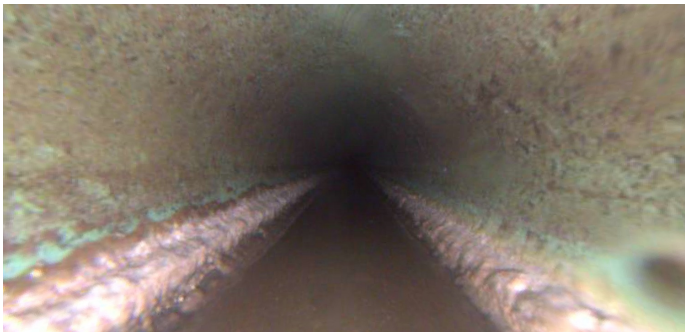
Code:	<b>DAGS</b>
Description:	<b>Deposits Attached Grease</b>

Distance (ft):	<b>16.5</b>
Structural Grade:	<b>0</b>
O&M Grade:	<b>2</b>
Clock Start/From:	<b>7</b>
Clock To:	<b>5</b>
1st Value:	
2nd Value:	
Value Percent:	<b>5.000</b>
Continuous Index:	<b>S01</b>
Within 8" of Joint:	<b>NO</b>
Remarks:

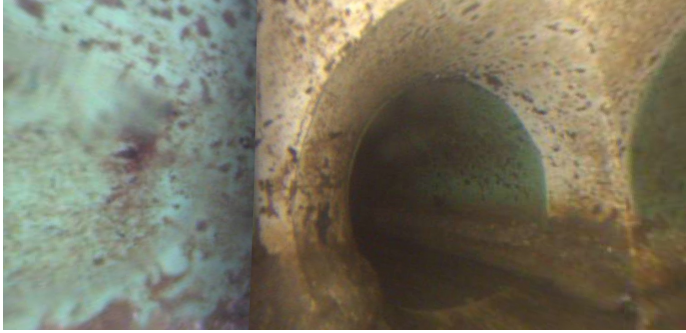
Code: **TFA**  
Description: **Tap Factory Active**

Distance (ft): **26.6**  
Structural Grade: **0**  
O&M Grade: **0**  
Clock Start/From: **3**  
Clock To:  
1st Value: **4.000**  
2nd Value:  
Value Percent:  
Continuous Index:  
Within 8" of Joint:  
Remarks:

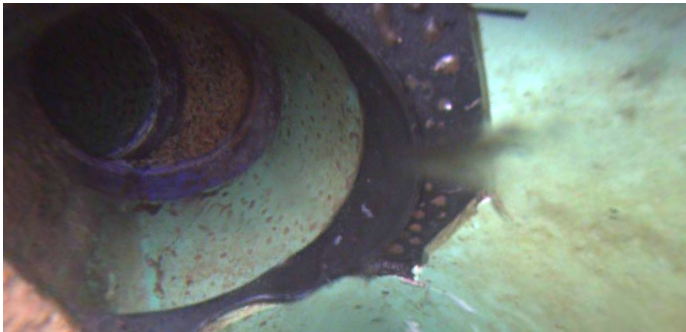
Code: **TS**  
Description: **Tap Saddle**

Distance (ft): **50.8**  
Structural Grade: **0**  
O&M Grade: **0**  
Clock Start/From: **11**  
Clock To:  
1st Value: **4.000**  
2nd Value:  
Value Percent:  
Continuous Index:  
Within 8" of Joint:  
Remarks:

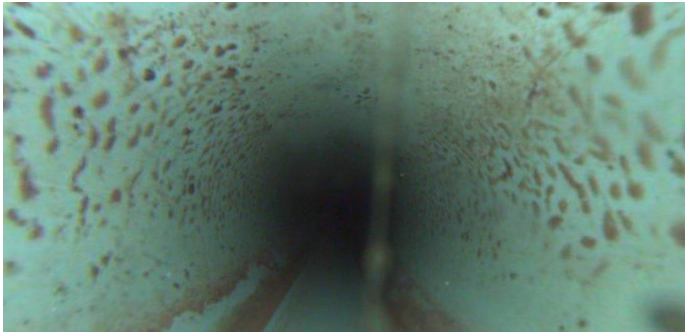
Code: **DAGS**  
Description: **Deposits Attached Grease**

Distance (ft): **71.3**  
Structural Grade: **0**  
O&M Grade: **2**  
Clock Start/From: **7**  
Clock To: **5**  
1st Value:  
2nd Value:  
Value Percent: **5.000**  
Continuous Index: **F01**  
Within 8" of Joint: **NO**  
Remarks:

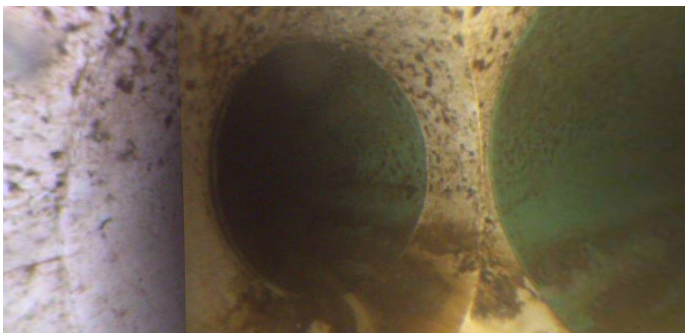
Code: **TF**  
Description: **Tap Factory**

Distance (ft): **79.4**  
Structural Grade: **0**  
O&M Grade: **0**  
Clock Start/From: **3**  
Clock To:  
1st Value: **4.000**  
2nd Value:  
Value Percent:  
Continuous Index:  
Within 8" of Joint:  
Remarks:

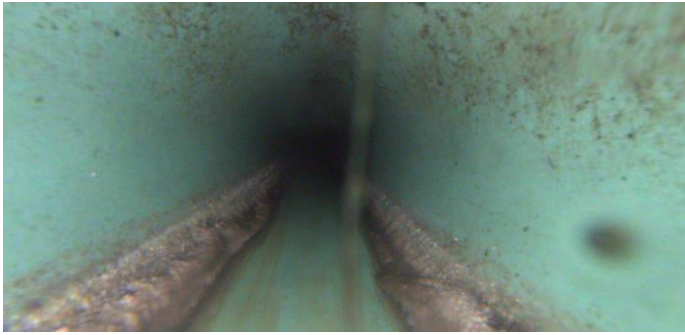
Code: **DAGS**  
Description: **Deposits Attached Grease**

Distance (ft): **81.2**  
Structural Grade: **0**  
O&M Grade: **2**  
Clock Start/From: **7**  
Clock To: **5**  
1st Value:  
2nd Value:  
Value Percent: **5.000**  
Continuous Index: **S02**  
Within 8" of Joint: **NO**  
Remarks:

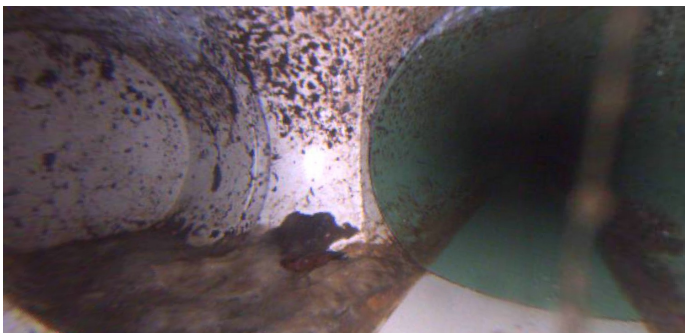
Code: **TFC**  
Description: **Tap Factory Capped**

Distance (ft): **92.6**  
Structural Grade: **0**  
O&M Grade: **0**  
Clock Start/From: **9**  
Clock To:  
1st Value: **4.000**  
2nd Value:  
Value Percent:  
Continuous Index:  
Within 8" of Joint:  
Remarks:

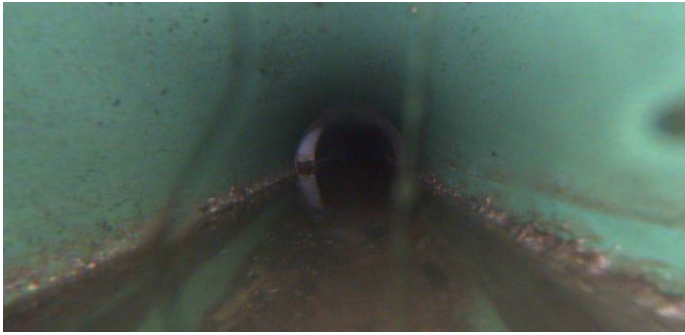
Code: **MWL**  
Description: **Water Level**

Distance (ft): **170.3**  
Structural Grade: **0**  
O&M Grade: **0**  
Clock Start/From:  
Clock To:  
1st Value:  
2nd Value:  
Value Percent: **30.000**  
Continuous Index:  
Within 8" of Joint: **NO**  
Remarks:

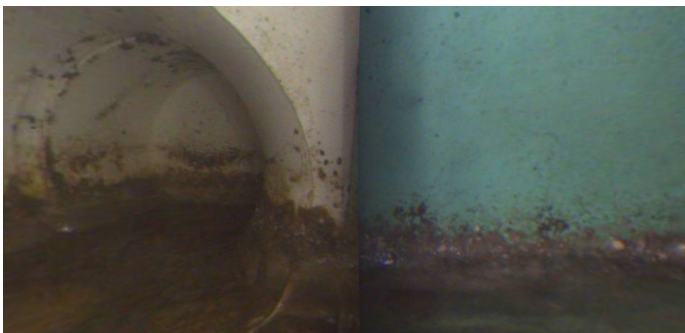
Code: **TFC**  
Description: **Tap Factory Capped**

Distance (ft): **172.8**  
Structural Grade: **0**  
O&M Grade: **0**  
Clock Start/From: **9**  
Clock To:  
1st Value: **4.000**  
2nd Value:  
Value Percent:  
Continuous Index:  
Within 8" of Joint:  
Remarks:

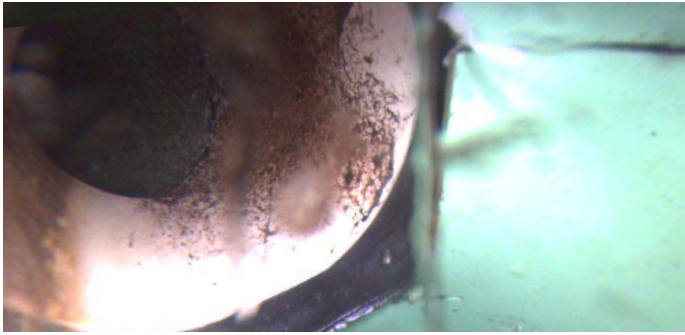
Code: **TB**  
Description: **Tap Break-in**

Distance (ft): **192.2**  
Structural Grade: **0**  
O&M Grade: **0**  
Clock Start/From: **10**  
Clock To:  
1st Value: **4.000**  
2nd Value:  
Value Percent:  
Continuous Index:  
Within 8" of Joint:  
Remarks:

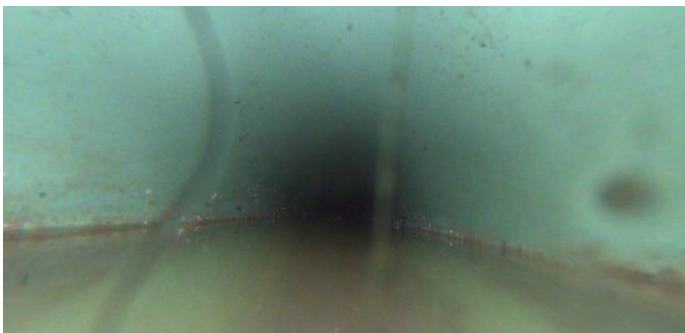
Code: **DAGS**  
Description: **Deposits Attached Grease**

Distance (ft): **194.8**  
Structural Grade: **0**  
O&M Grade: **2**  
Clock Start/From: **7**  
Clock To: **5**  
1st Value:  
2nd Value:  
Value Percent: **5.000**  
Continuous Index: **F02**  
Within 8" of Joint: **NO**  
Remarks:

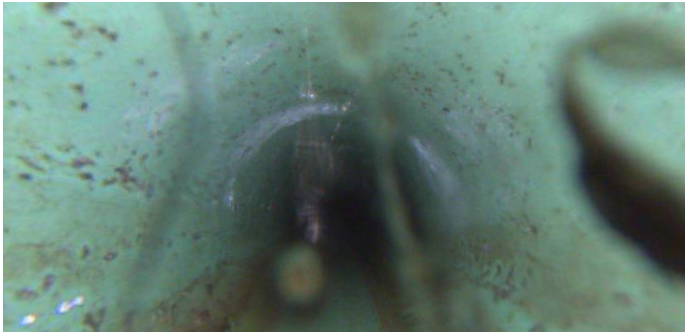
Code: **MWL**  
Description: **Water Level**

Distance (ft): **217.7**  
Structural Grade: **0**  
O&M Grade: **0**  
Clock Start/From:  
Clock To:  
1st Value:  
2nd Value:  
Value Percent: **5.000**  
Continuous Index:  
Within 8" of Joint: **NO**  
Remarks:

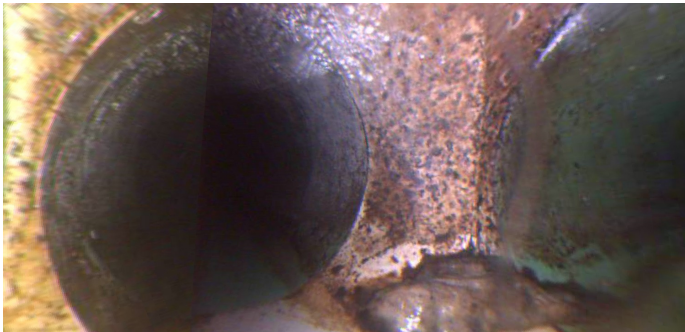
Code: **TF**  
Description: **Tap Factory**

Distance (ft): **238.5**  
Structural Grade: **0**  
O&M Grade: **0**  
Clock Start/From: **9**  
Clock To:  
1st Value: **4.000**  
2nd Value:  
Value Percent:  
Continuous Index:  
Within 8" of Joint:  
Remarks:

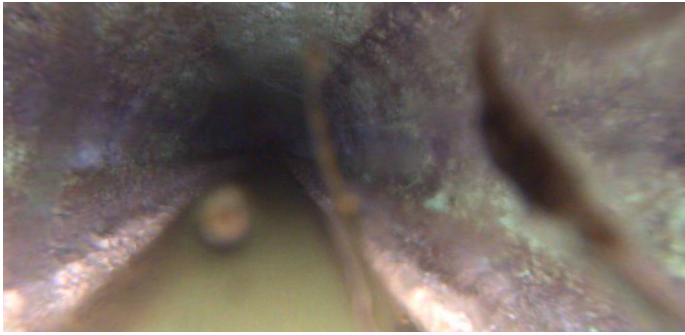
Code: **DAGS**  
Description: **Deposits Attached Grease**

Distance (ft): **256.0**  
Structural Grade: **0**  
O&M Grade: **2**  
Clock Start/From: **8**  
Clock To: **4**  
1st Value:  
2nd Value:  
Value Percent: **5.000**  
Continuous Index: **S03**  
Within 8" of Joint: **NO**  
Remarks:

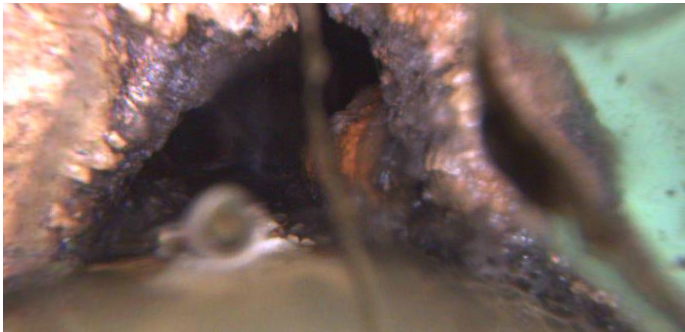
Code: **DAE**  
Description: **Deposits Attached Encrustation**

Distance (ft): **265.2**  
Structural Grade: **0**  
O&M Grade: **4**  
Clock Start/From: **8**  
Clock To: **4**  
1st Value:  
2nd Value:  
Value Percent: **30.000**  
Continuous Index:  
Within 8" of Joint: **NO**  
Remarks:

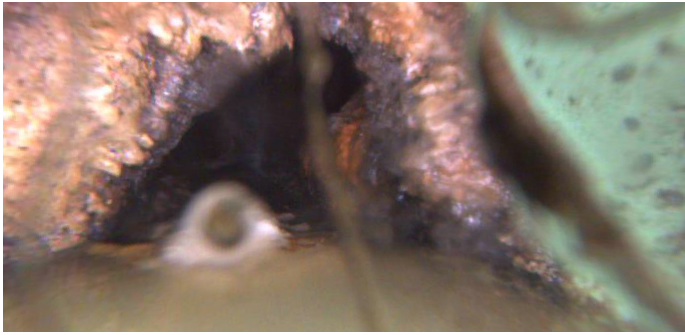
Code: **DAGS**  
Description: **Deposits Attached Grease**

Distance (ft): **265.2**  
Structural Grade: **0**  
O&M Grade: **2**  
Clock Start/From: **8**  
Clock To: **4**  
1st Value:  
2nd Value:  
Value Percent: **5.000**  
Continuous Index: **F03**  
Within 8" of Joint: **NO**  
Remarks:

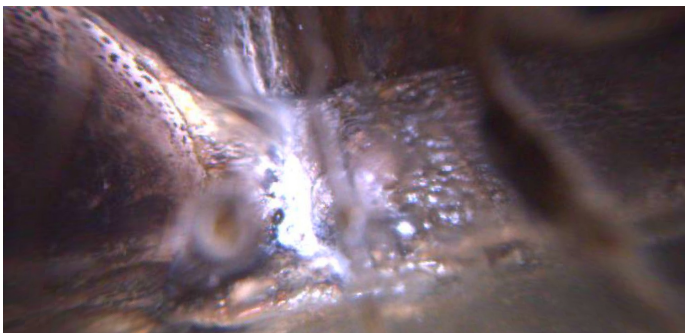
Code: **AMH**  
Description: **Manhole**

Distance (ft): **267.5**  
Structural Grade: **0**  
O&M Grade: **0**  
Clock Start/From:  
Clock To:  
1st Value:  
2nd Value:  
Value Percent:  
Continuous Index:  
Within 8" of Joint: **NO**  
Remarks: **M-303-064**
