Profile/Photo Observation Report

Date:	04/04/2018	Weather:		Coding:	PACP 6.0
Pipe Length (ft):	265.8	Owner:	NA	Pre Clean:	Not Known
P.O.#:		Surveyor:	Jen Costello	PSR:	P-303-065-064
Customer:		Clean Date:	01/01/1900	Shape:	C

Street:	w hansen blvd	Flow Control:	Not Controlled
City:	Hobart, IN	Year Renewed:	
Location:	Other	Tape/Media #:	
Purpose:	Not Known	Dia/Height:	10"
Use:	Sanitary	Material:	PVC
Drain Area:	NA	Lining:	
Category:	NA		
Comment:

Location Details:		Direction of Survey:	Downstream
US MH:	M-303-065	DS MH:	M-303-064
		Total Length Surveyed (ft):	267.5

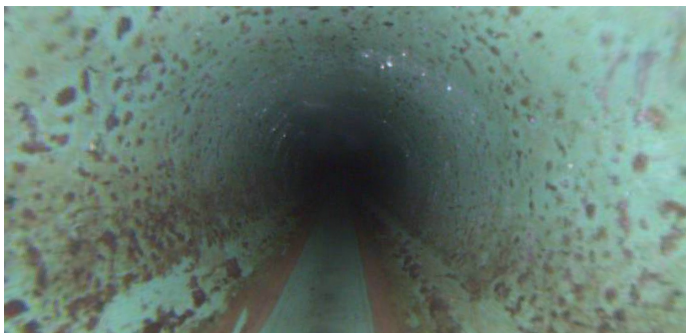
Code: **AMH**
Description: **Manhole**

Distance (ft): **.0**
Structural Grade: **0**
O&M Grade: **0**
Clock Start/From:
Clock To:
1st Value:
2nd Value:
Value Percent:
Continuous Index:
Within 8" of Joint: **NO**
Remarks: **M-303-065**

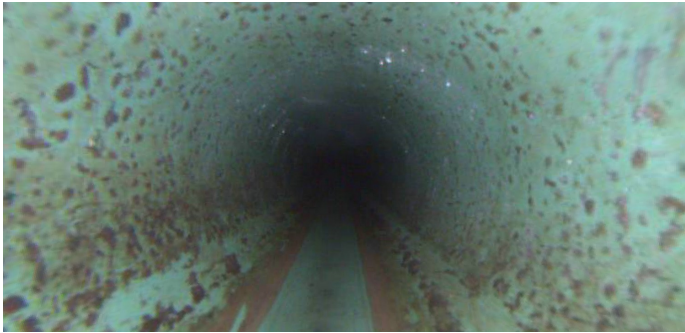
Code:	MWL
Description:	Water Level

Distance (ft):	.0
Structural Grade:	0
O&M Grade:	0
Clock Start/From:	
Clock To:	
1st Value:	
2nd Value:	
Value Percent:	5.000
Continuous Index:	
Within 8" of Joint:	NO
Remarks:

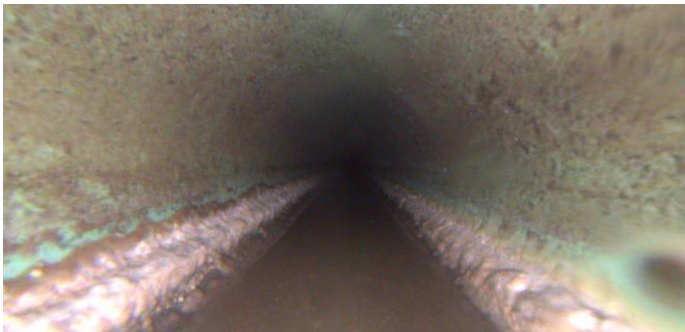
Code:	DAGS
Description:	Deposits Attached Grease

Distance (ft):	16.5
Structural Grade:	0
O&M Grade:	2
Clock Start/From:	7
Clock To:	5
1st Value:	
2nd Value:	
Value Percent:	5.000
Continuous Index:	S01
Within 8" of Joint:	NO
Remarks:

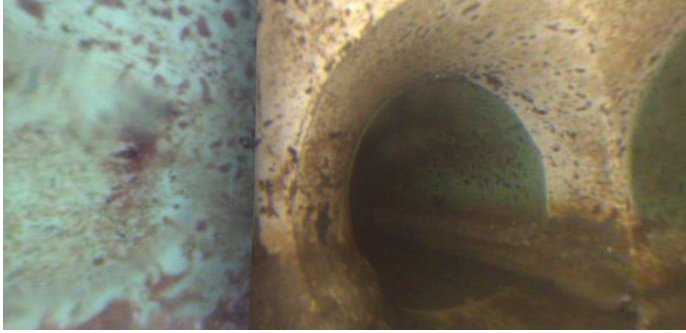
Code: **TFA**
Description: **Tap Factory Active**

Distance (ft): **26.6**
Structural Grade: **0**
O&M Grade: **0**
Clock Start/From: **3**
Clock To:
1st Value: **4.000**
2nd Value:
Value Percent:
Continuous Index:
Within 8" of Joint:
Remarks:

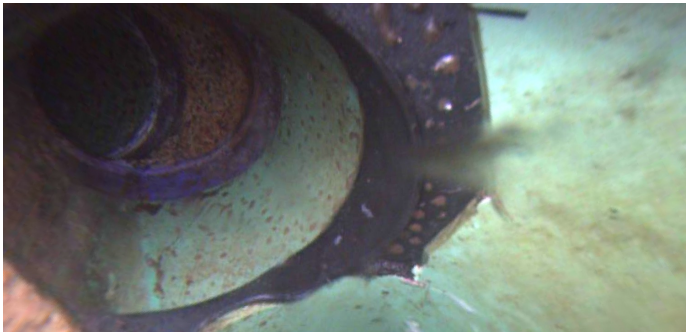
Code: **TS**
Description: **Tap Saddle**

Distance (ft): **50.8**
Structural Grade: **0**
O&M Grade: **0**
Clock Start/From: **11**
Clock To:
1st Value: **4.000**
2nd Value:
Value Percent:
Continuous Index:
Within 8" of Joint:
Remarks:

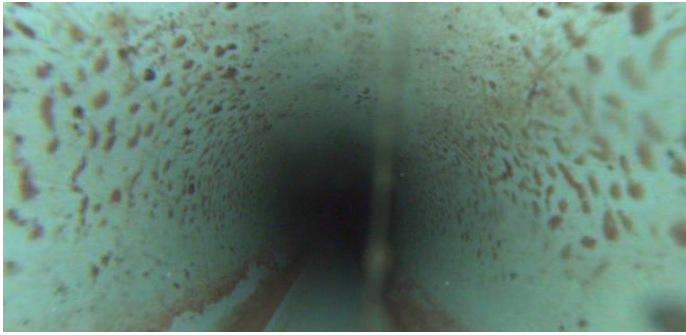
Code: **DAGS**
Description: **Deposits Attached Grease**

Distance (ft): **71.3**
Structural Grade: **0**
O&M Grade: **2**
Clock Start/From: **7**
Clock To: **5**
1st Value:
2nd Value:
Value Percent: **5.000**
Continuous Index: **F01**
Within 8" of Joint: **NO**
Remarks:

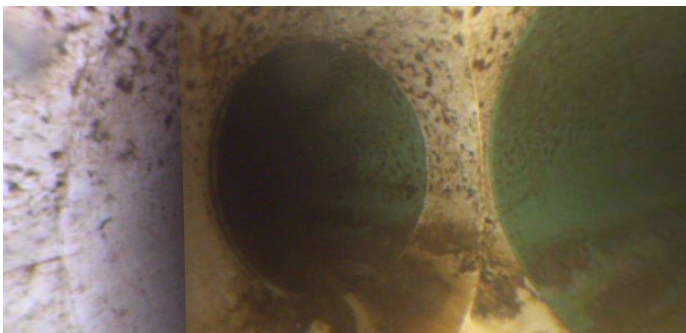
Code: **TF**
Description: **Tap Factory**

Distance (ft): **79.4**
Structural Grade: **0**
O&M Grade: **0**
Clock Start/From: **3**
Clock To:
1st Value: **4.000**
2nd Value:
Value Percent:
Continuous Index:
Within 8" of Joint:
Remarks:

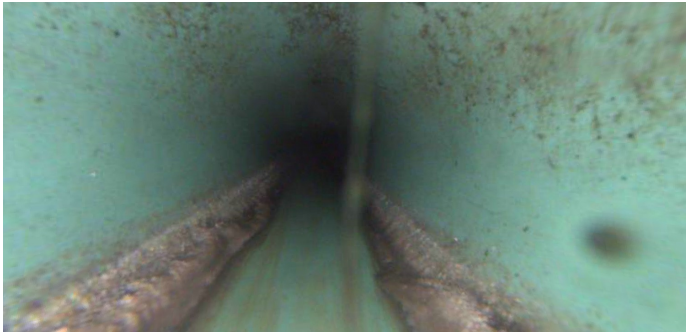
Code: **DAGS**
Description: **Deposits Attached Grease**

Distance (ft): **81.2**
Structural Grade: **0**
O&M Grade: **2**
Clock Start/From: **7**
Clock To: **5**
1st Value:
2nd Value:
Value Percent: **5.000**
Continuous Index: **S02**
Within 8" of Joint: **NO**
Remarks:

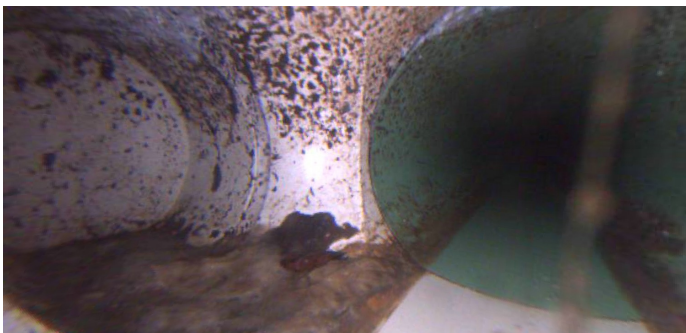
Code: **TFC**
Description: **Tap Factory Capped**

Distance (ft): **92.6**
Structural Grade: **0**
O&M Grade: **0**
Clock Start/From: **9**
Clock To:
1st Value: **4.000**
2nd Value:
Value Percent:
Continuous Index:
Within 8" of Joint:
Remarks:

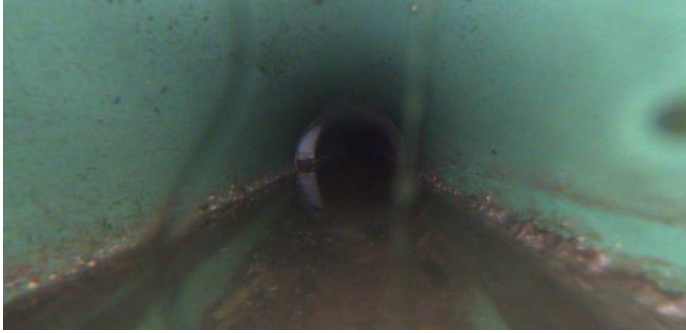
Code: **MWL**
Description: **Water Level**

Distance (ft): **170.3**
Structural Grade: **0**
O&M Grade: **0**
Clock Start/From:
Clock To:
1st Value:
2nd Value:
Value Percent: **30.000**
Continuous Index:
Within 8" of Joint: **NO**
Remarks:

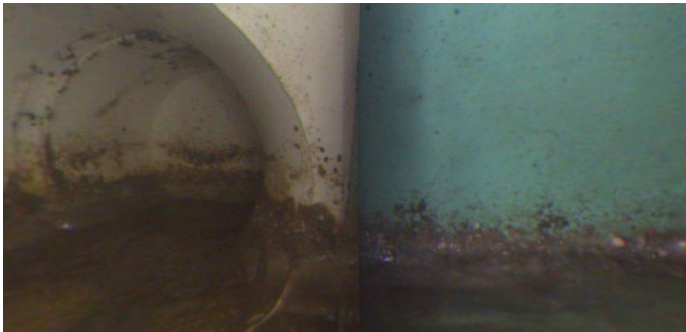
Code: **TFC**
Description: **Tap Factory Capped**

Distance (ft): **172.8**
Structural Grade: **0**
O&M Grade: **0**
Clock Start/From: **9**
Clock To:
1st Value: **4.000**
2nd Value:
Value Percent:
Continuous Index:
Within 8" of Joint:
Remarks:

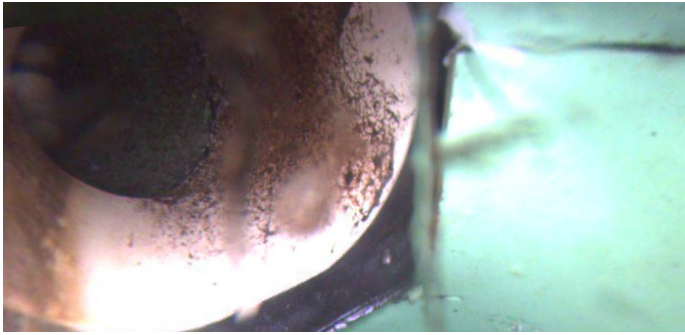
Code: **TB**
Description: **Tap Break-in**

Distance (ft): **192.2**
Structural Grade: **0**
O&M Grade: **0**
Clock Start/From: **10**
Clock To:
1st Value: **4.000**
2nd Value:
Value Percent:
Continuous Index:
Within 8" of Joint:
Remarks:

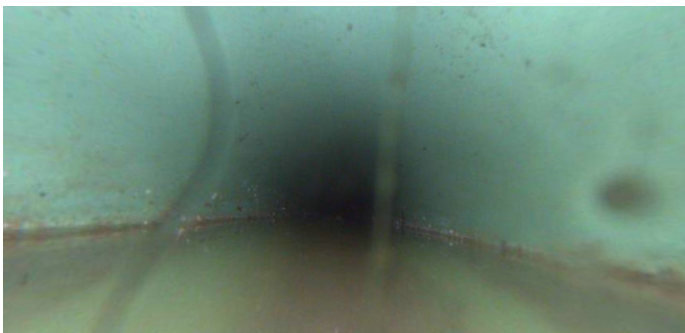
Code: **DAGS**
Description: **Deposits Attached Grease**

Distance (ft): **194.8**
Structural Grade: **0**
O&M Grade: **2**
Clock Start/From: **7**
Clock To: **5**
1st Value:
2nd Value:
Value Percent: **5.000**
Continuous Index: **F02**
Within 8" of Joint: **NO**
Remarks:

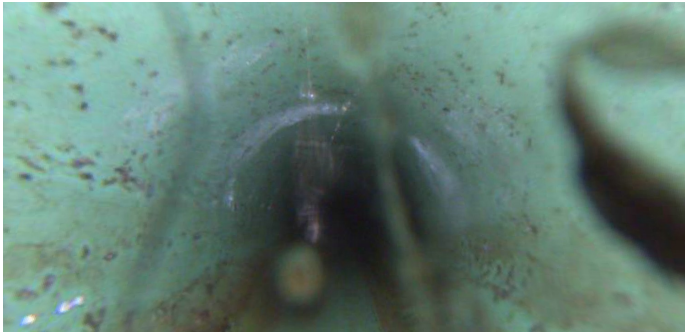
Code: **MWL**
Description: **Water Level**

Distance (ft): **217.7**
Structural Grade: **0**
O&M Grade: **0**
Clock Start/From:
Clock To:
1st Value:
2nd Value:
Value Percent: **5.000**
Continuous Index:
Within 8" of Joint: **NO**
Remarks:

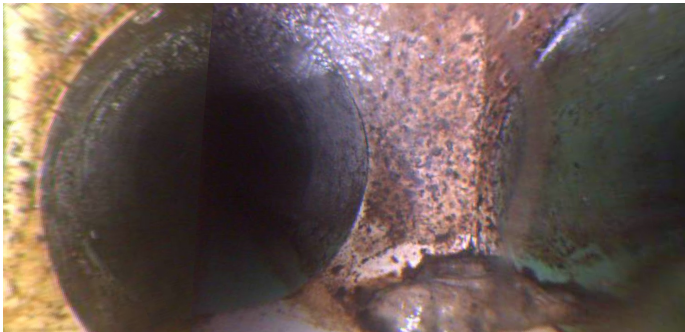
Code: **TF**
Description: **Tap Factory**

Distance (ft): **238.5**
Structural Grade: **0**
O&M Grade: **0**
Clock Start/From: **9**
Clock To:
1st Value: **4.000**
2nd Value:
Value Percent:
Continuous Index:
Within 8" of Joint:
Remarks:

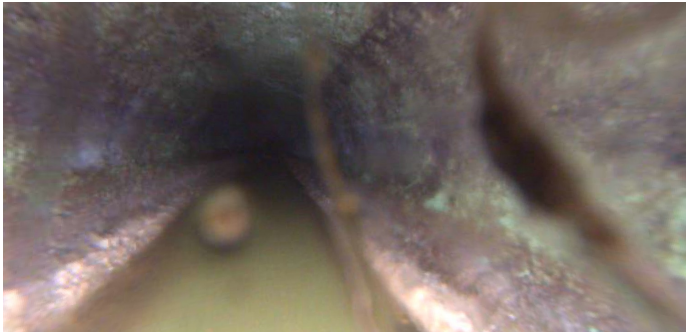
Code: **DAGS**
Description: **Deposits Attached Grease**

Distance (ft): **256.0**
Structural Grade: **0**
O&M Grade: **2**
Clock Start/From: **8**
Clock To: **4**
1st Value:
2nd Value:
Value Percent: **5.000**
Continuous Index: **S03**
Within 8" of Joint: **NO**
Remarks:

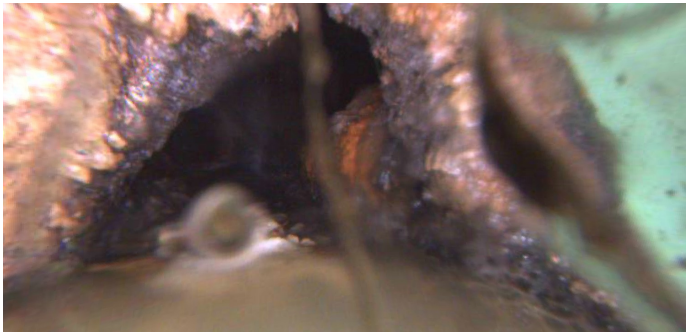
Code: **DAE**
Description: **Deposits Attached Encrustation**

Distance (ft): **265.2**
Structural Grade: **0**
O&M Grade: **4**
Clock Start/From: **8**
Clock To: **4**
1st Value:
2nd Value:
Value Percent: **30.000**
Continuous Index:
Within 8" of Joint: **NO**
Remarks:

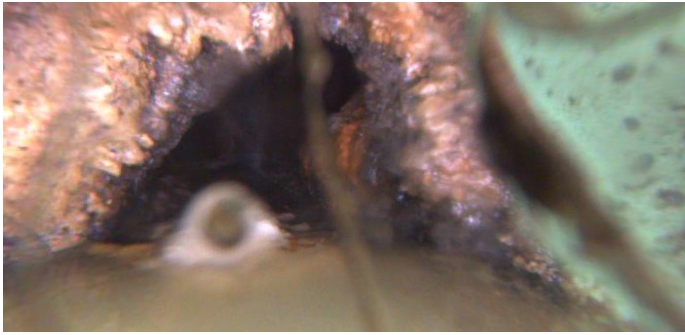
Code: **DAGS**
Description: **Deposits Attached Grease**

Distance (ft): **265.2**
Structural Grade: **0**
O&M Grade: **2**
Clock Start/From: **8**
Clock To: **4**
1st Value:
2nd Value:
Value Percent: **5.000**
Continuous Index: **F03**
Within 8" of Joint: **NO**
Remarks:

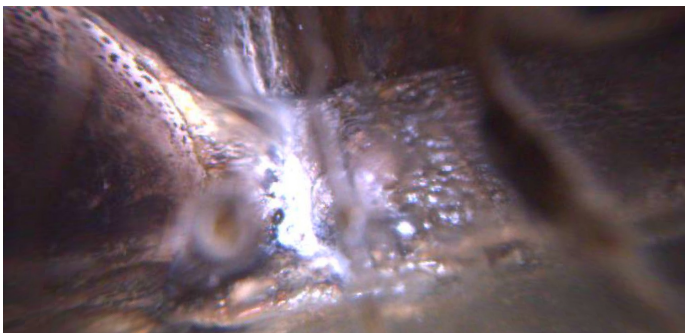
Code: **AMH**
Description: **Manhole**

Distance (ft): **267.5**
Structural Grade: **0**
O&M Grade: **0**
Clock Start/From:
Clock To:
1st Value:
2nd Value:
Value Percent:
Continuous Index:
Within 8" of Joint: **NO**
Remarks: **M-303-064**
