## Profile/Photo Observation Report

Date:	<b>04/04/2018</b>	Weather:		Coding:	<b>PACP 6.0</b>
Pipe Length (ft):	<b>282.5</b>	Owner:	<b>NA</b>	Pre Clean:	<b>Not Known</b>
P.O.#:		Surveyor:	<b>Jen Costello</b>	PSR:	<b>P-303-066-065</b>
Customer:		Clean Date:	<b>01/01/1900</b>	Shape:	<b>C</b>

Street:	<b>E HANSEN BLVD</b>	Flow Control:	<b>Not Controlled</b>
City:	<b>Hobart, IN</b>	Year Renewed:	
Location:	<b>Other</b>	Tape/Media #:	
Purpose:	<b>Not Known</b>	Dia/Height:	<b>10"</b>
Use:	<b>Sanitary</b>	Material:	<b>PVC</b>
Drain Area:	<b>NA</b>	Lining:	
Category:	<b>NA</b>		
Comment:

Location Details:		Direction of Survey:	<b>Upstream</b>
US MH:	<b>M-303-065</b>	DS MH:	<b>M-303-066</b>
		Total Length Surveyed (ft):	<b>278.3</b>

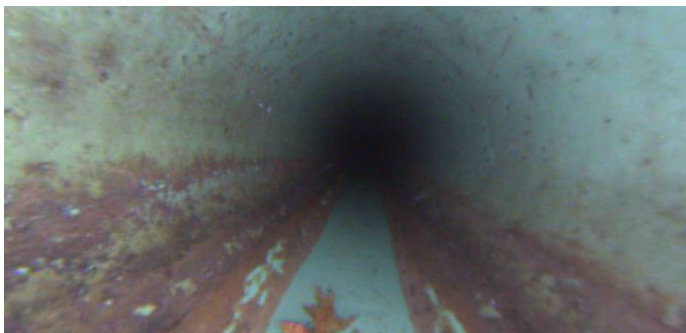
Code: **AMH**  
Description: **Manhole**

Distance (ft): **.0**  
Structural Grade: **0**  
O&M Grade: **0**  
Clock Start/From:  
Clock To:  
1st Value:  
2nd Value:  
Value Percent:  
Continuous Index:  
Within 8" of Joint: **NO**  
Remarks: **M-303-066**

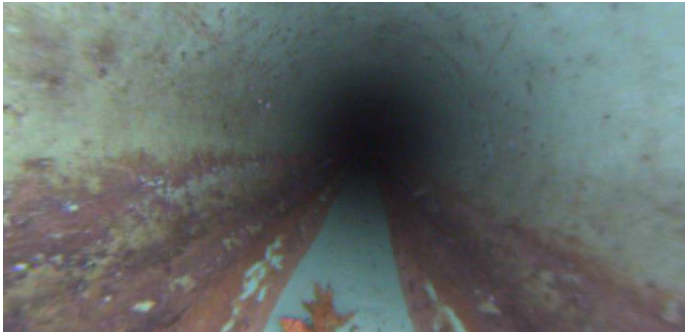
Code:	<b>MWL</b>
Description:	<b>Water Level</b>

Distance (ft):	<b>.0</b>
Structural Grade:	<b>0</b>
O&M Grade:	<b>0</b>
Clock Start/From:	
Clock To:	
1st Value:	
2nd Value:	
Value Percent:	<b>5.000</b>
Continuous Index:	
Within 8" of Joint:	<b>NO</b>
Remarks:

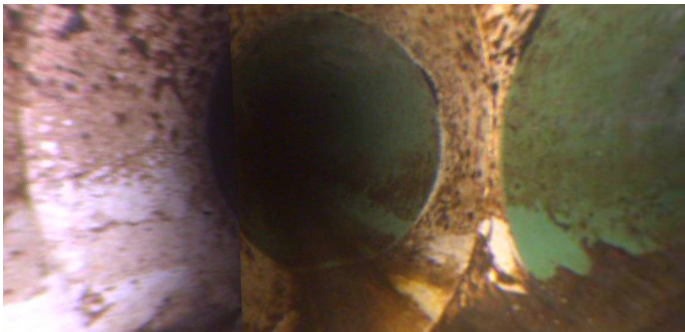
Code:	<b>TFA</b>
Description:	<b>Tap Factory Active</b>

Distance (ft):	<b>32.0</b>
Structural Grade:	<b>0</b>
O&M Grade:	<b>0</b>
Clock Start/From:	<b>3</b>
Clock To:	
1st Value:	<b>4.000</b>
2nd Value:	
Value Percent:	
Continuous Index:	
Within 8" of Joint:	
Remarks:

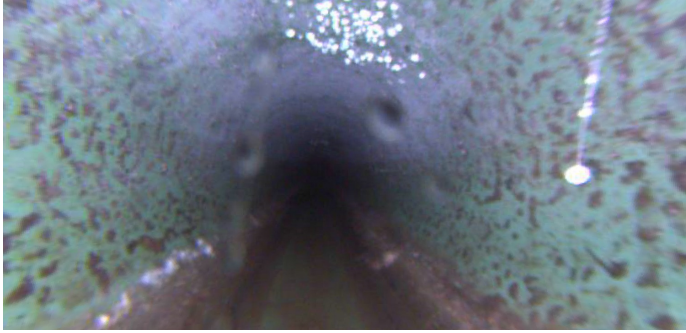
Code: **DAGS**  
Description: **Deposits Attached Grease**

Distance (ft): **88.6**  
Structural Grade: **0**  
O&M Grade: **2**  
Clock Start/From: **4**  
Clock To: **8**  
1st Value:  
2nd Value:  
Value Percent: **5.000**  
Continuous Index: **S01**  
Within 8" of Joint: **NO**  
Remarks:

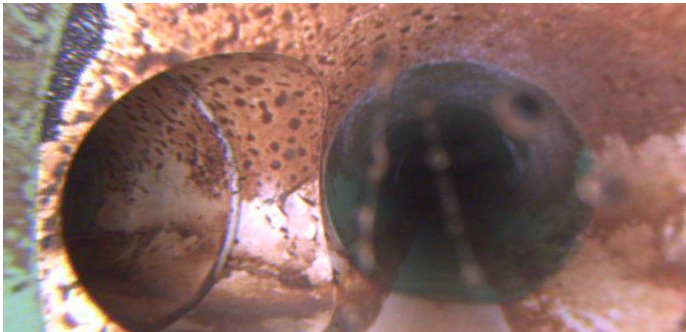
Code: **TF**  
Description: **Tap Factory**

Distance (ft): **95.4**  
Structural Grade: **0**  
O&M Grade: **0**  
Clock Start/From: **9**  
Clock To:  
1st Value: **4.000**  
2nd Value:  
Value Percent:  
Continuous Index:  
Within 8" of Joint:  
Remarks:

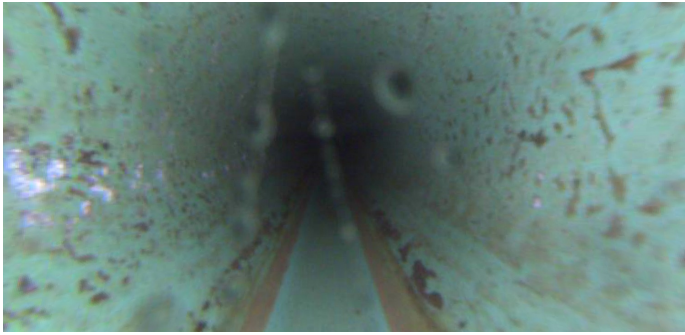
Code: **DAGS**  
Description: **Deposits Attached Grease**

Distance (ft): **101.5**  
Structural Grade: **0**  
O&M Grade: **2**  
Clock Start/From: **4**  
Clock To: **8**  
1st Value:  
2nd Value:  
Value Percent: **5.000**  
Continuous Index: **F01**  
Within 8" of Joint: **NO**  
Remarks:

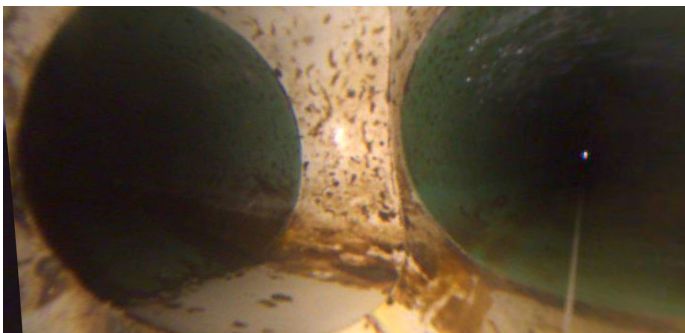
Code: **TF**  
Description: **Tap Factory**

Distance (ft): **109.3**  
Structural Grade: **0**  
O&M Grade: **0**  
Clock Start/From: **3**  
Clock To:  
1st Value: **4.000**  
2nd Value:  
Value Percent:  
Continuous Index:  
Within 8" of Joint:  
Remarks:

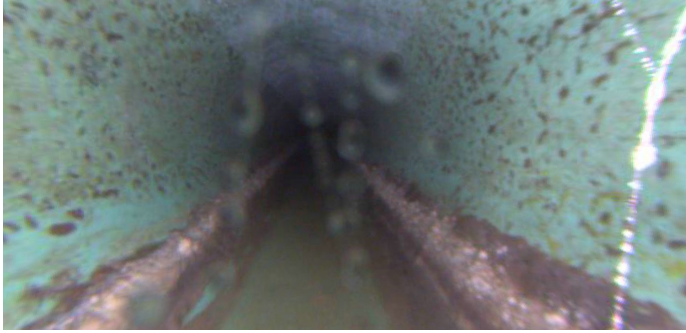
Code: **DAGS**  
Description: **Deposits Attached Grease**

Distance (ft): **113.1**  
Structural Grade: **0**  
O&M Grade: **2**  
Clock Start/From: **7**  
Clock To: **5**  
1st Value:  
2nd Value:  
Value Percent: **5.000**  
Continuous Index: **S02**  
Within 8" of Joint: **NO**  
Remarks:

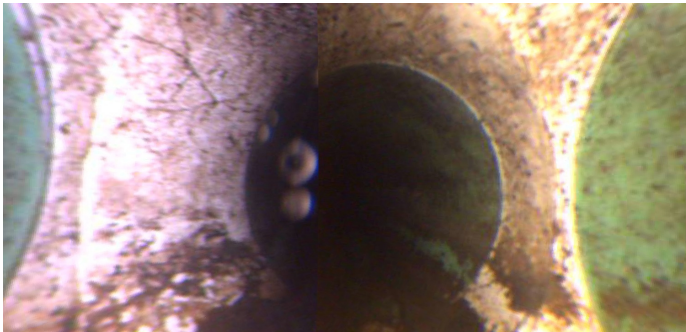
Code: **TF**  
Description: **Tap Factory**

Distance (ft): **160.5**  
Structural Grade: **0**  
O&M Grade: **0**  
Clock Start/From: **3**  
Clock To:  
1st Value: **4.000**  
2nd Value:  
Value Percent:  
Continuous Index:  
Within 8" of Joint: **NO**  
Remarks:

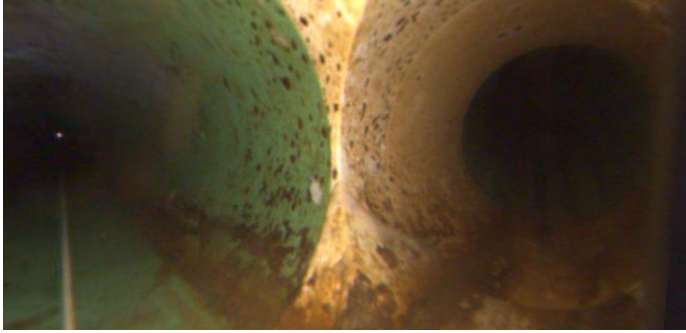
Code: **TF**  
Description: **Tap Factory**

Distance (ft): **173.7**  
Structural Grade: **0**  
O&M Grade: **0**  
Clock Start/From: **9**  
Clock To:  
1st Value: **4.000**  
2nd Value:  
Value Percent:  
Continuous Index:  
Within 8" of Joint:  
Remarks:

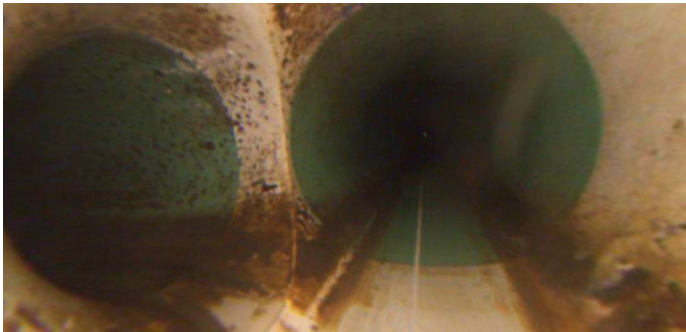
Code: **TF**  
Description: **Tap Factory**

Distance (ft): **225.5**  
Structural Grade: **0**  
O&M Grade: **0**  
Clock Start/From: **3**  
Clock To:  
1st Value: **4.000**  
2nd Value:  
Value Percent:  
Continuous Index:  
Within 8" of Joint:  
Remarks:

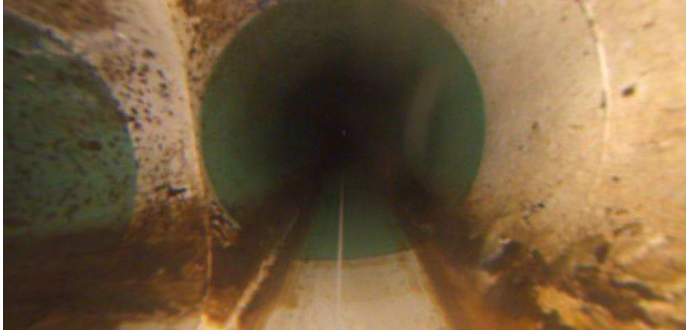
Code: **MGO**  
Description: **General Observation**

Distance (ft): **225.5**  
Structural Grade: **0**  
O&M Grade: **0**  
Clock Start/From:  
Clock To:  
1st Value:  
2nd Value:  
Value Percent:  
Continuous Index:  
Within 8" of Joint: **NO**  
Remarks: **rear camera**

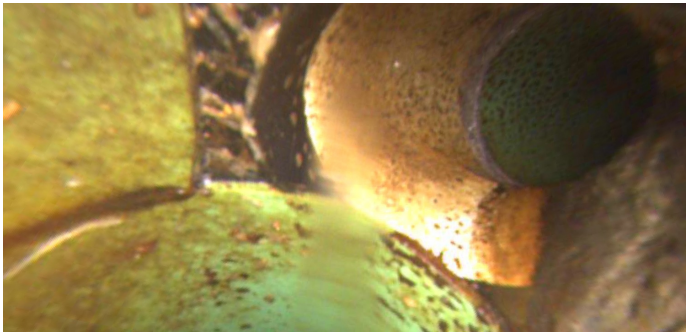
Code: **TB**  
Description: **Tap Break-in**

Distance (ft): **226.6**  
Structural Grade: **0**  
O&M Grade: **0**  
Clock Start/From: **11**  
Clock To:  
1st Value: **4.000**  
2nd Value:  
Value Percent:  
Continuous Index:  
Within 8" of Joint:  
Remarks:

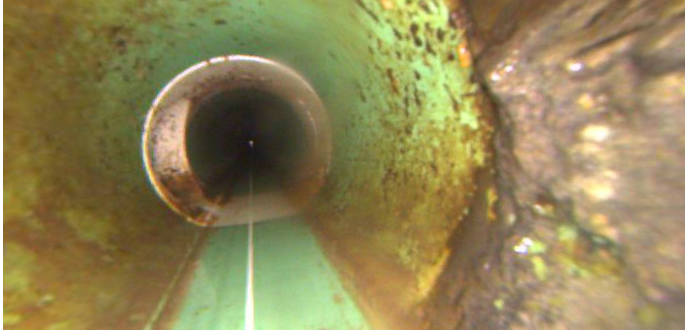
Code: **DAGS**  
Description: **Deposits Attached Grease**

Distance (ft): **226.6**  
Structural Grade: **0**  
O&M Grade: **2**  
Clock Start/From: **7**  
Clock To: **11**  
1st Value:  
2nd Value:  
Value Percent: **5.000**  
Continuous Index:  
Within 8" of Joint: **NO**  
Remarks:

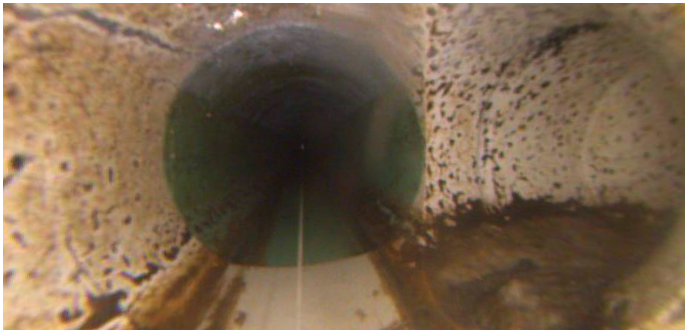
Code: **TFC**  
Description: **Tap Factory Capped**

Distance (ft): **238.8**  
Structural Grade: **0**  
O&M Grade: **0**  
Clock Start/From: **9**  
Clock To:  
1st Value: **4.000**  
2nd Value:  
Value Percent:  
Continuous Index:  
Within 8" of Joint:  
Remarks:

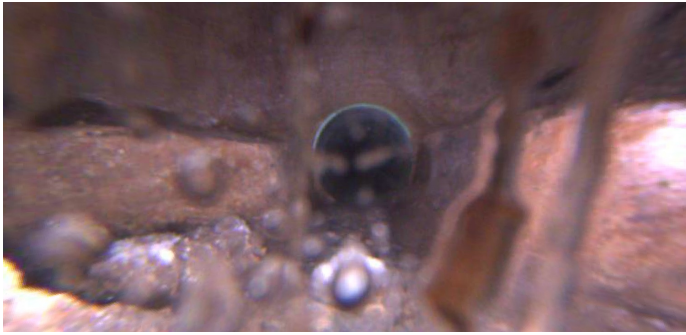
Code: **DAGS**  
Description: **Deposits Attached Grease**

Distance (ft): **278.3**  
Structural Grade: **0**  
O&M Grade: **2**  
Clock Start/From: **7**  
Clock To: **5**  
1st Value:  
2nd Value:  
Value Percent: **5.000**  
Continuous Index: **F02**  
Within 8" of Joint: **NO**  
Remarks:

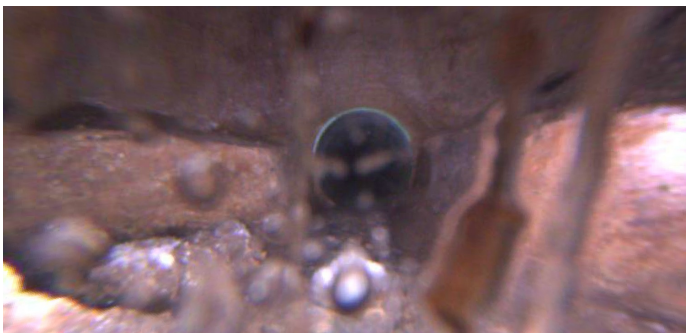
Code: **AMH**  
Description: **Manhole**

Distance (ft): **278.3**  
Structural Grade: **0**  
O&M Grade: **0**  
Clock Start/From:  
Clock To:  
1st Value:  
2nd Value:  
Value Percent:  
Continuous Index:  
Within 8" of Joint: **NO**  
Remarks: **M-303-065**
